Document: Confederation Line Wheel Flats report

Project: Confederation Line Performance Oversight

Client: Rideau Transit Group

Document Ref: JBAUSA/RTM/023-04-04

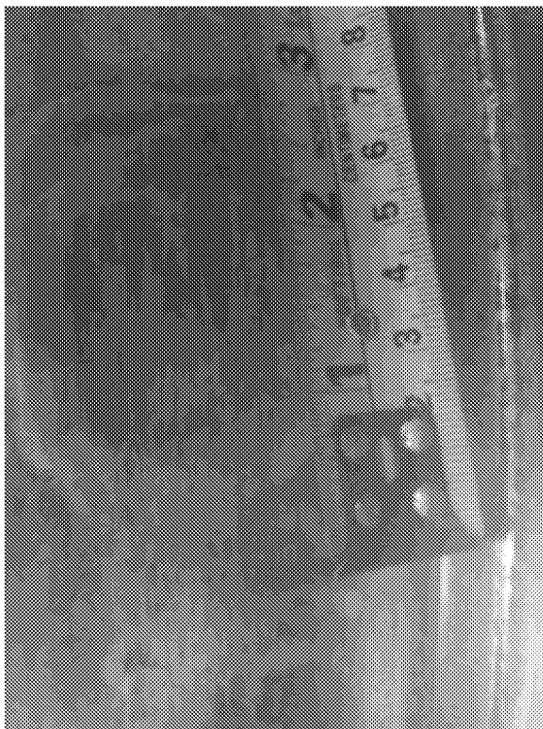
During winter 2019-2020 there were many incidents involving flatted wheels on the LRV's (see Figure 1). These resulted in noise in the car, requiring the trains to be stopped for tire turning. This caused a loss of availability and concern on the part of the train operator.

Figure 1 - Example of wheel flat

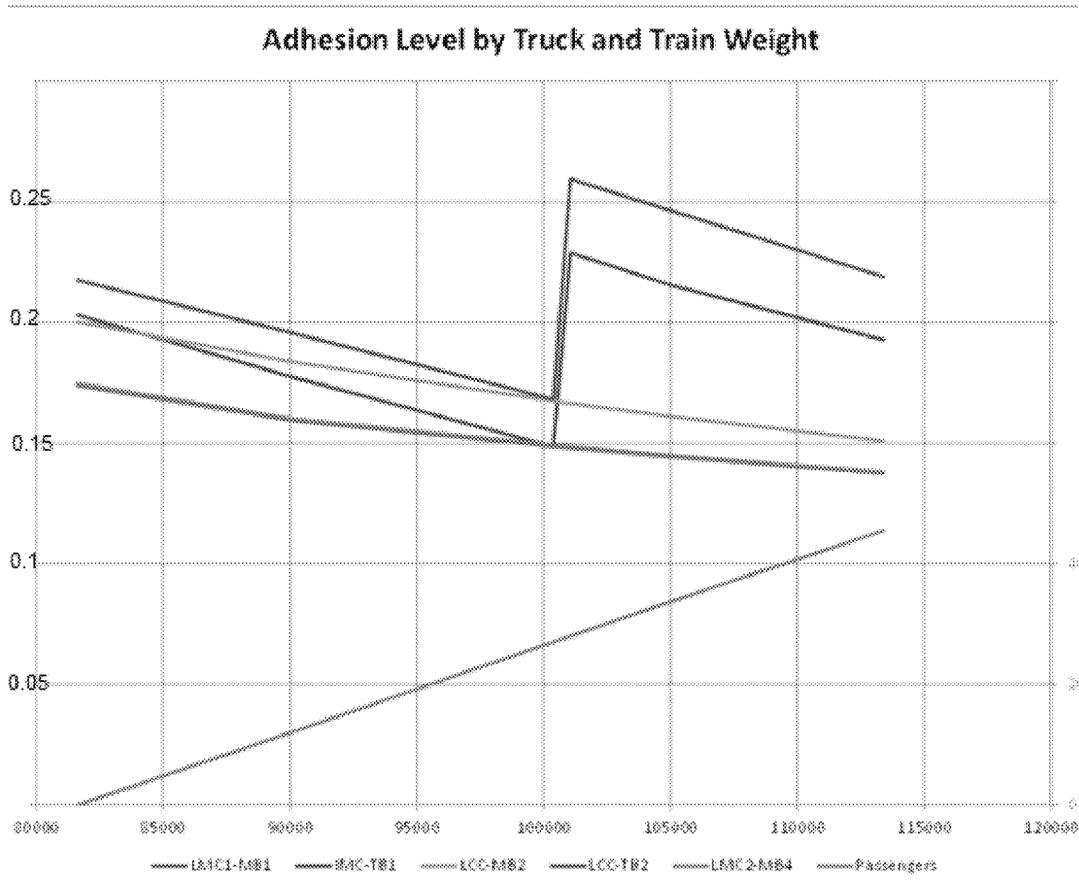
additional energy from the loaded train. The resulting adhesion on the trailer trucks steps up at around 100 tons train weight (see Figure 4)

Figure 4 - Emergency brake adhesion requirement for each truck based against passenger load

Because of the high increase in adhesion requirement when the car goes over AW2 load level the train is more susceptible to sliding when full. When the train is empty the motor truck and trailer truck have more convergent adhesion requirements; any wheel slide will not affect trailer axles especially unless other factors (e.g. sanding) affect adhesion levels on the train. This step up in the brake effort takes place at a passenger load level consistent with the maximum system design capacity and was very infrequent in the events reviewed.

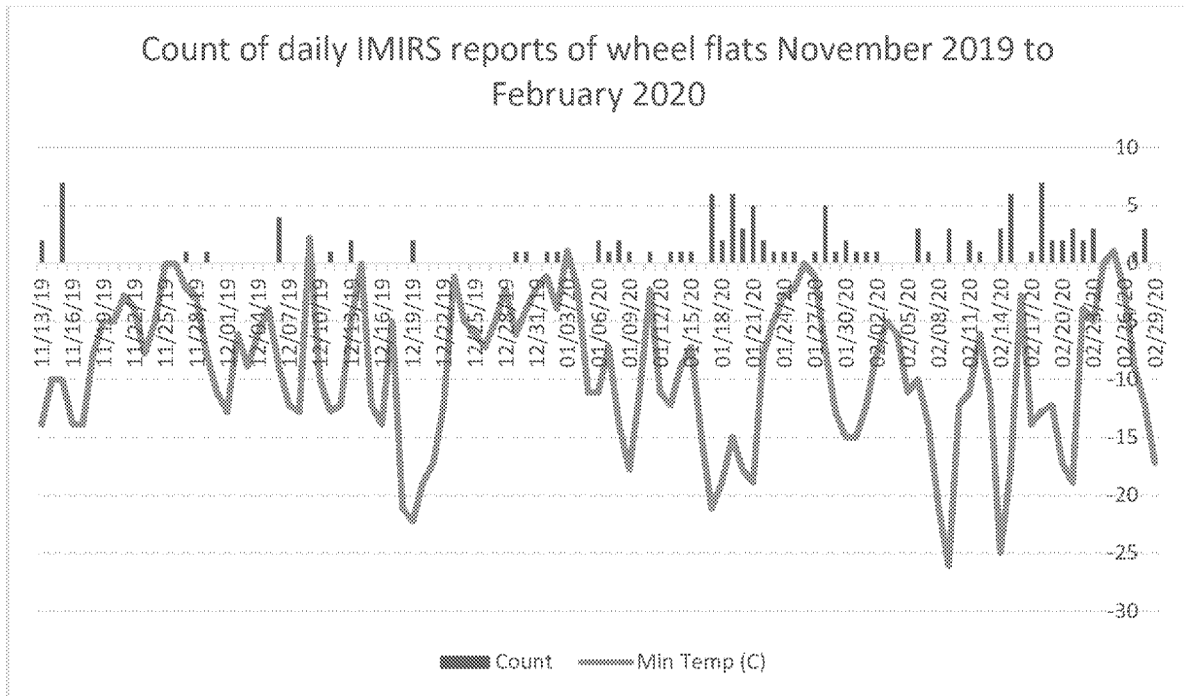
Figure 8 - Plot of number of wheel flats reports on IMIRS with minimum daily temperatures

The problem started with the onset of cold weather in November 2019. Some periods of cold weather had relatively few flats (such as around December 20th); there was more of a correlation between a combination of cold weather and snowfall occurring in late January and February 2020. Note that there can be a lag between the flats occurring and being reported by customers and staff.

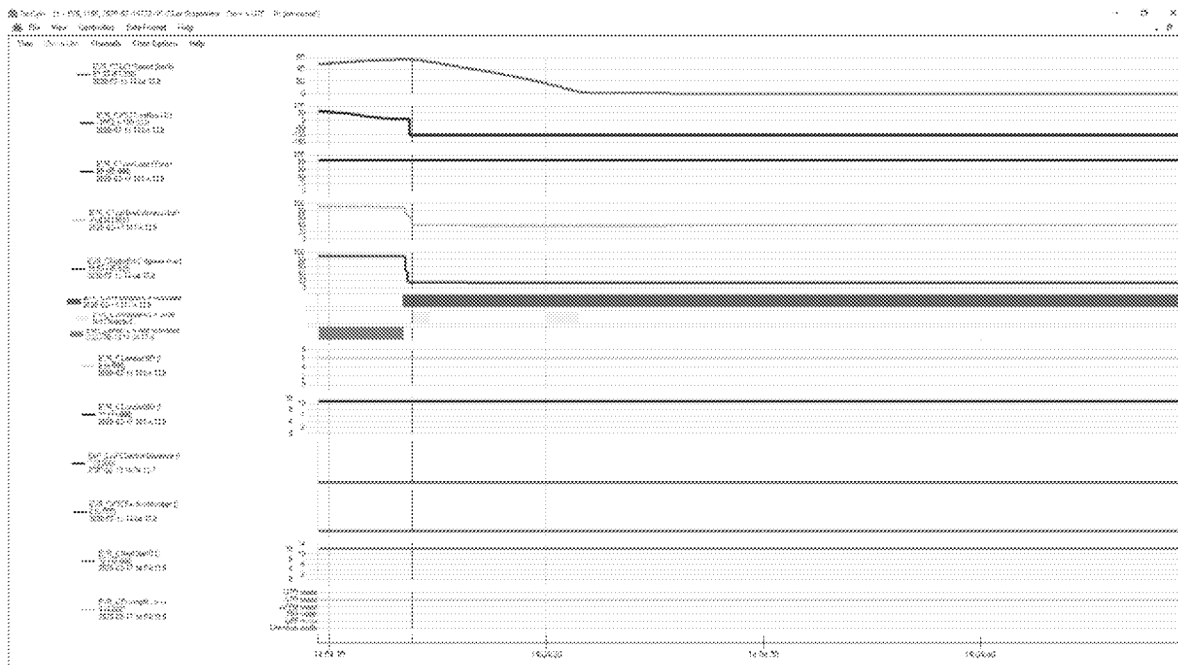
If the ATC torque demand is available, it is possible to see possible reasons for an emergency brake. For instance, in the following case the ATC has a zero brake demand before the EB, pointing to an unexpected loss of movement authority (Figure 14)

Figure 14 - EB application when driving in Auto

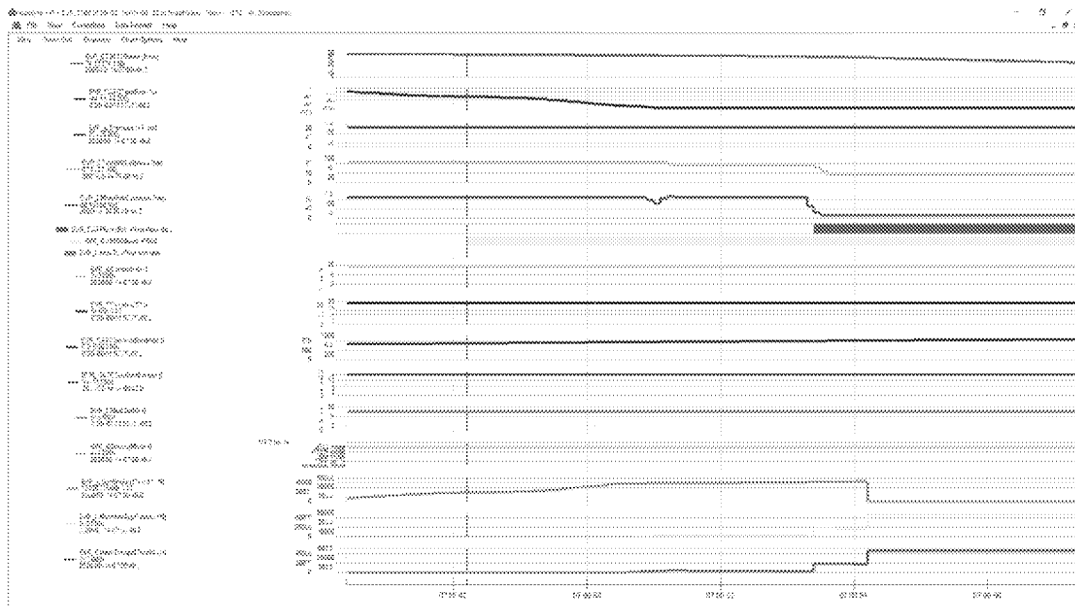
In the following case the car is sliding prior to the emergency brake and the ATC increases the service brake demand to 100% to try and stop the train. This requires some mechanical brake effort at 75km/h. The service brake does not respond, and the car is too far forward to stop safely in service brake, so an emergency brake is applied.(Figure 15)

Figure 15 - EB application because of low adhesion

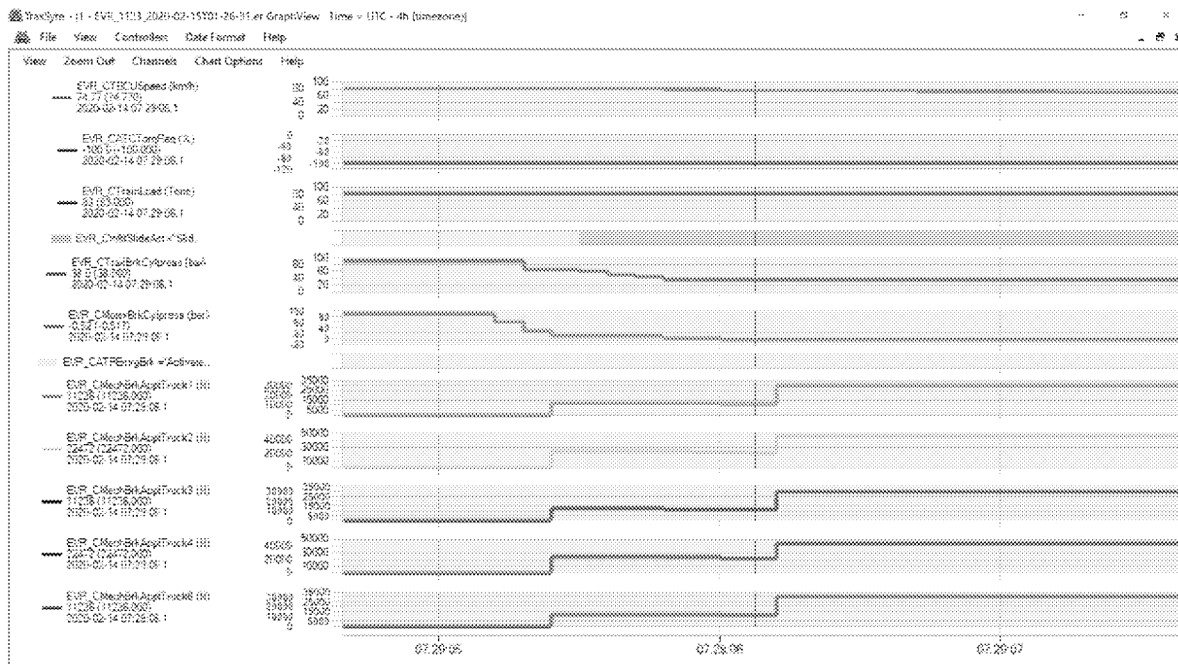
The EVR shows actual cylinder pressure for the brakes on truck 1 and truck 4 of each car. This allowed the diagnosis of loss of hydraulic pressure during emergency brake demands in some cases, where the loss of pressure coincided with the monitored trucks (Figure 16)

Figure 16 - EB with zero-cylinder pressure

Since the initial investigation the supplier, WABTEC, have identified a specific problem with the HPU in cold temperatures which relates to this issue, therefore no further field investigations in this area are necessary.

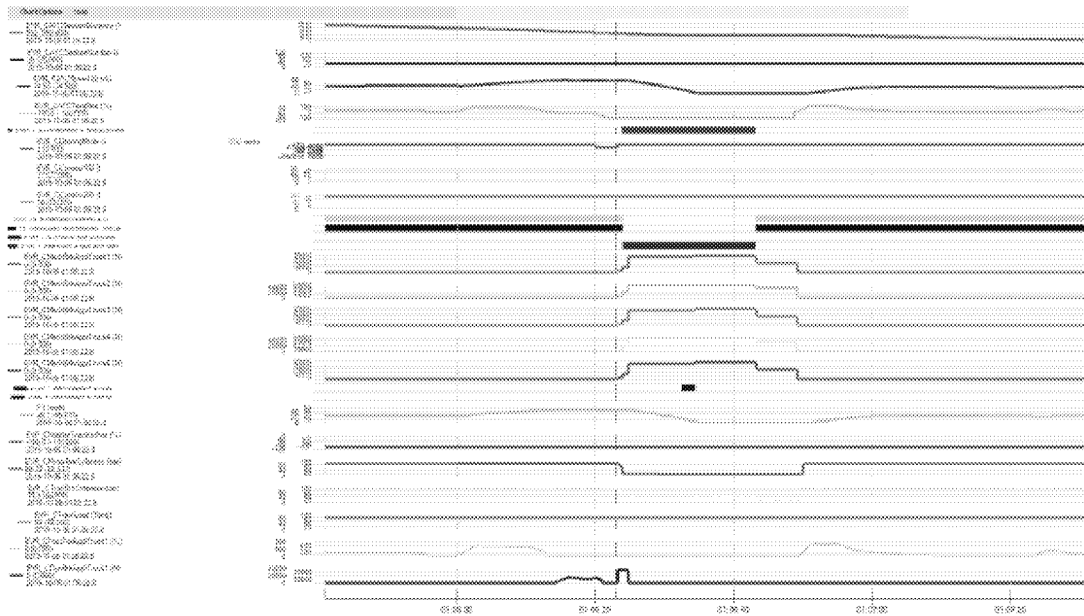
There were EB's identified as being caused by the operator switching between ATP manual and fully automatic operation when the train was at or approaching a point where braking is required. This caused EB applications, because to place the train in ATO requires the master controller handle to be placed in coast which then requires the ATC to ramp the brake demand from coast to what is necessary to stop, usually too late.

Figure 19 - EB caused by mode change from ATO to ATPM and back at speed

The task team sent a message to OC Transpo requesting the operators did not change modes when moving.

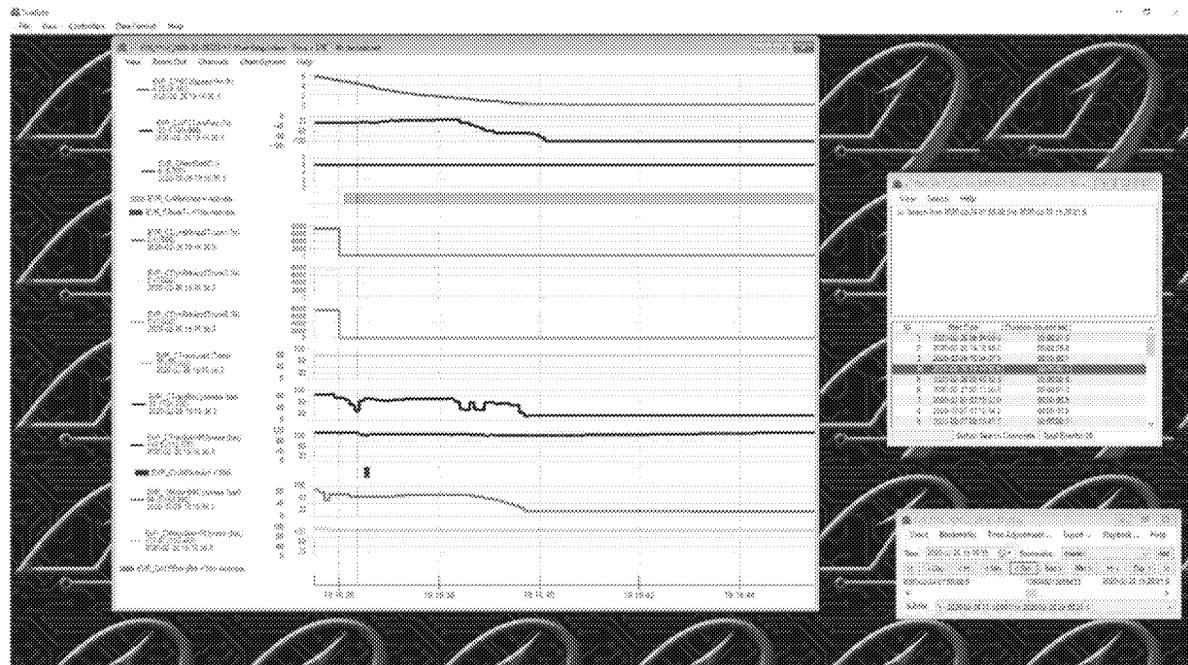
In addition to the problem with loss of EB pressure, some EVR's show an intermittent 'overshoot' of pressure during service braking, normally at station stops, but sometimes during brake blending. Figure 23 shows the pressure dropping below the EB level during a station stop, causing a brief wheel slide. Figure 24 shows the cylinder pressure dropping to emergency levels during a small blended brake application. In both cases these pressure drops are rapidly corrected by the system.

Figure 23 - Overshoot of cylinder pressure during station stop

1. The cause is eliminated in the design of the HPU and that a thorough evaluation of any solution proposed by WABTEC takes place to ensure that it is consistent with the failure modes seen.
2. The brake software monitoring is improved to log a fault when the pressure is not maintained correctly during an emergency brake application.

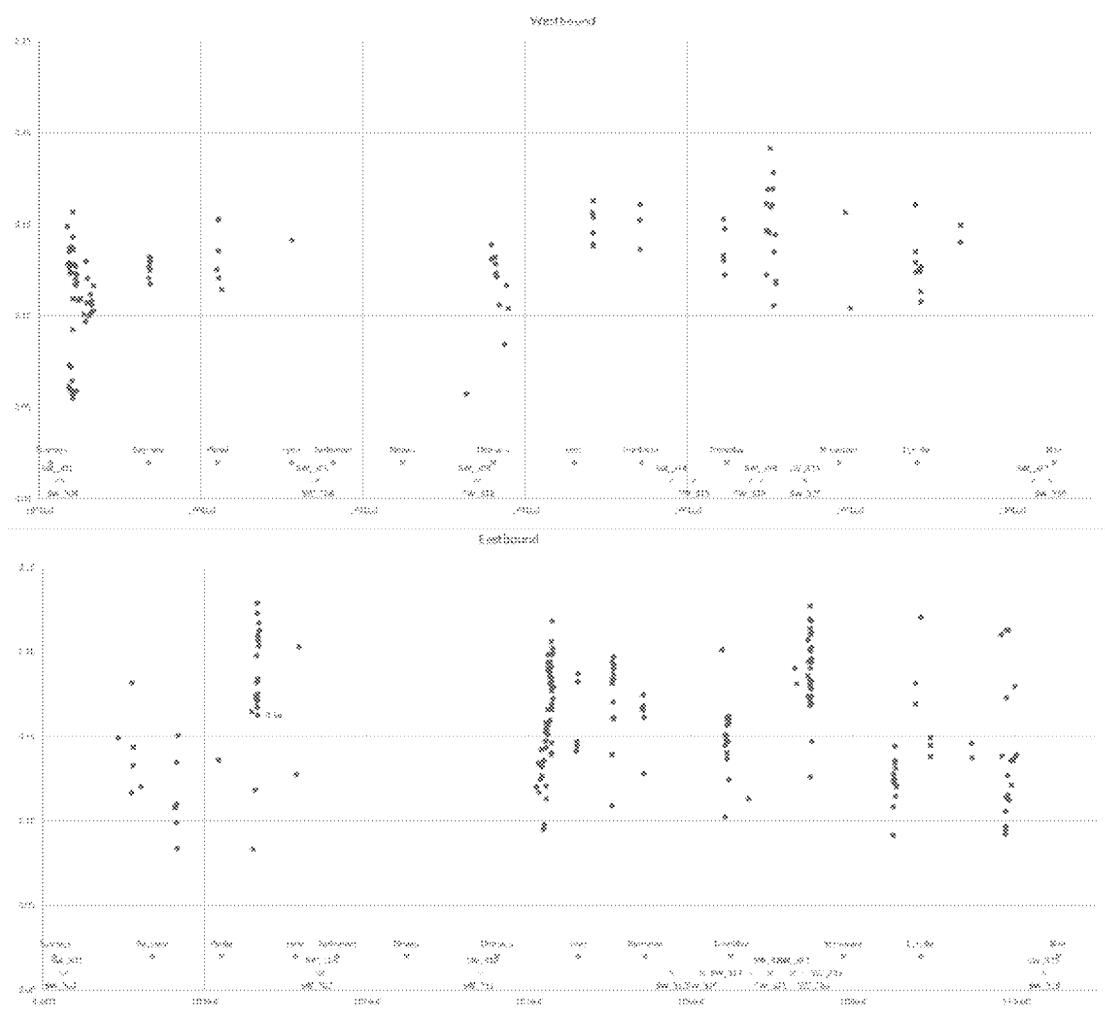
Figure 26 - Plots of wheel slide location against the chainage on the Confederation line in each direction

It is intended to use a specialist consultant to attend these locations and assess the friction of the railhead and other conditions in May 2020.

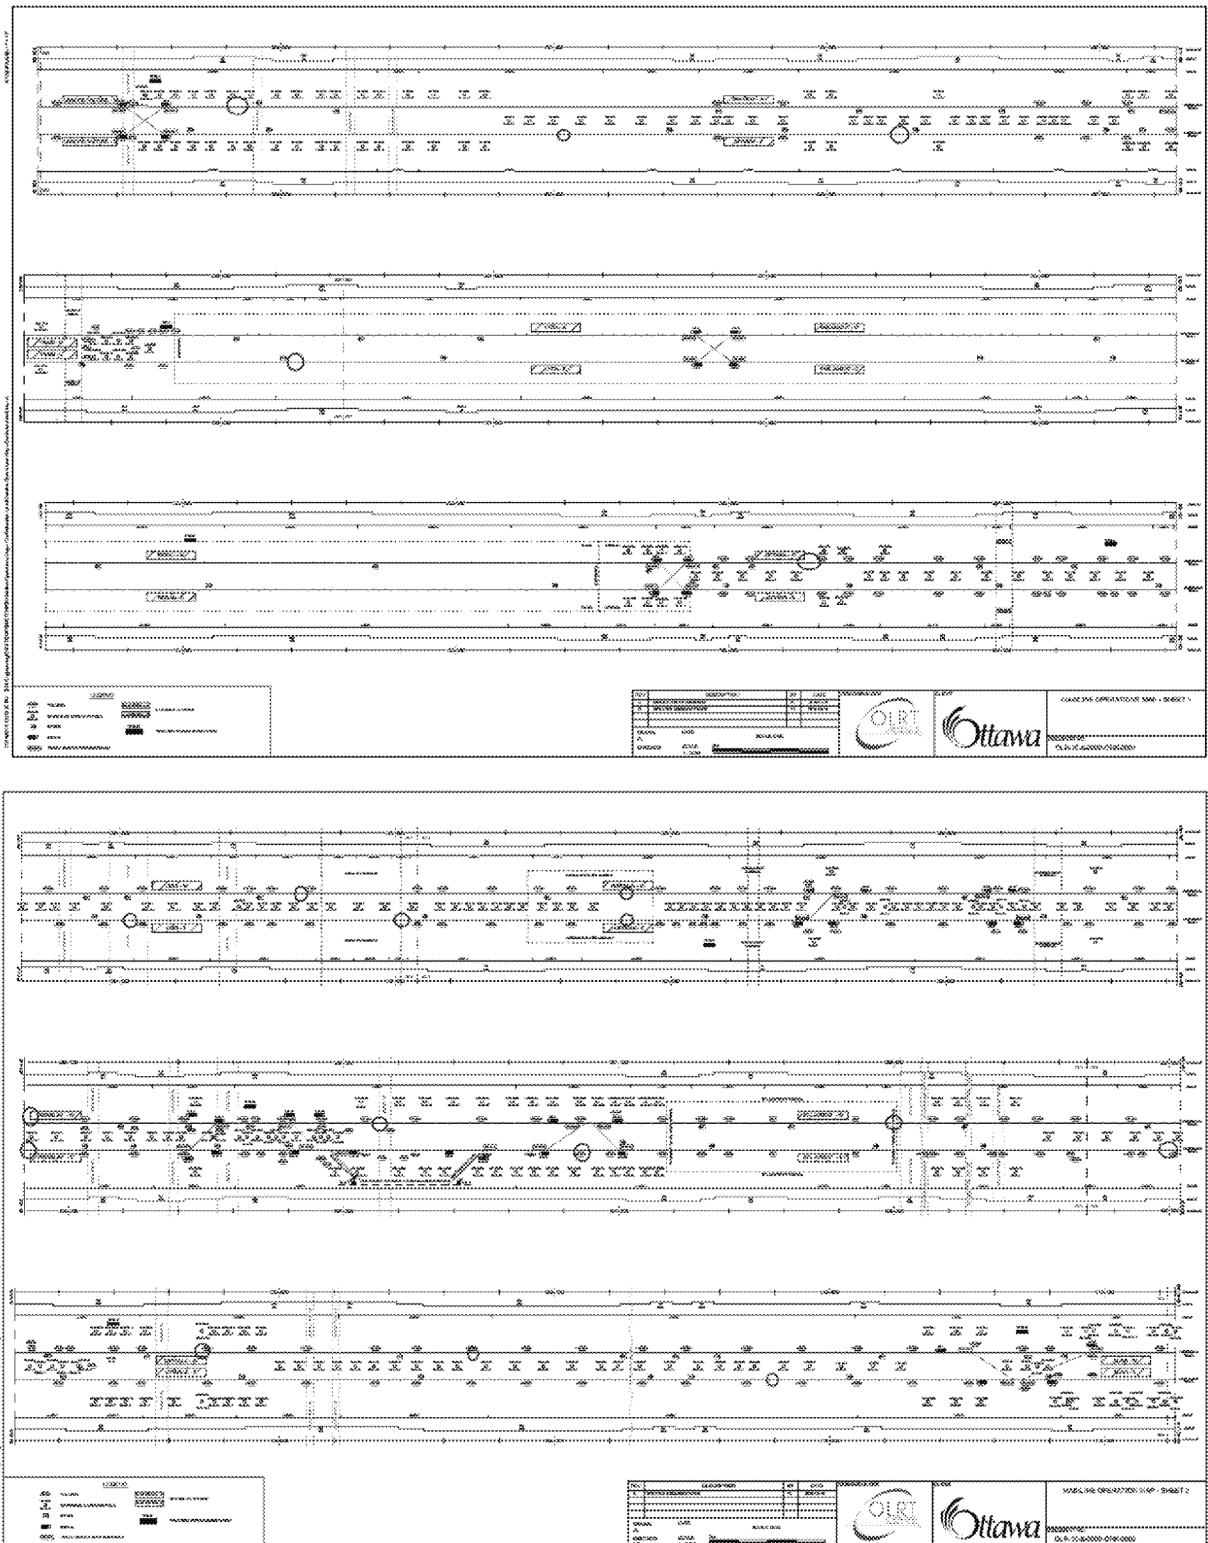
Figure 27 - Wheel slide locations marked on line diagrams for Confederation line

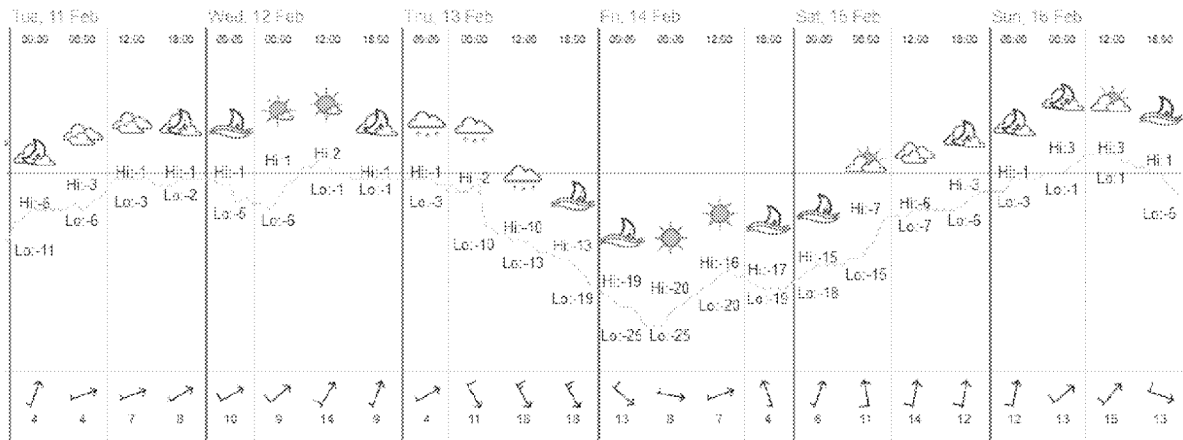
One of the worst periods for slide and flats occurred on the February 14th. This was partially caused by a signaling fault caused by tag damage which caused many EB's. The EVR's showed a high level of slide on the morning of the 14th. Note the weather report shows no snow that morning, though temperatures were very low overnight.

Figure 28 - Weather conditions from Feb 11 to 16, 2020

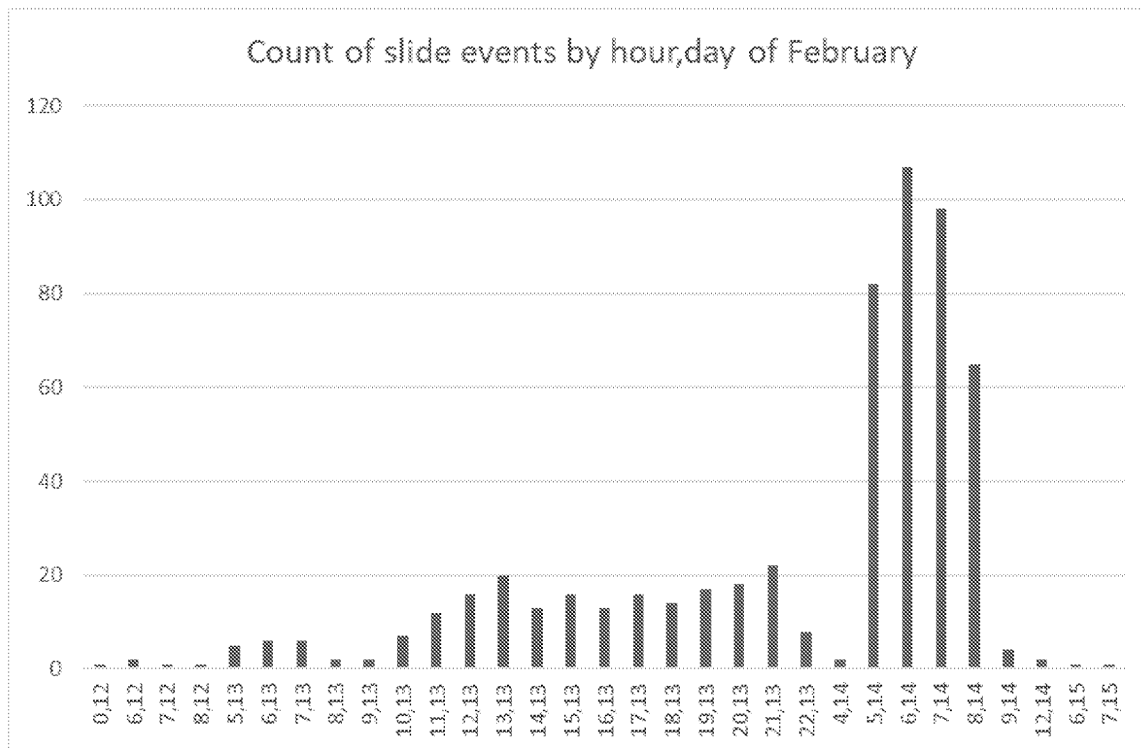
Figure 29 - Number of wheel slides reported from EVR sample by day/ hour, 12-15 Feb 2020

The snow conditions on the 13th did not cause large amounts of sliding during mild conditions and a relatively warm day and night on the 12/13th. The sliding seemed to increase with the snow and dropping temperatures on the 13th PM. There was no snow on the morning of the 14th though there was significant cumulative snowfall at the time.

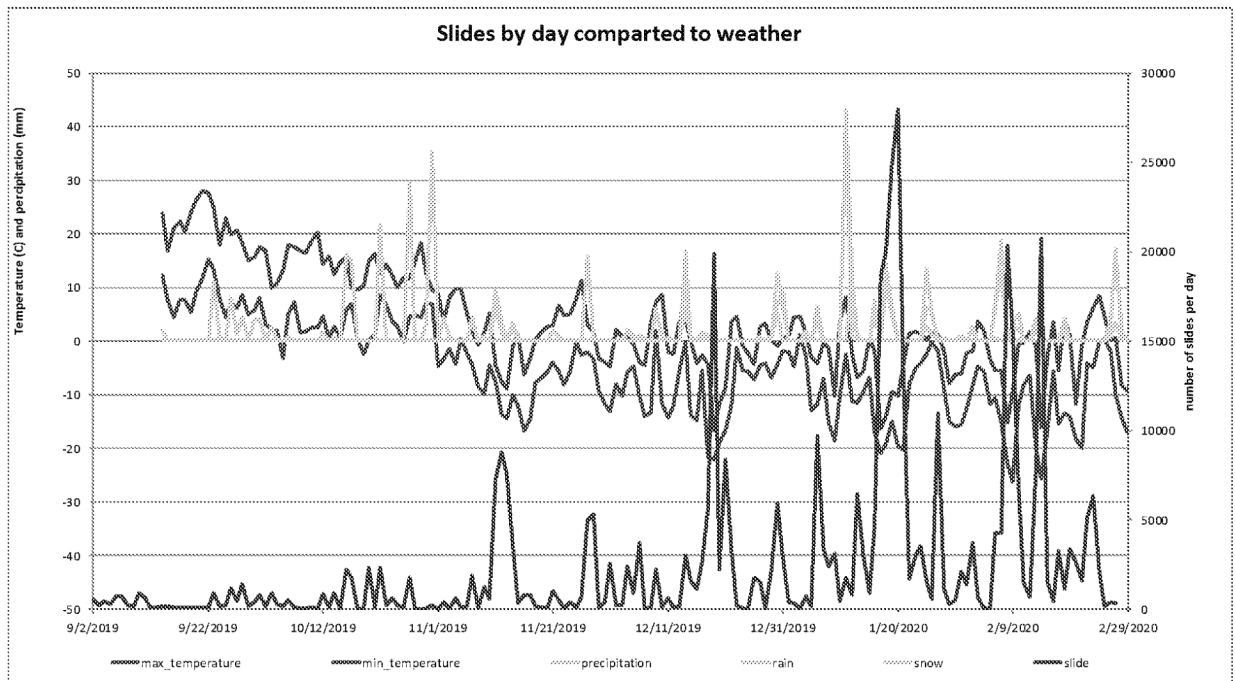
Figure 34 - Total slides and temperature

There is a clear correlation between very cold days and a high number of slides, especially when the weather station temperature is below -15 C. (note exact track conditions are impossible to determine)

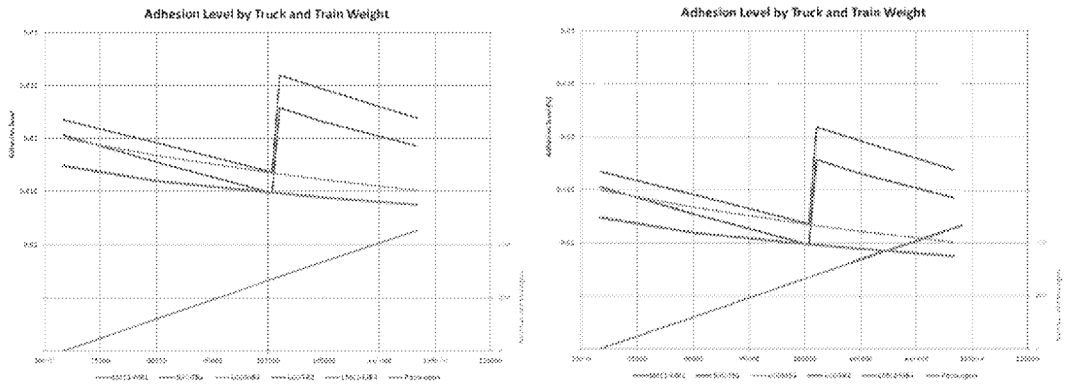
Alstom suggested reducing the emergency brake rate on the train from 2.29ms⁻² to 1.79 ms⁻² at speeds over 80km/h. As the Track brake gives deceleration of 0.5ms⁻² in AW3 this will involve reducing the emergency brake to the same as the full-service brake. The brake force can be reduced by around 25% as a result.

Figure 35 - Adhesion requirement before and after pro-rata brake effort reduction by 25%

The effect of doing this is to reduce all the truck adhesion requirement in weights up to AW2 to below the current lowest adhesion requirement at that weight level. If flats are being caused on the trailer car up to AW2 and not on the motor cars the brake change will be effective in preventing flats on trailer cars up to AW2 and reduce the risk at higher weights.
