Ligne de la  
**Confédération**

## Pre-Grind Inspection Optical Measurements

**Proponent name:** Advanced Rail Management (Canada) Inc.  
**Address:** 26 Harry Collins Avenue, Winnipeg, MB R2M 4N2  
**Phone number:** 321.984.1474  
**Contact:** Gordon Bachinsky, P.Eng.

**Revision 3: March 18, 2021**

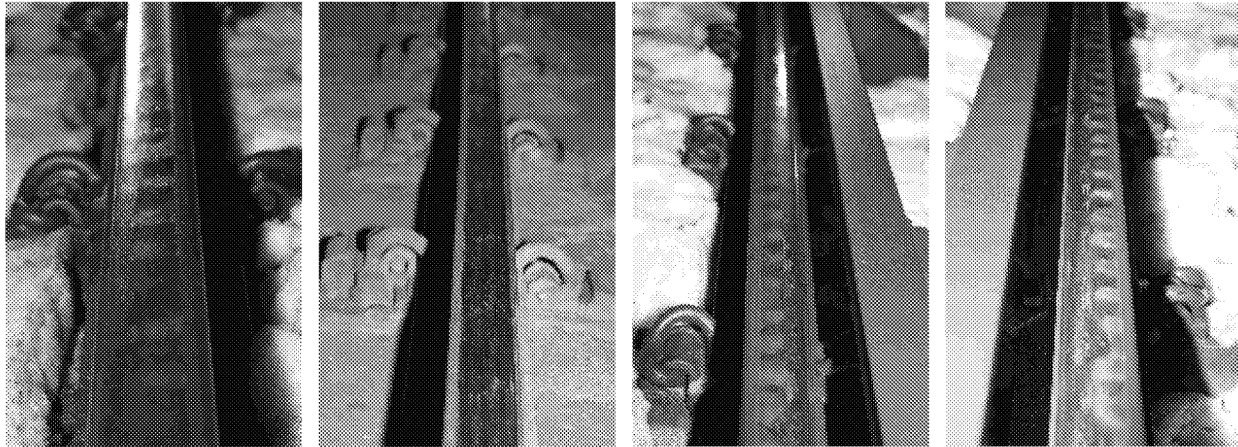
Confederation Line and most severe in curves. While low rails more commonly have corrugation (and more severe corrugation) due to the wheel/rail interaction, the high rails on the Confederation Line also demonstrated moderate to severe corrugation.

Figure 3 provides example corrugation from the Confederation Line on various track geometry including low rails, high rails, and restrained rails. The right two images show more severe corrugation on the restrained rails in sharper curves.

**Figure 3: Example Corrugation from the Confederation Line**

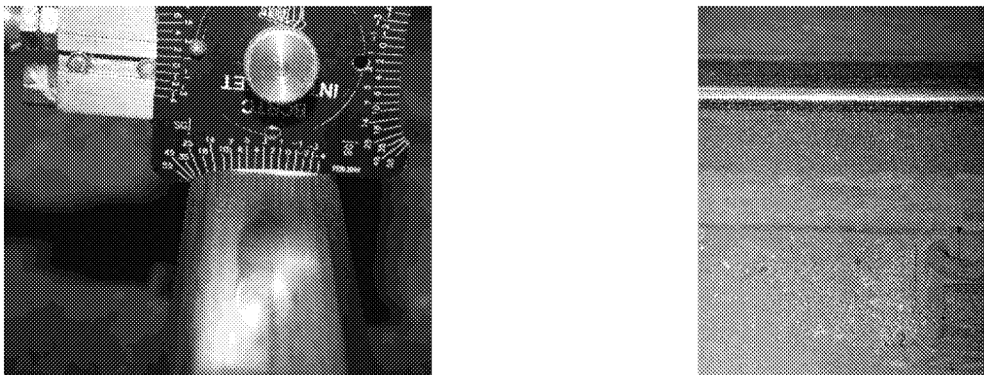
In addition to the heavy corrugation, which was quite surprising to the project team given the Confederation Line has only been in revenue service for approximately one year, ARM noticed the rail profiles were very flat and that in some instances severe flanging was occurring. The left image in Figure 4 shows the Confederation Line rail profiles compared to a new rail profile that would have an 8 inch crown radius. The light coming through between the template and the rail shows a gap indicating the crown radius is closer to 12 or 14 inches. Flat rails are prone to the development of corrugation due to the wheel/rail interaction. In the right image of Figure 4, the gauge corner shows wear and steel dust can be seen at the base of the rail adjacent to the fastener. This is indicative of gauge face contact with the wheel flange – this can be reduced with correct wheel and rail profiles to help steer the train through the curve and minimized by applying lubrication. In conjunction with the 1:60 tapered wheels being used on the vehicle fleet, the flat rails and high gauge wear are leading to, and indicating, lateral instability.

**Figure 4: Flat rails (left image) and rail flanging showing steel dust by fasteners (right image)**

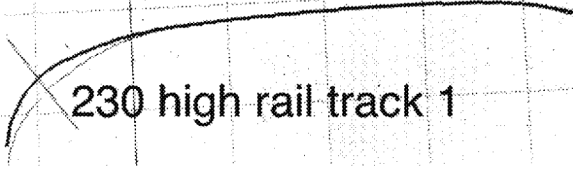
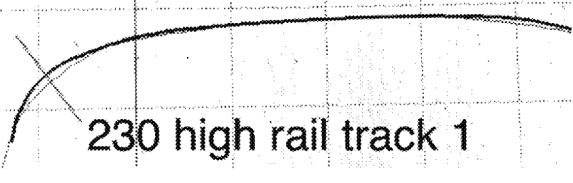
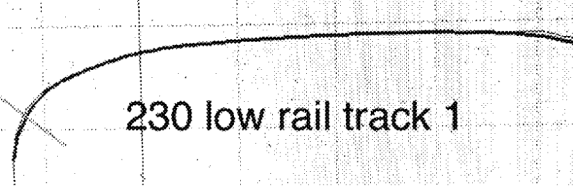
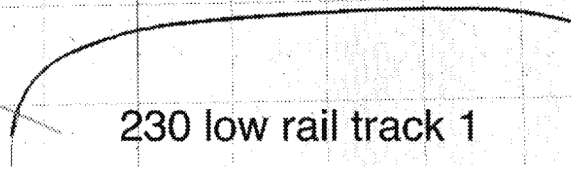
**Table 1: Pre and Post Grind Profiles at Curve 230**

**Since grinding these curves back to the original 115RE rail profile, ARM noticed that corrugation is already beginning to return within three (3) months of traffic.** Table 1 provides an example of the pre-grind and post-grind rail profiles (more profiles available in ARM’s Post-Grind report). The high rail pre-grind images were significantly over-relieved on the gauge corner side which can also result in two-point contact. Gauge corner relief is not a major concern and high rails should be somewhat over-relieved to help prevent strong conformal contact. The grinding program helped correct some of the over-relief at the gauge corner to return to a more realistic level but full removal was not considered necessary as it would require far too much metal removal without any benefit. The high rail and low rails are not a perfect match as again, the level of effort to achieve this is much higher than the benefit. Furthermore, it appears the wheel/rail profile is not optimized for steering through the curves. The ARM Rail Maintenance Specialist worked the rail profiles to positions where high rail contact is more towards the gauge corner and low rail contact is towards the field side. This orientation helps promote steering through the curve to prevent poor wheel/rail contact forces and reduce flanging.

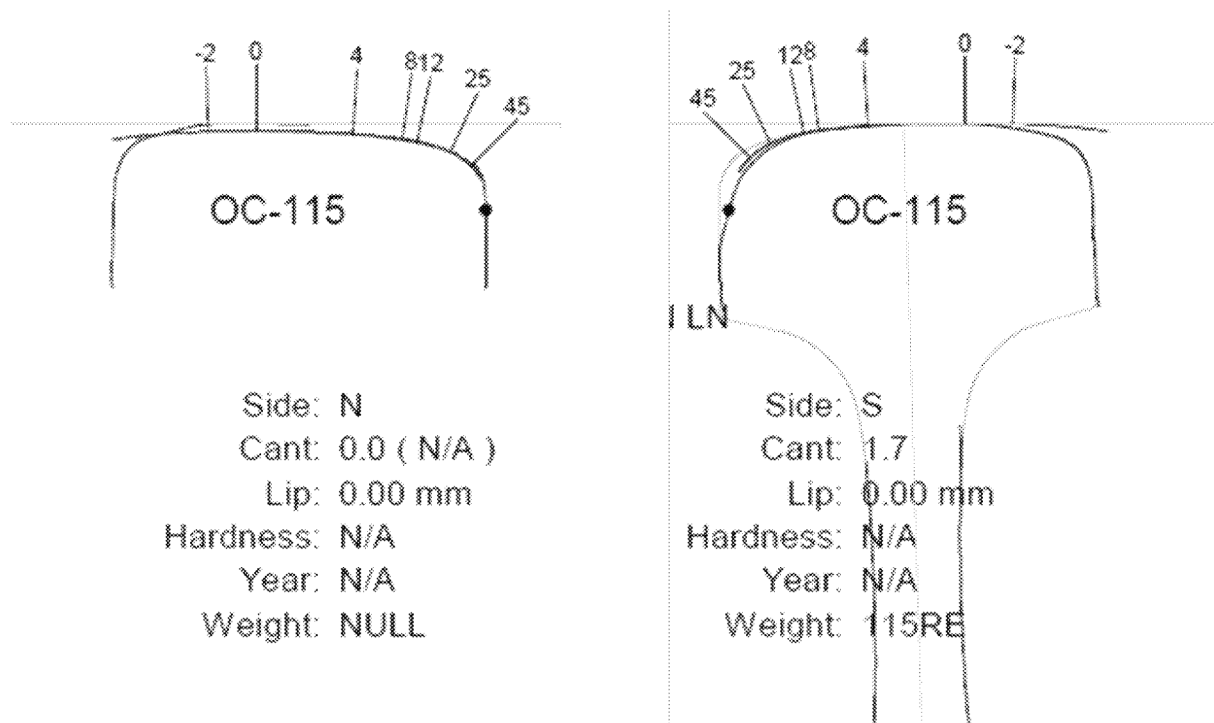
Figure 5 shows the low and high rail as they look today. In general, the profiles are holding reasonably well after three months with some flattening perhaps occurring on the low rail. The strip charts of the same are on Figure 6 show no exceptional values through the curve but do highlight the gauge wear that is occurring on the high rail. The Confederation Line track standards indicate that at a gauge face wear level of 4.5 mm the rails should be transposed. Currently, the high rail gauge wear is reaching 3mm on average since the system opened.

Figure 5: 2-Up profiles of Curve 230 (left rail is low rail, right rail is high rail)

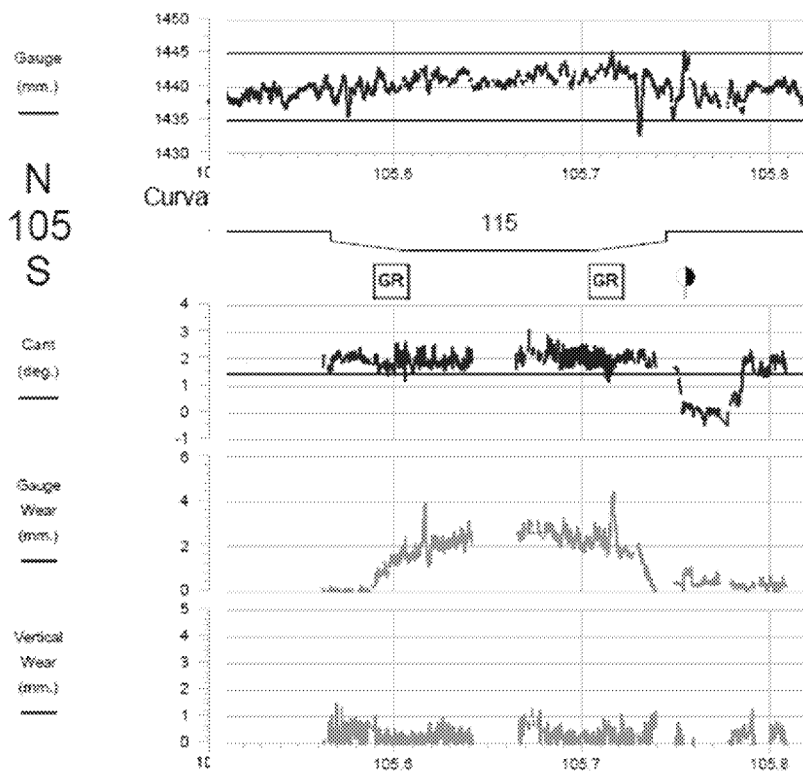
Figure 6: Strip chart of Curve 230 showing track gauge and hi-rail wear metrics

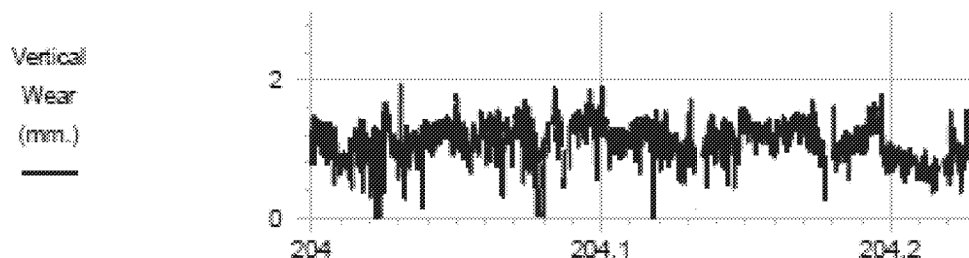
In general, ARM noticed very little total vertical wear and there is no risk of any grind program removing metal that would put the rail into a warning or condemnable condition. Vertical wear varies between 0 and 2 mm and Figure 8 provides an example section of data where vertical wear is approaching 2mm. While this is not high total wear, it is surprising to see vertical wear this high after only a year or two of traffic. Considering transit agencies may have a vertical wear condemning limit between 12mm and 16mm and expect rail to last 25+ years, the current wear measurements suggest Ottawa will not see rail lifespan anywhere near this limit under the current annual rate of wear.

**Figure 8: Sample vertical wear data**

Vertical wear was generally seen to be 1mm or less and was not a concern in terms of reaching condemning limits of 12mm according to the Confederation Line Track Standards.

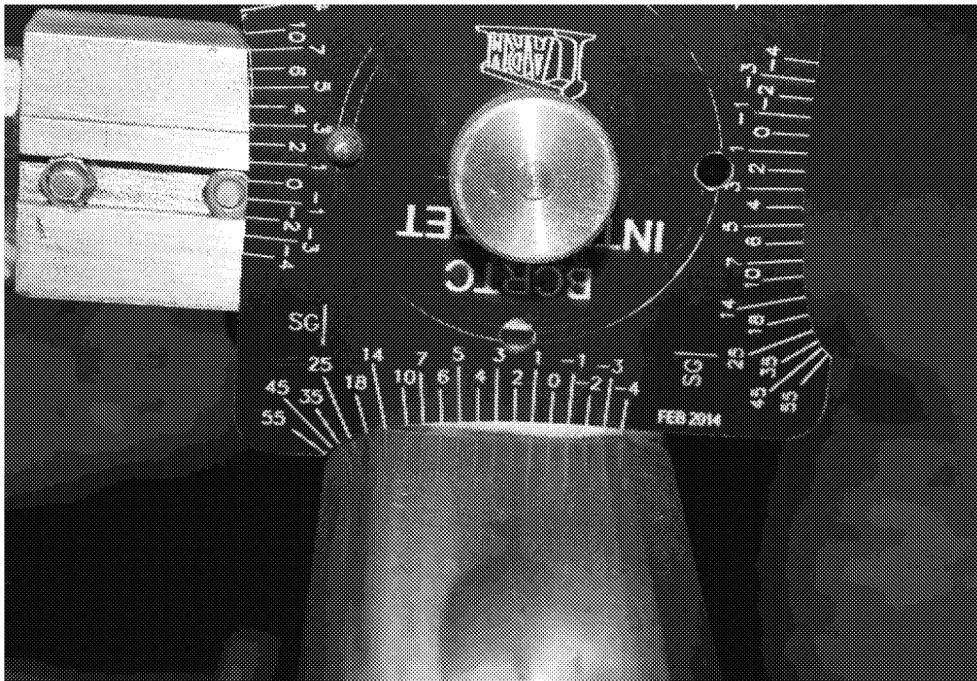
Figure 9 shows a typical 8 inch radius rail template (typical new rail) compared against the existing Ottawa profile. The gap between the template and the rail illustrates the rail crown radius is quite flat (approaching a 12 or 14 inch radius). The wide shiny running band also demonstrates the wheels are making broad contact with the rail. These conditions are conducive to the development of corrugation and consistent with reports of ride quality and noise issues on the system.

Figure 9: Bar gauge measurement with 8" radius template on Ottawa Rail

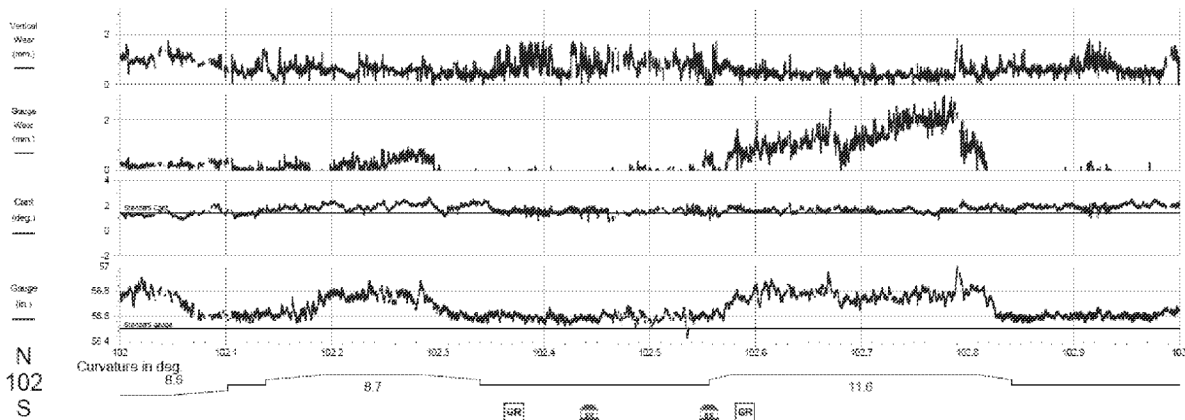
Gauge wear was mostly consistent and low (under 0.4mm) across the entire system with the exception of the high rails in sharper curves (approximately 7 degrees and sharper). The gauge wear is seen over 2mm in the sharpest curves. Figure 10 shows the climbing gauge wear through the 11.6 degree curve around MP 100.4 to 100.8. Similar to vertical wear, these are not particularly outstanding values but they are significant because of the young age of the system. This level of gauge wear is not expected within a year or two of operations.

Figure 10: Example of high gauge wear in a sharp curve

The potential root causes for the high gauge wear in sharper curves could be one of, or a combination of, the following conditions:

1. Incorrect wheel/rail dynamics due to mismatched wheel and rail profiles which are not promoting steering through the curves
2. Incorrect operating speed for the superelevation in the sharper curves
  - a. More likely to affect the low rail versus the high rail (unlikely to operate over the balance speed)
3. Steerable bogies may be ‘attacking’ these curves improperly and/or not steering through the sharper curves due to existing setup
  - a. Vancouver SkyTrain went through steerable bogie issues
  - b. LA Metro had issues with long wheel base and stiff bogies that resulted in higher noise and wear rates
4. Limited or no lubrication – dry rail conditions

No exceptions to gauge wear were recorded according to the Confederation Track Standards limits of 9mm gauge face wear. However, some high rails in sharp curves exhibit wear of up to 3mm which is nearing the 4.5mm transpose limit.

Further review of this specific rail condition is required in addition to a review of wheel profiles. A future grind program could also provide interim rail profiles to help promote steering and a test set up in one or more curves to compare if a slight rail profile modification helps improve this condition versus rail profiles with only 115RE.

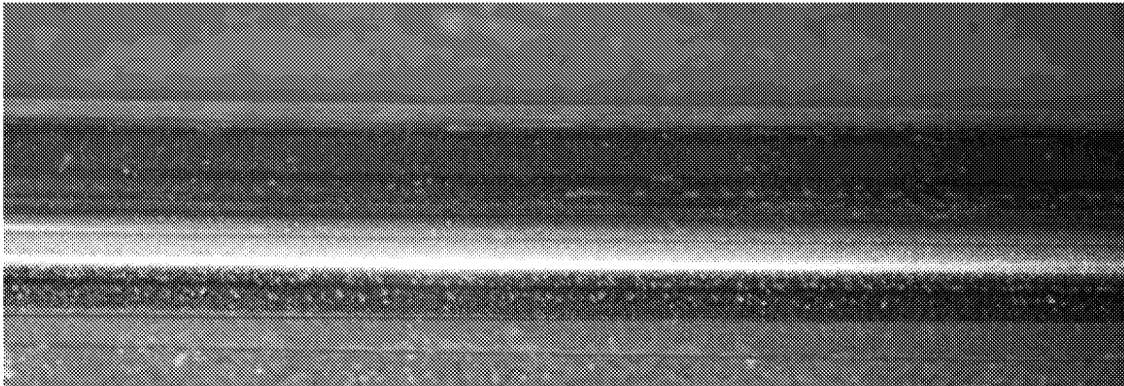
Figure 11 shows the gauge corner of a high rail with a slight lip and a shiny gauge corner – both illustrated the contact occurring and the severity of the gauge corner wear. This condition was seen at many of the sharper curves with guard rails. Figure 12 illustrates the metal dust that accumulates at the base of the rail due to strong flanging forces and no lubrication.

**Figure 11: Gauge corner contact and gauge face wear (between red lines)**

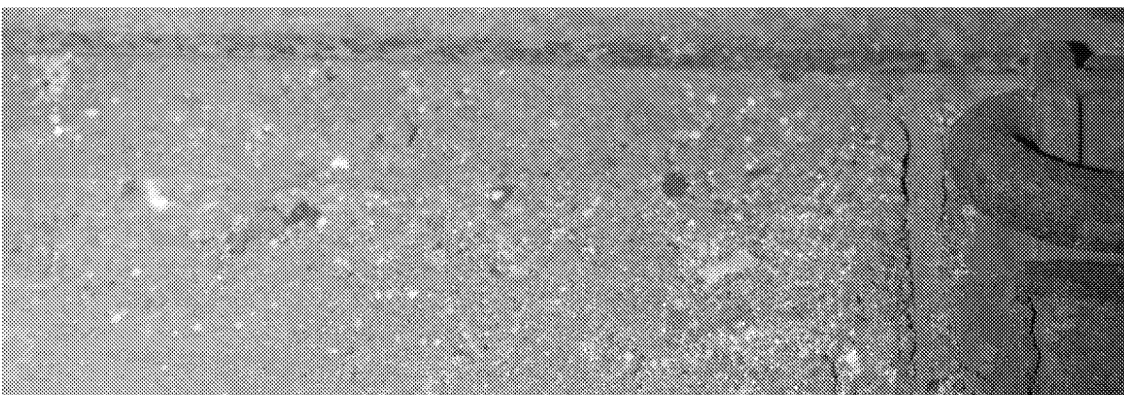
**Figure 12: Resulting metal dust at base of rail from gauge wear**

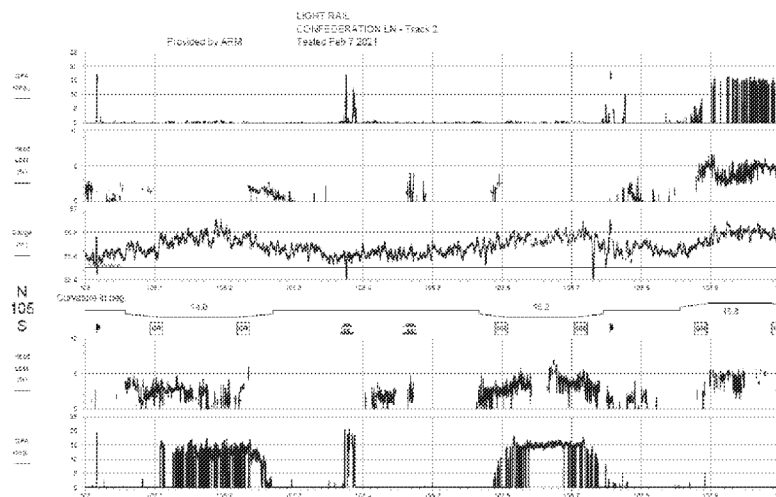
Gauge face angle (GFA) becomes an issue with the slope of gauge face becomes too flat that wheel climb can occur. With an assumed flange angle of 75 degrees on the wheel, the rail should naturally wear to a 15degree GFA. But if the value climbs over 20 degrees, suggesting that at least some wheels have a flange angle of less than 70 degrees, the risk of wheel climb increases considerably. In general, the rail profiles do not exceed 15 degrees (example shown in Figure 13).

The current GFA values are not a safety concern but should be raised as a concern as soon as they start to exceed 20 degrees over any appreciable lengths of rails. The GFA is also another metric for gauge wear and follows similar recommendations and root causes.

Figure 13: Sample data showing GFA at approximately 15 degrees on high rails

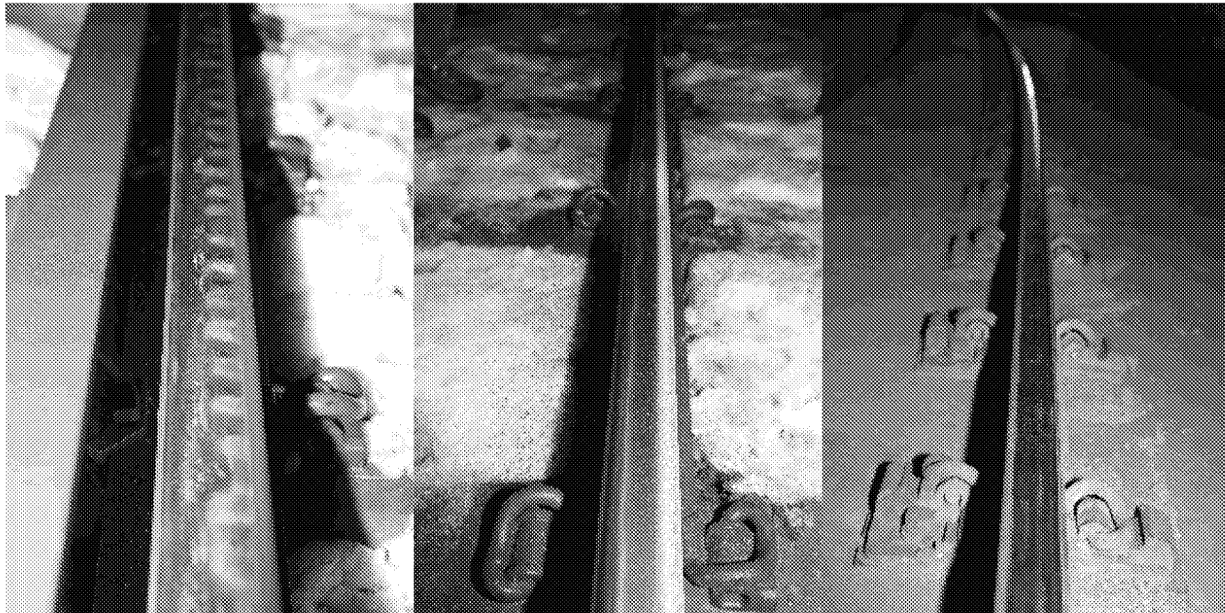
The ARM Rail Maintenance Specialist collected several photos depicting the existing corrugation that is developing throughout the system. In some instances the corrugation is quite severe and as noted, the curves that were ground in December, 2020 already show signs of corrugation returning. Figure 14 provides several examples of corrugation on the Confederation Line on low rails, tangents, and high rails. While the types and root causes of corrugation can be quite complex, the end result is the same: high frequency vibrations resulting in an increase in noise emissions. Left unchecked, the corrugation can develop into more severe rolling contact fatigue (RCF), lead to broken fasteners and cracking in rolling stock undercarriage components.

Figure 14: Example photographs of corrugation

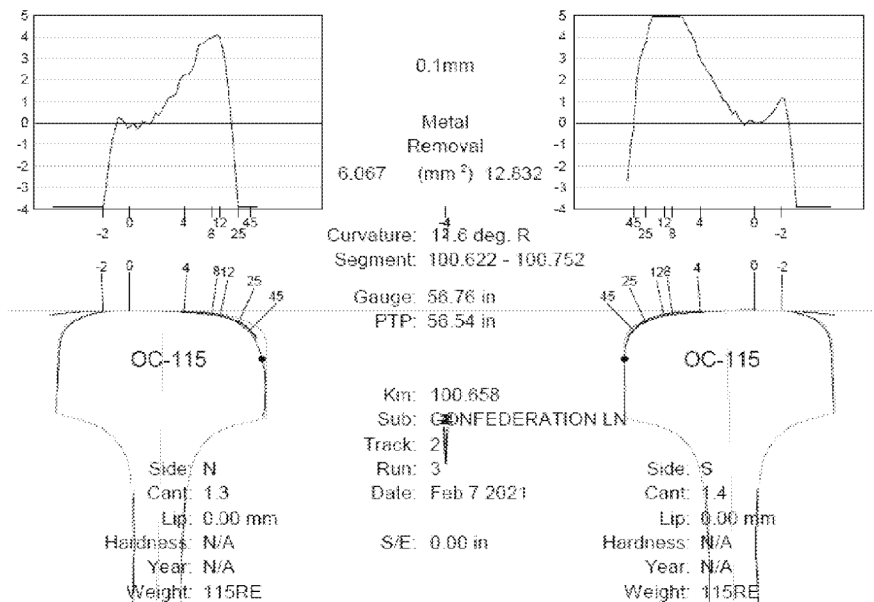
ARM has supplied representative 2-ups for all track segments as well as separate files for specific curves where multiple 2-ups are supplied through the body of the curve. Figure 16 shows Curve #090 on Track 2 which is a typical example of a sharp curve. The left rail (North) is the high rail and illustrates the gauge face angle while the right rail (South) shows a flat low rail. Figure 17 shows Curve #050 on Track 1 with similar conditions of gauge corner wear on the high rail and a flat low rail. In this figure, the optical laser is impeded from measuring the web and base of the low rail so some details are missing (like rail cant).

Figure 16: 2-Up of Curve #090 on Track 2

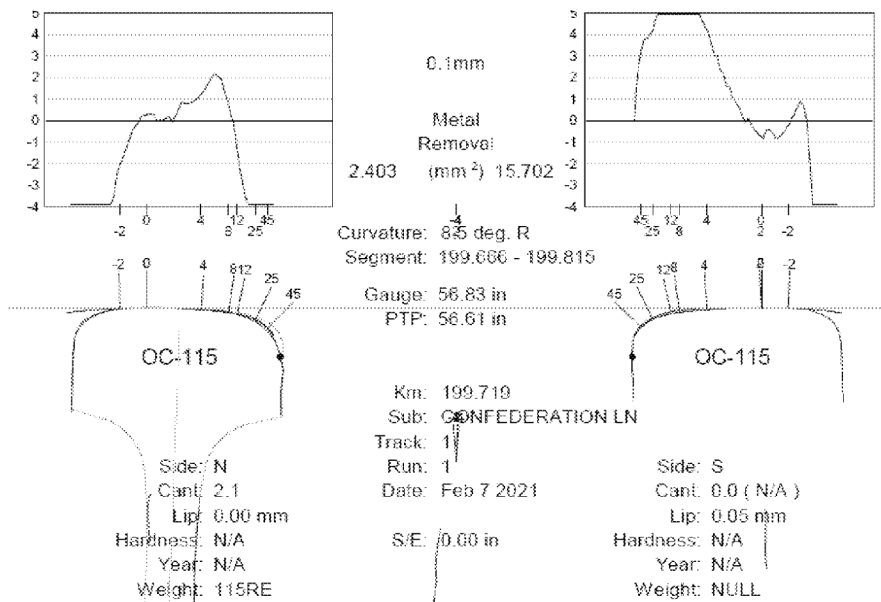
Figure 17: 2-Up of Curve #050 on Track 1

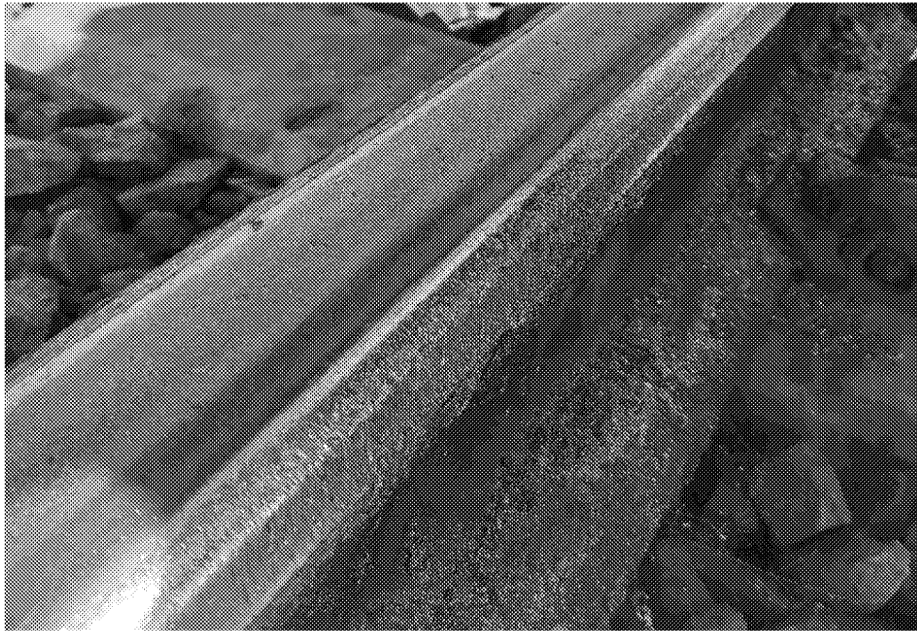
ARM's inspection of the rail yard track did not identify any outstanding rail profile issues that could be leading to the low-speed derailments that have occurred in the yard. The Rail Maintenance Specialist on site did observe some conditions of poor track geometry including the presence of kinked rail so it may be that track geometry is a contributing factor. In addition, given the rail and wheel conditions occurring in the mainline, the low speed derailments may be resulting due to wheel/rail profile issues that are causing the same maintenance issues on the mainline. The wheel gauge may be too tight (similar issue that may be contributing to high gauge wear) could be resulting in wheel lift as well. Yard derailments are common because of very sharp curves (present in the yard) and high friction levels, particularly for wheels that have just come off the lathe.

**Figure 18: High rail of yard curve showing high degree of metal shavings**

At this point in time, there is not enough information to determine a precise cause. Additional measurements should be taken in summer when the track guideway is clear of snow in addition to a review of wheel profiles.

ARM suspects that the use of a wayside lubricator in a tangent leading up to the curves causing derailments could help resolve some of these issues. The photographs shown to ARM indicate dry conditions and high forces against the gauge face of the high rail (see Figure 18 showing gauge face wear and metal shavings at base of rail). Grinding is unlikely to address the issues of these derailments as the wheel climb begins on the gauge face and grinding is intended to correct rail profiles. Other transit agencies have helped resolve yard issues using similar lubrication methods. Another option could be the use of a guard rail through these yard curves.
