**May 2021
Ottawa Reliability Report**

ALSTOM RS

2021-07-08
ANDERSON Gail
NGO MBELEG Gladine

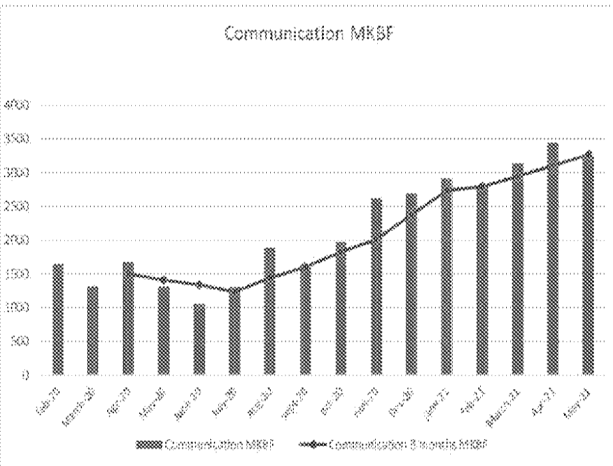
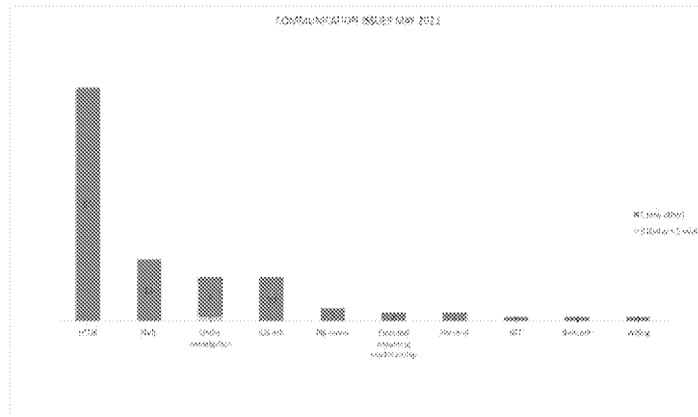
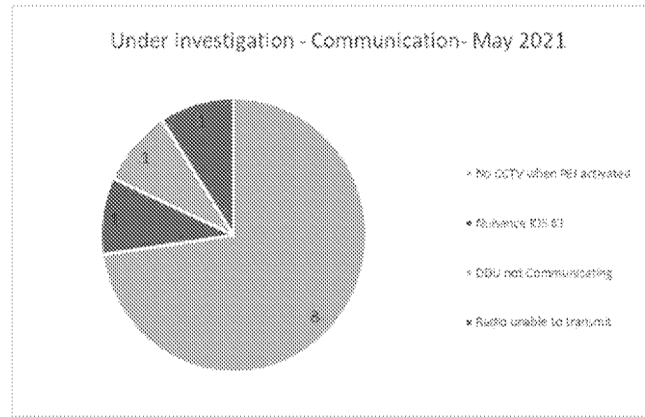
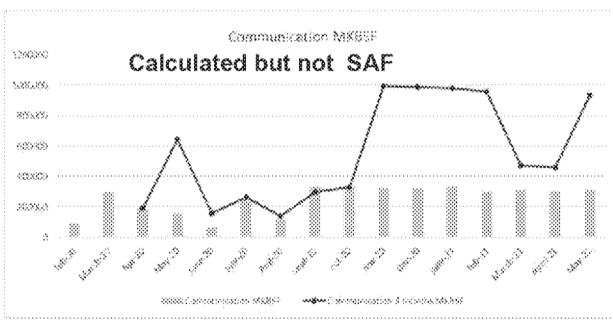
Communication reliability figures

97 Events

- HSDR :** Wrong station - station jumps, CCTV black screen - CCTV not populating, and incorrect IOS will be partially solved by new release of software (7.2.3). Fleet deployment ongoing at end of May
- NVR :** Some issues(incorrect IOS) will be solved by another software version and a case-by-case investigation for the rest.
- PIS server retrofit** Hardware modification , memory size extended is ongoing. 12 out of 15 trains retrofitted
- IDS issues (IOS 66):** internal logs to be monitored.

Handset : Potential Quality issue. Quality follow-up ongoing.
 PEI (Internal cameras not loading) issues will be addressed in MPU 1.2.7.2

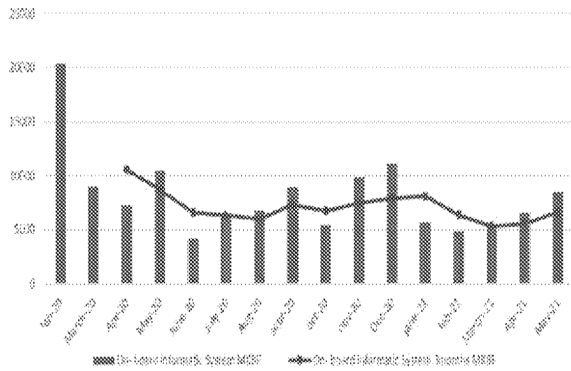
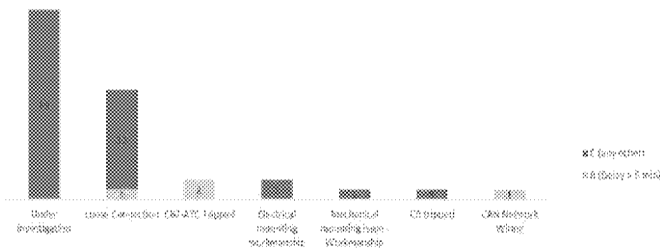
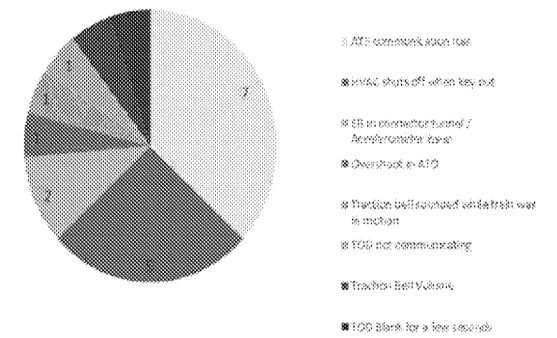
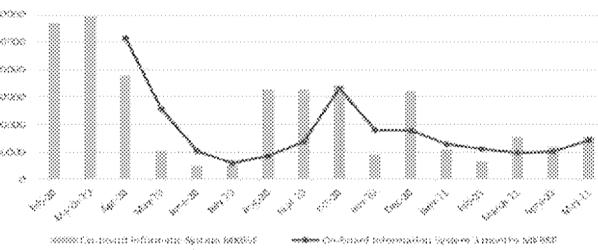
On board information system (TCMS) reliability figures

37 Events

- Wiring and Loose connection: Quality actions have been launched.
- CB 7- ATC tripped under monitoring. Awaiting city approval for LRV 02, to be tested on mainline.

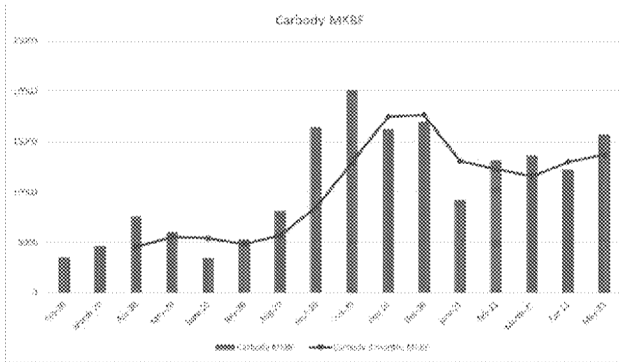
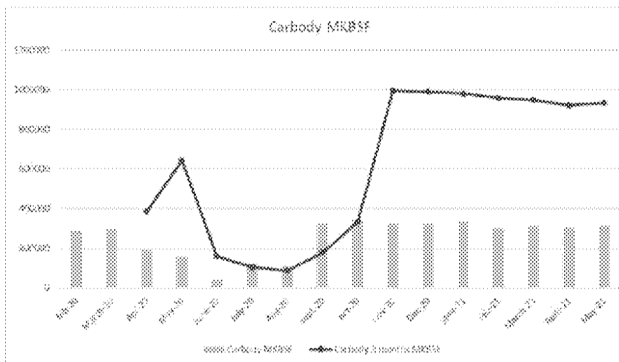
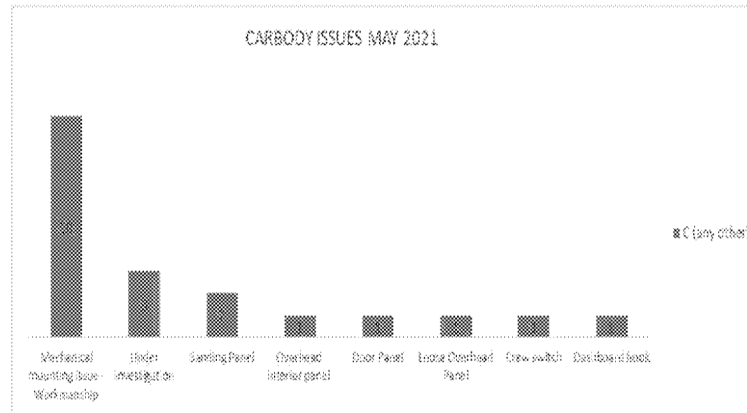
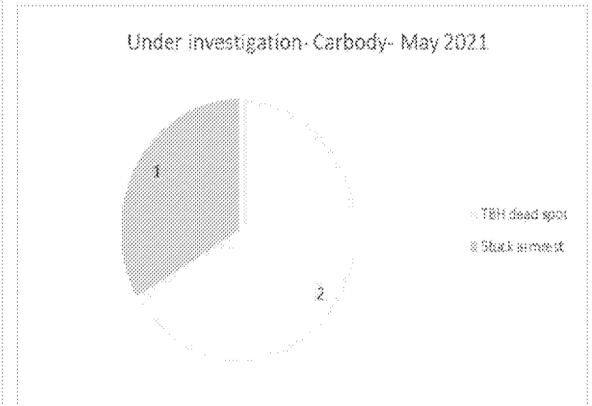
Carbody reliability figures

20 Events

Mechanical mounting issues involves skirt panels, C pin, nuts. These issues are likely to be as result of workmanship.

Cab door lock issues : removed from the reliability . Awaiting for the City approval

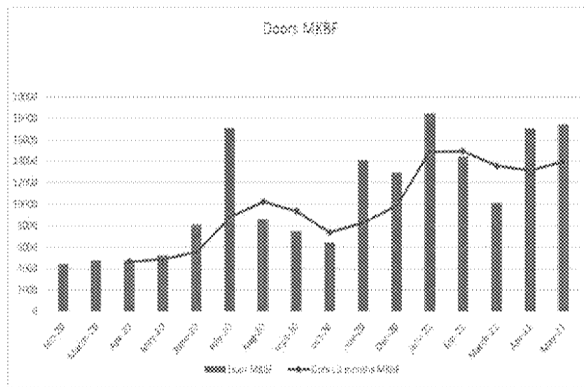
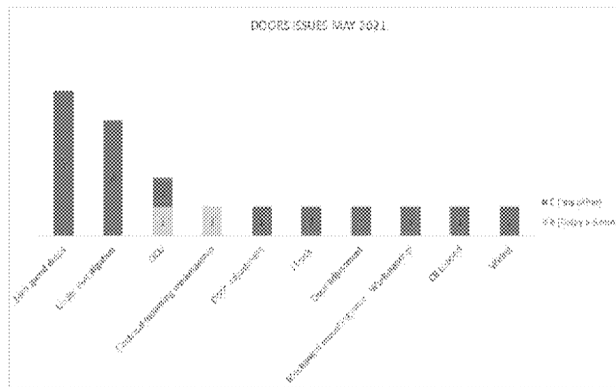
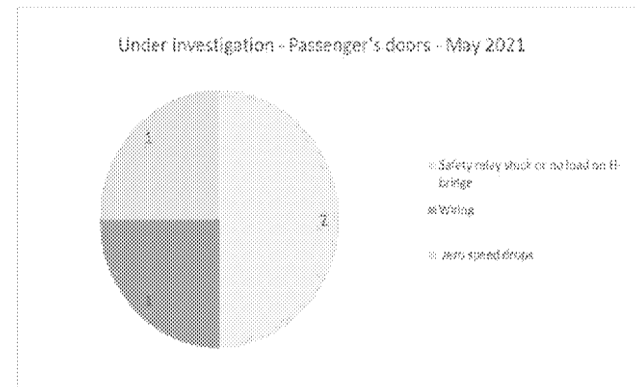
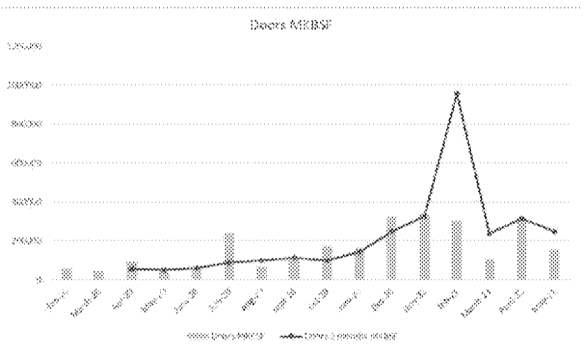
Passenger's doors reliability figures

18 Events

- Zero speed drops issue will be addressed in the software EBCU 1.35
- DCU: issue observed on the same LRV within 24hrs
- Wiring :Quality actions have been launched (Sanity check inspection ongoing)

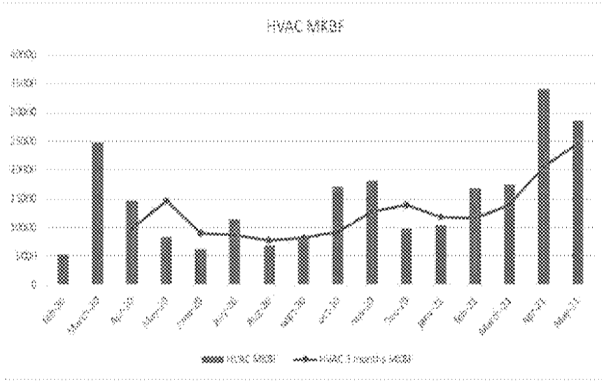
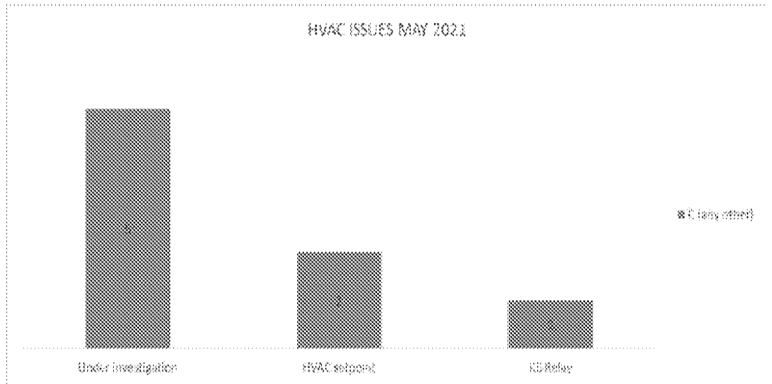
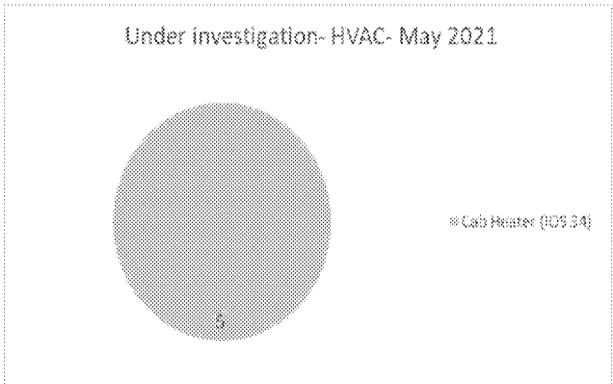
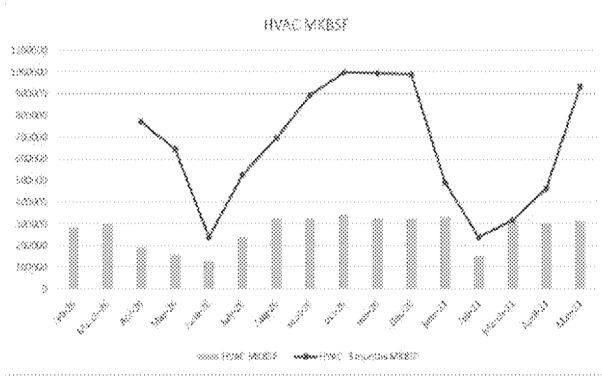
HVAC reliability figures

8 Events

- Loss of cab heater issue: Root cause under analysis.

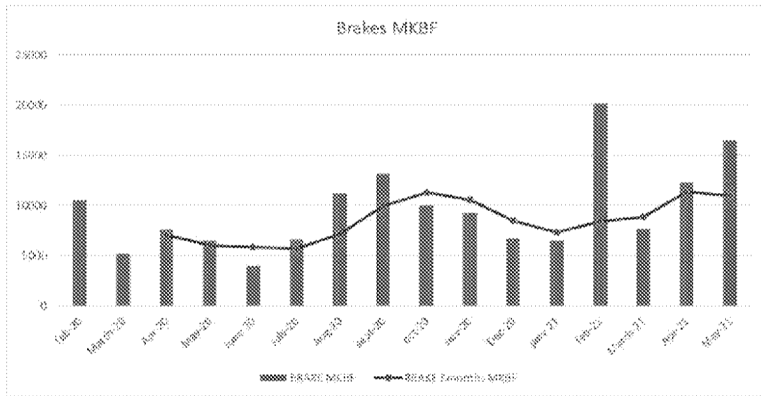
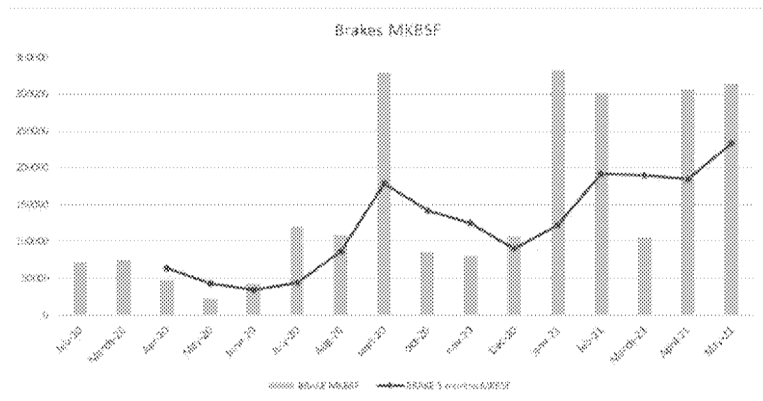
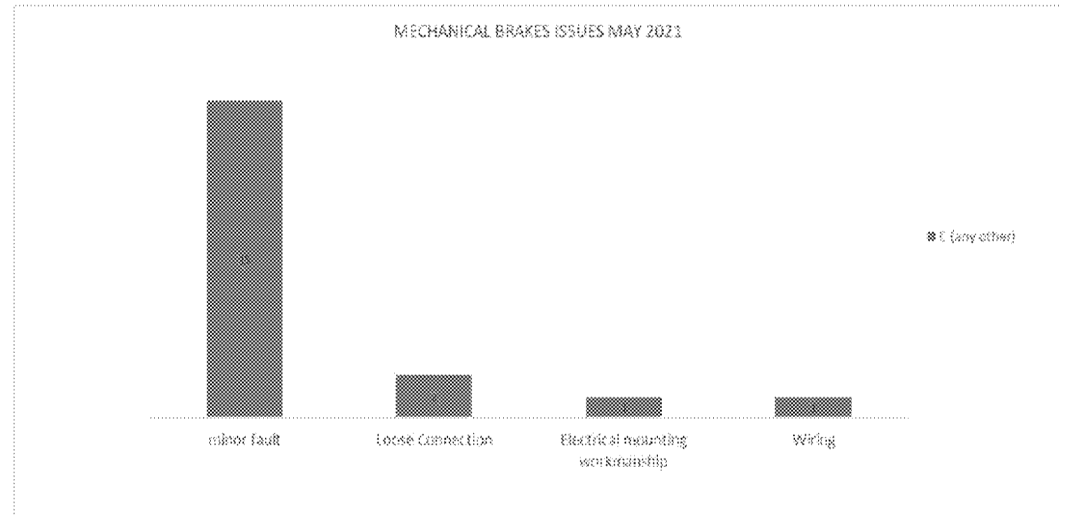
Mechanical brake reliability figures

19 Events

- Minor fault in manual mode (during the driver practice in the revenue service) will be filtered by MPU 1.2.7.2.
- Wiring and Loose connection: Quality actions have been launched (Sanity check inspection ongoing)

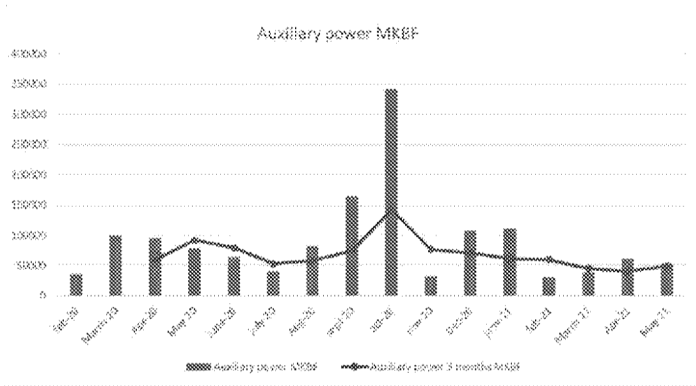
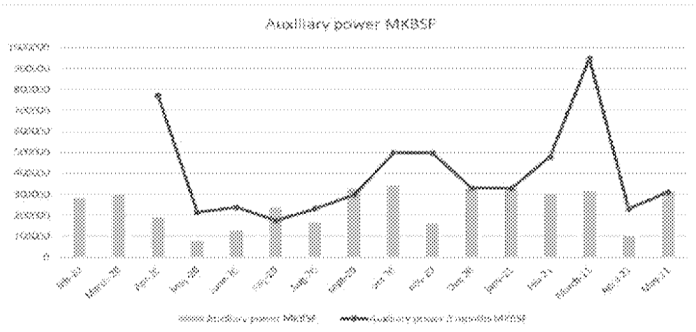
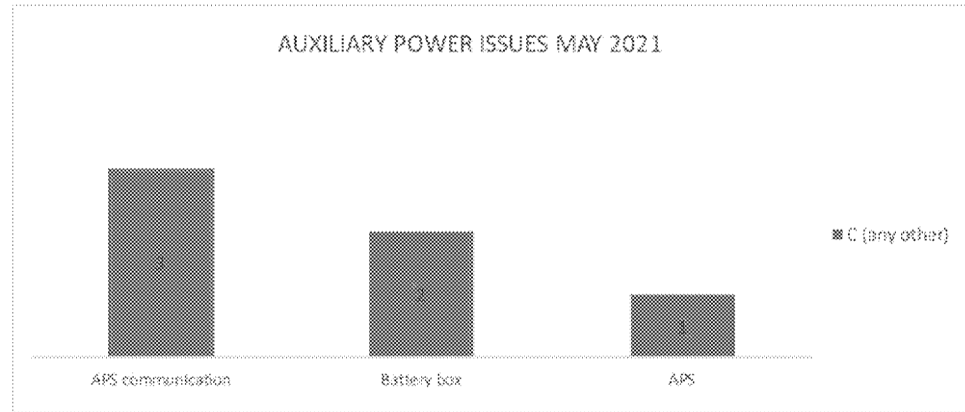
Auxiliary power reliability figures

6 Events

- General investigation ongoing with Adetel and Alstom engineering team.
- Software C17 is deployed.

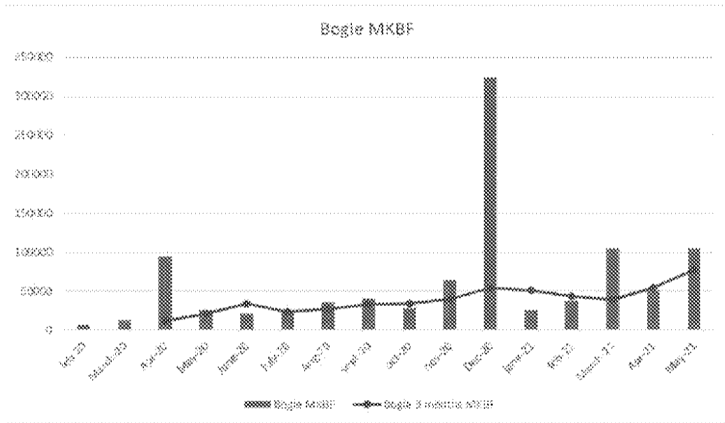
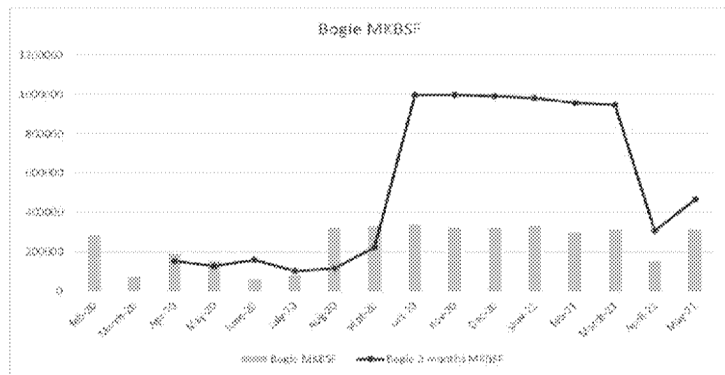
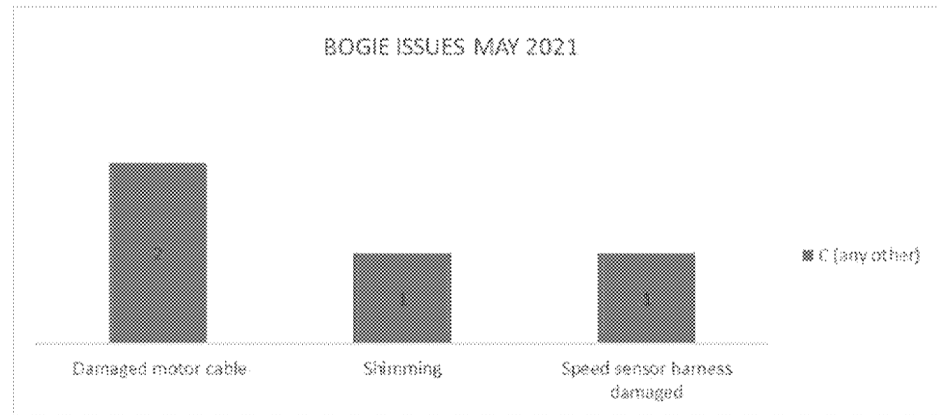
Bogies reliability figures

4 Events

- Speed sensor harness: containment (reduce PMA length) validated. fleet implementation to be started
- Traction motor, damaged motor cable: Quality actions have been launched

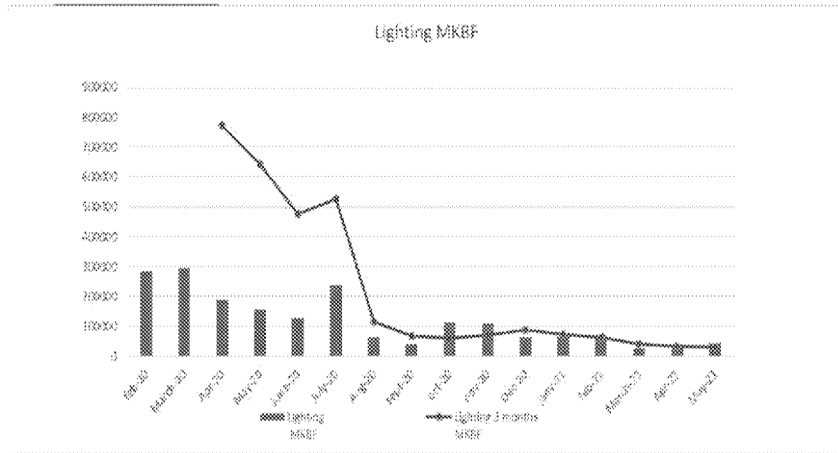
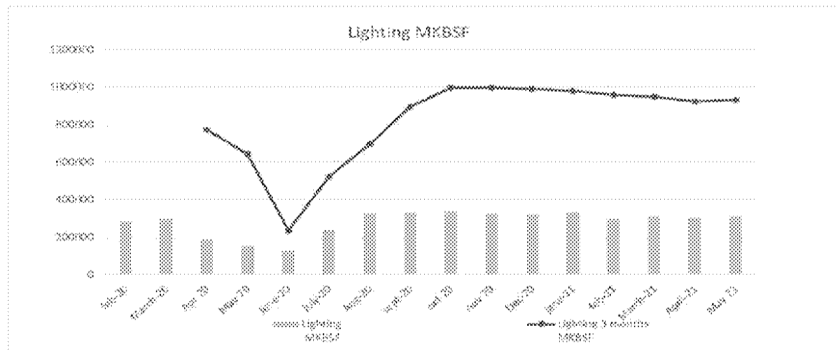
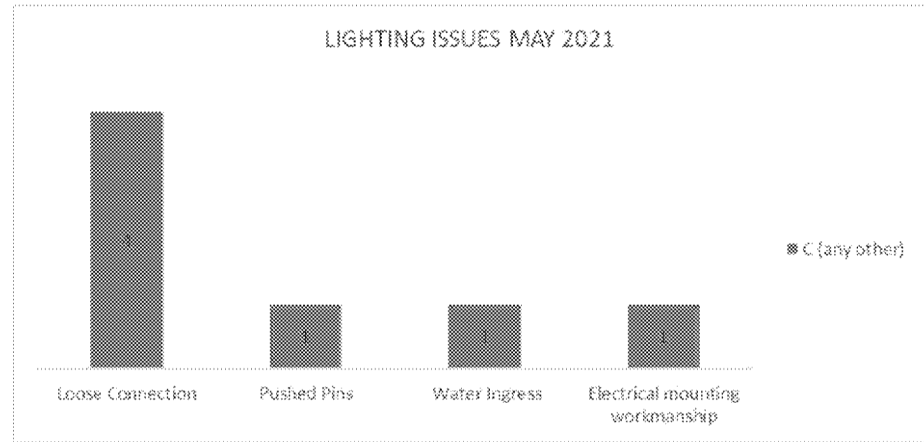
Lighting reliability figures

7 Events

- Loose connection : Quality actions have been launched.

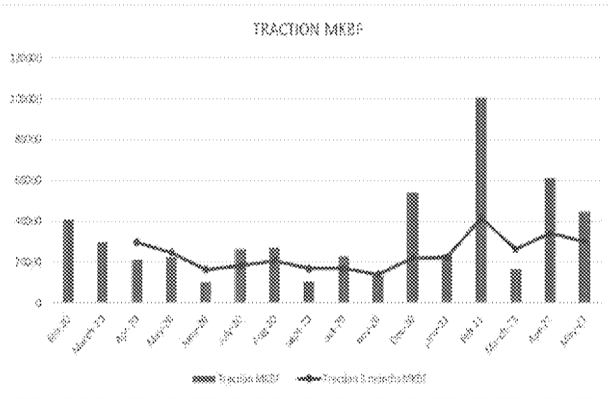
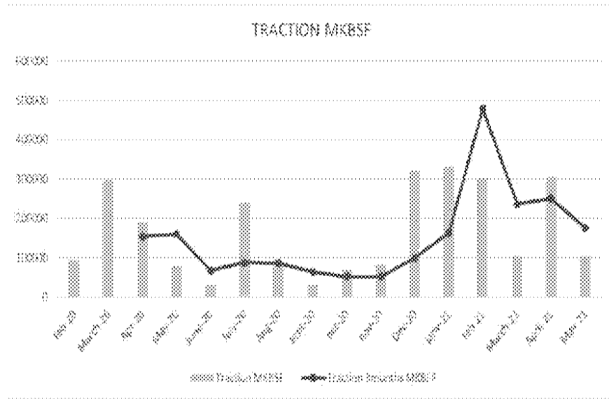
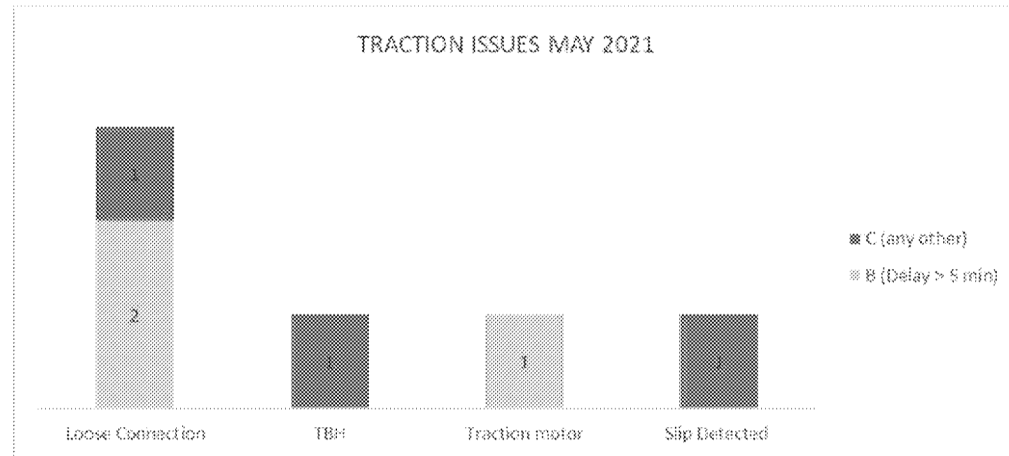
Traction reliability figures

6 Events

- Loose connection: Quality actions have been launched (Sanity check inspection ongoing).
