Transportation
Safety Board
of Canada

Rail Safety Advisory Letter 617-02/21

Roller bearing failure resulting in derailment of Ottawa Light Rail Transit vehicle

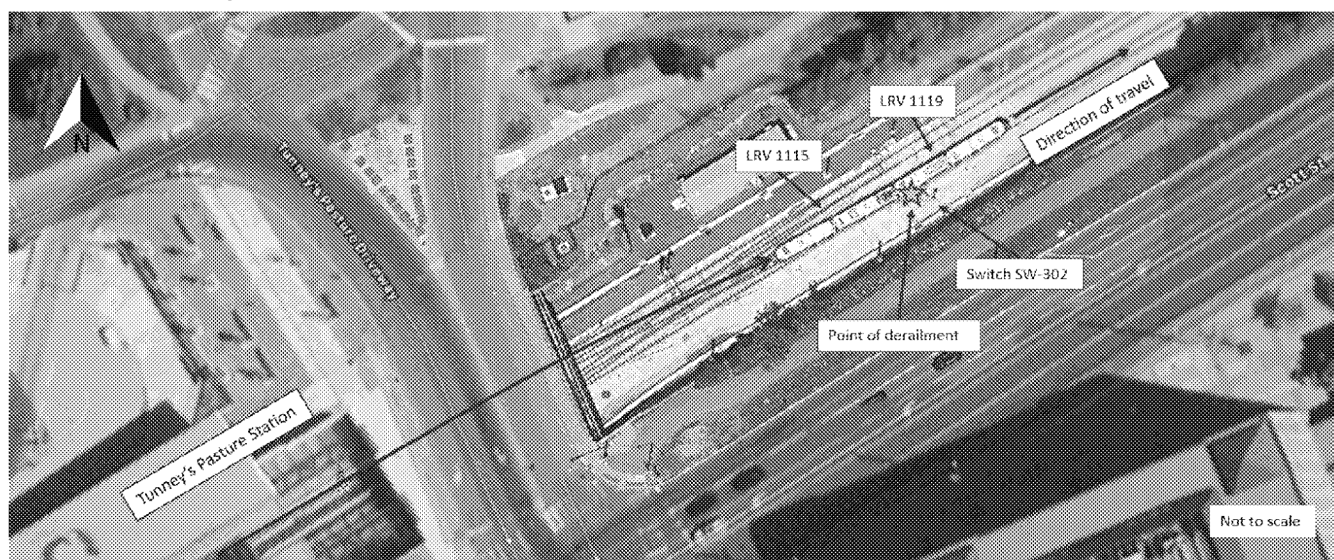
On 08 August 2021 at about 2034,³ an eastbound OLRT commuter train (the train) was proceeding from the north track to the south track over the SW-302 south crossover switch at a speed of about 30 km/h when it derailed about 90 m east of Tunney's Pasture Station in Ottawa, Ontario (Figure 4). There were no passengers on board at the time of the accident.

Site examination identified that while the train was traversing the crossover the No. 3 wheel climbed the rail and derailed to the field side of the south track. The mate No. 4 wheel on the same axle derailed to the gauge side of the north rail and came to rest between the rails. The concrete ties and the tie plates of the south track sustained impact damage.

Figure 4. Derailment location (Source: Google Earth, with TSB annotations)

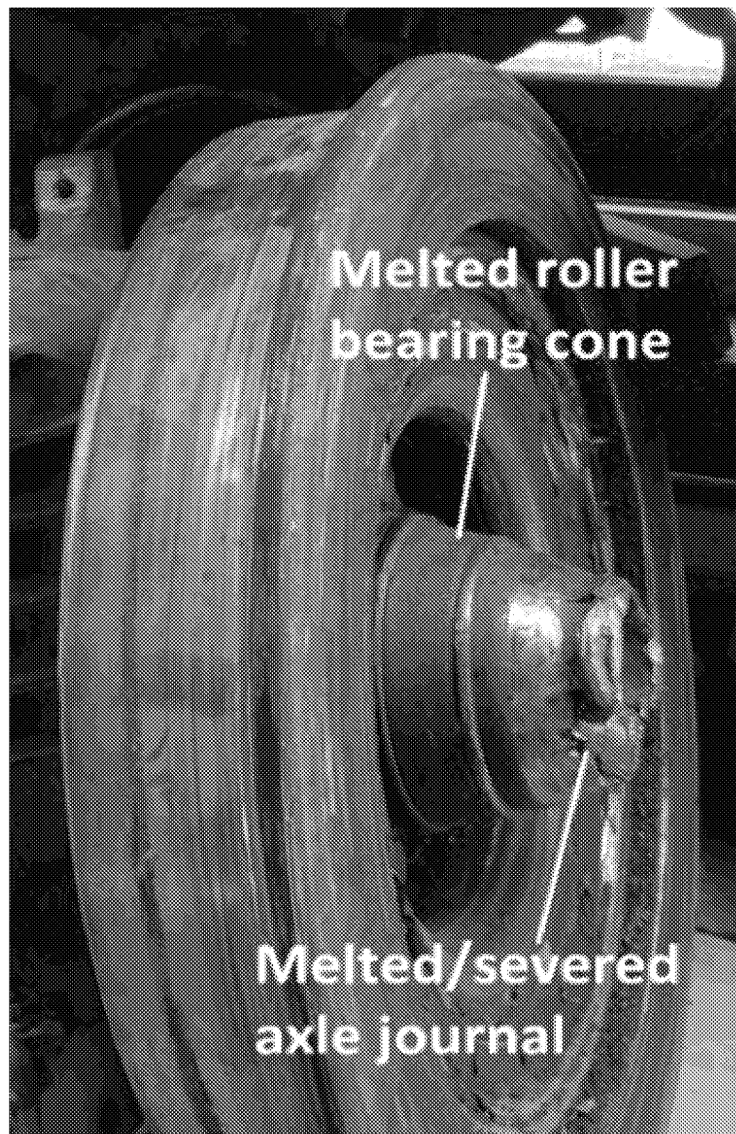
- To minimize service disruptions, it was decided to re-rail the train after 2300.
- As the train was being re-railed, it was discovered that the No. 3 wheel was no longer attached to the axle.
- The No. 3 wheel had severed from the axle due to a previously undetected catastrophic roller bearing failure and subsequent axle journal burn-off (Figures 6 and 7).

Figure 6. Severed wheel and axle assemblies from No. 3 position (Source: TSB)

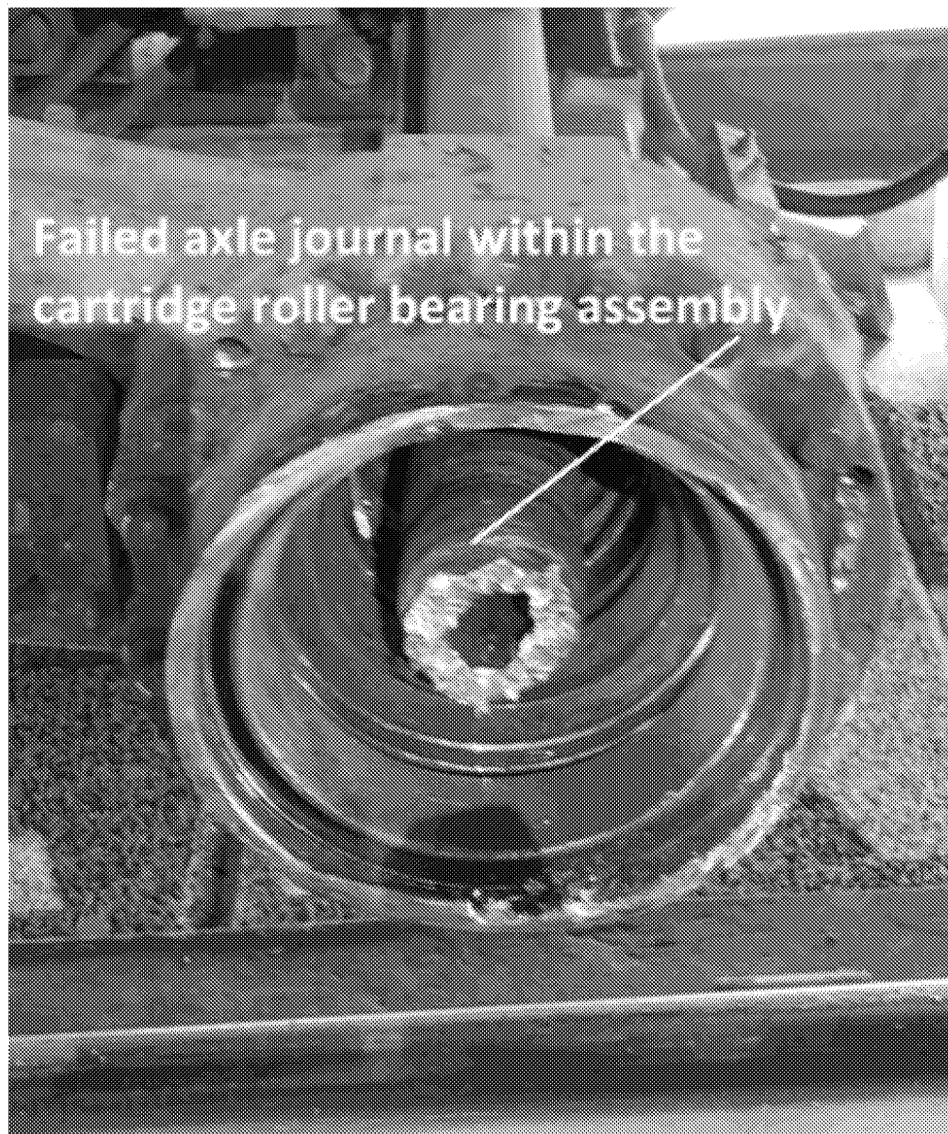
Figure 7. Damaged cartridge roller bearing assembly, No. 3 position on axle B (Source: TSB)

- Roller bearing rollers were later found on the track near uOttawa Station. This suggests that, as the train travelled westward between 1325 and 1450, a cartridge assembly failed and some rollers were expelled.

Alstom's root cause failure analysis suggested that the roller bearing failure was related to the loosening of the large locking nut that holds the cartridge assembly together.

- All failed or loose cartridge assemblies were replaced with new ones before the LRVs were returned to service.
- A new periodic inspection was implemented. The inspection requires the LRV to be elevated in order to inspect the cartridge assemblies from beneath the bogies. With the use of a pry bar, axial endplay clearance measurements are recorded for each cartridge assembly. Loose cartridge assemblies must be replaced. This additional labour-intensive inspection is required for each LRV, every 7500 km, on an ongoing basis.

As demonstrated by this derailment, there can be serious consequences resulting from an overheated roller bearing failure on an LRV in commuter passenger service. OLRT may wish to ensure that it has heat detection systems in place to monitor temperatures of LRV cartridge roller bearing assemblies in order to detect overheated roller bearings in a timely manner and intervene before an in-service catastrophic roller bearing failure occurs.
