Transportation
Safety Board
of Canada

617-02/21
TSB file R21H0099

SUBJECT: RAIL SAFETY ADVISORY LETTER 02/21
Roller bearing failure resulting in derailment of Ottawa Light Rail Transit vehicle

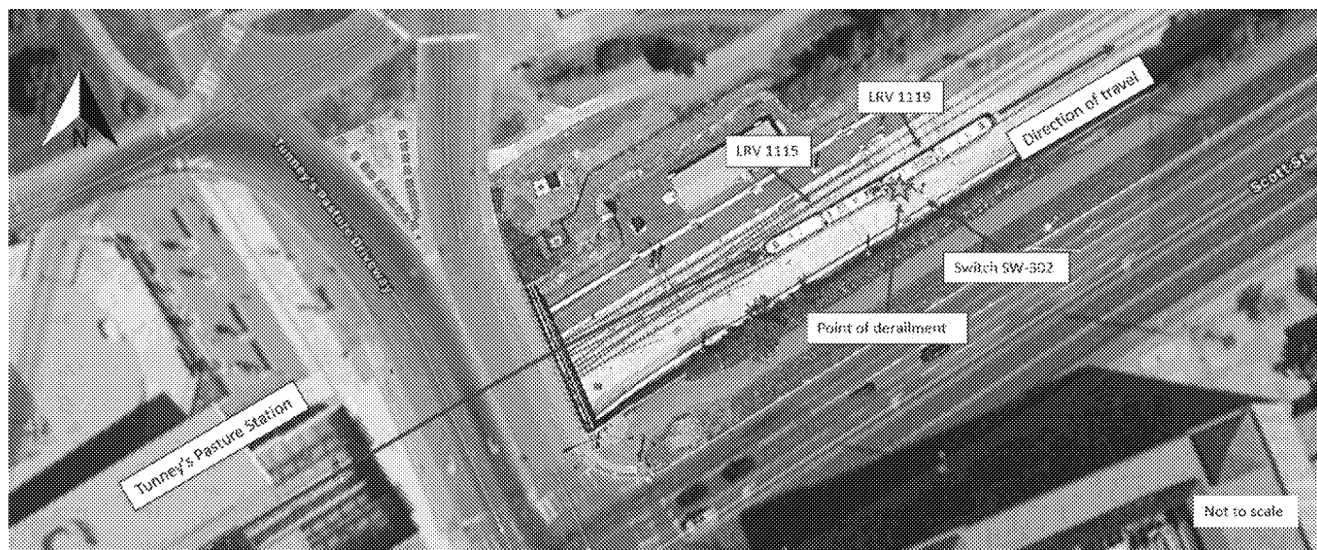
On 08 August 2021 at about 2034,³ an eastbound OLRT commuter train (the train) was proceeding from the north track to the south track over the SW-302 south crossover switch at a speed of about 30 km/h when it derailed about 90 m east of Tunney's Pasture Station in Ottawa, Ontario (Figure 4). There were no passengers on board at the time of the accident.

Site examination identified that while the train was traversing the crossover the No. 3 wheel climbed the rail and derailed to the field side of the south track. The mate No. 4 wheel on the same axle derailed to the gauge side of the north rail and came to rest between the rails. The concrete ties and the tie plates of the south track sustained impact damage.

Figure 4. Derailment location (Source: Google Earth, with TSB annotations)

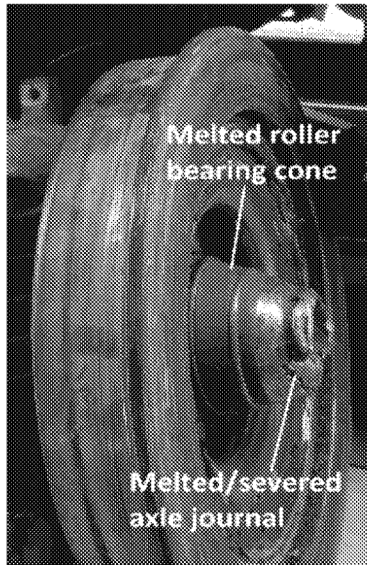
- At 1325, the splined axle on the No. 3 wheel likely failed as the LRV travelled eastward between Cyrville and Blair stations (Figure 5). A review of event recorder and vehicle logs showed that LRV 1119 had experienced multiple wheel slip warnings during this time.

Figure 6. Severed wheel and axle assemblies from No. 3 position (Source: TSB)

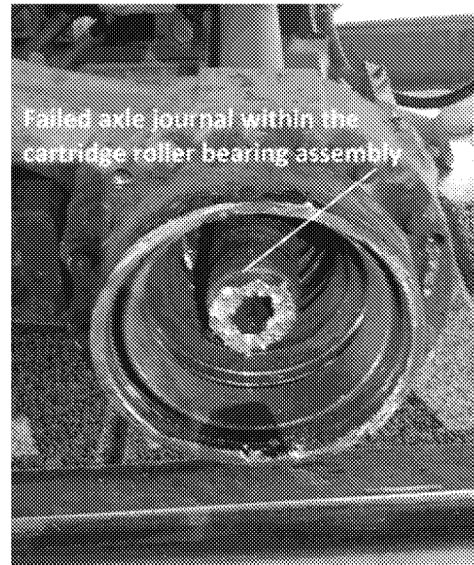
Figure 7. Damaged cartridge roller bearing assembly, No. 3 position on axle B (Source: TSB)

Alstom's root cause failure analysis suggested that the roller bearing failure was related to the loosening of the large locking nut that holds the cartridge assembly together.

- The entire OLRT LRV fleet was grounded for 5 days while cartridge assembly axial endplay clearance measurements were completed on the fleet (20 per LRV). Measured clearances in excess of 0.1 mm are considered to be loose and the associated cartridge assembly must be replaced with a new assembly.

- All failed or loose cartridge assemblies were replaced with new ones before the LRVs were returned to service.
- A new periodic inspection was implemented. The inspection requires the LRV to be elevated in order to inspect the cartridge assemblies from beneath the bogies. With the use of a pry bar, axial endplay clearance measurements are recorded for each cartridge assembly. Loose

cartridge assemblies must be replaced. This additional labour-intensive inspection is required for each LRV, every 7500 km, on an ongoing basis.
