Transportation
Safety Board
of Canada

617-03/21
TSB file R21H0121

SUBJECT: RAIL SAFETY ADVISORY LETTER 03/21
Work procedures for Ottawa Light Rail Transit vehicle maintenance

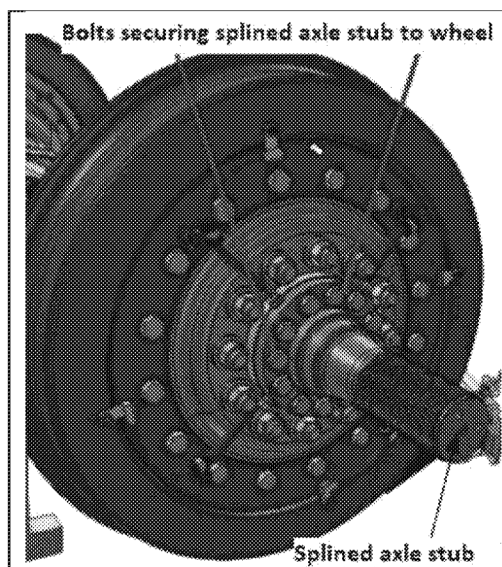
Each motor bogie is equipped with 2 motors—1 on each side of the bogie. Power from each motor is transmitted to a drive wheel through a gearbox that interconnects with a splined axle stub, also referred to as a reducer hub, which is secured to the wheel hub with 12 bolts (Figure 3). Disc brake rotors are attached to the wheel hub opposite the drive wheel of each motor bogie wheel set (Figure 4), and to each wheel of the trailer bogies. The rotors are also secured to the wheel hub with 12 bolts.

Figure 3. Splined axle stub secured to a wheel hub (Source: Alstom, with TSB annotations)

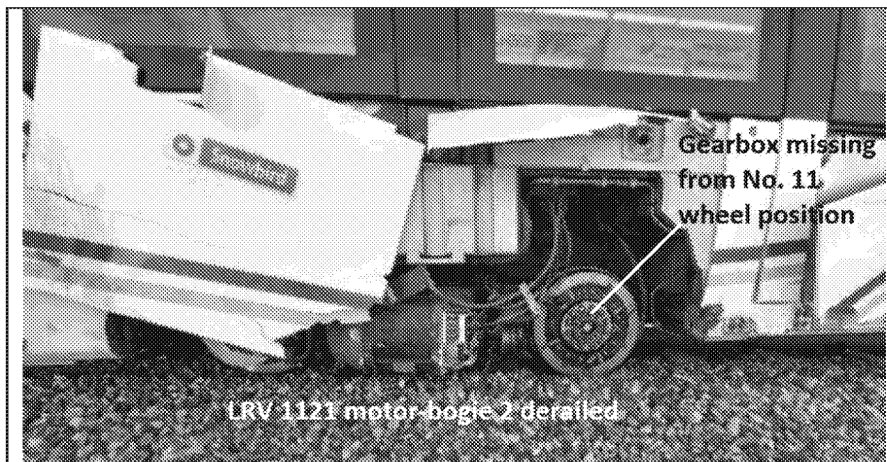
BM2 on LRV 1121 had derailed to the north side of the track. The motor gearbox from the No. 11 wheel position had detached from the wheel and was missing (Figure 5).

Figure 5. BM2 on LRV 1121 derailed and gearbox missing from wheel position No. 11 (Source: Alstom)

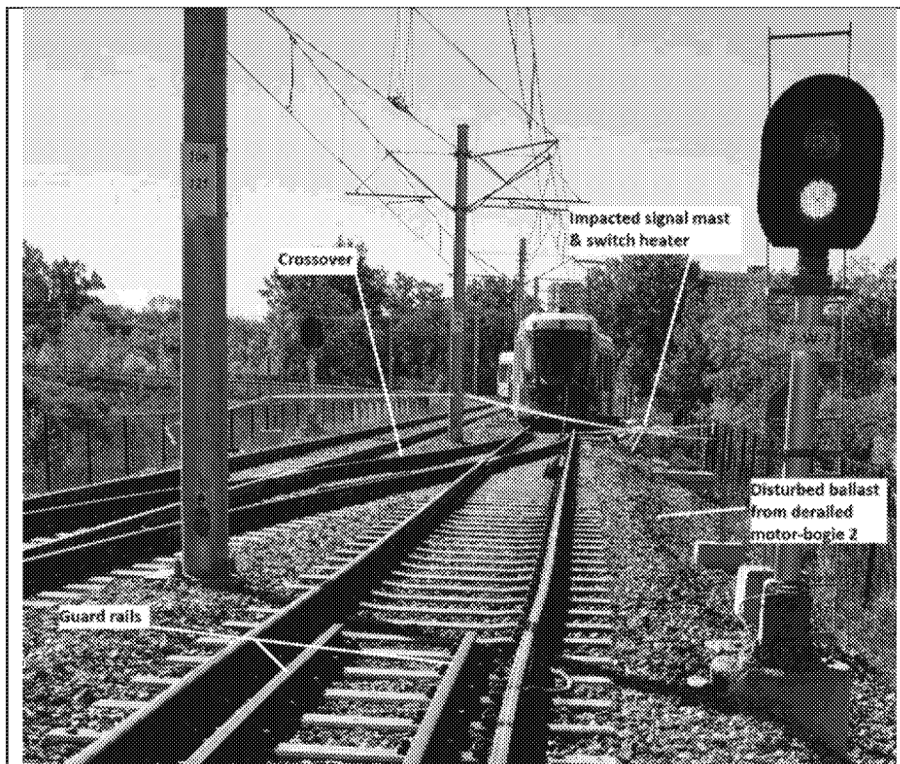
During the derailment, LRV 1121 had contacted and destroyed a signal mast and switch heater that were adjacent to, and north of, track 1 (Figure 6).

Figure 6. Looking west at LRV 1121 on track 1 (Source: TSB)

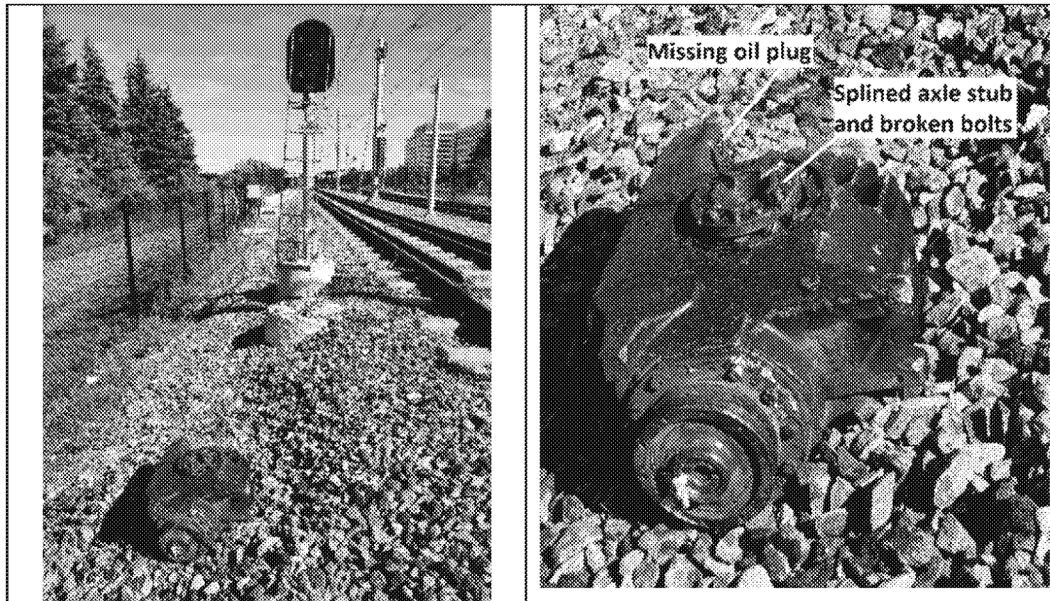
From LRV 1121 eastward, the ballast along the north side of track 1 was disturbed for about 1400 feet. The gearbox from the BM2 No. 11 wheel position was located on the ballast just north of the track. An oil plug was missing from the gearbox (Figures 7 and 8).

Figure 7. Looking east at gearbox (Source: TSB) **Figure 8.** Gearbox close-up (Source: TSB)

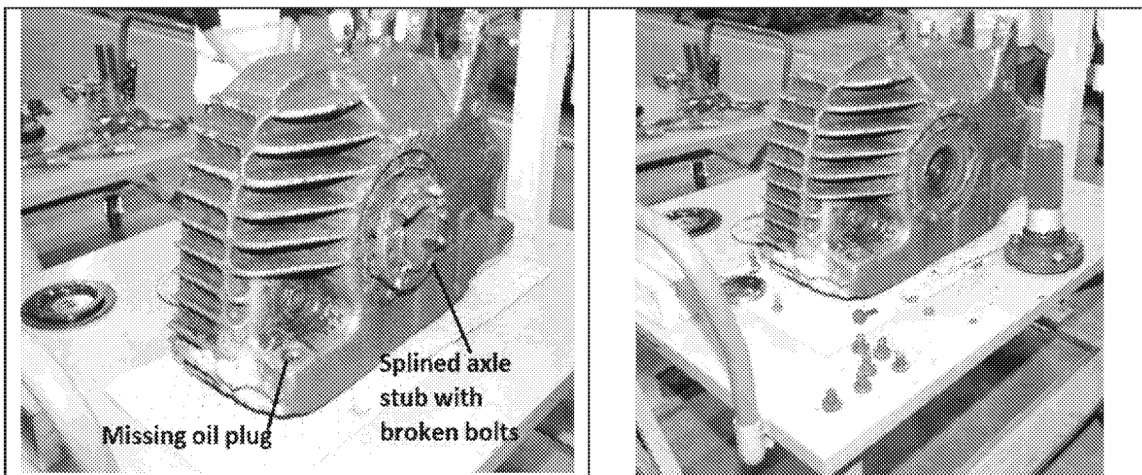
The splined axle stub is normally secured to the wheel hub with 12 fine-thread, class 12.9 M16x1.5 bolts. In this case, all 12 of the bolts from the BM2 No. 11 wheel position had failed (Figures 9 and 10).

Figure 9. Gearbox as received (Source: TSB)

Figure 10. Splined axle stub removed (Source: TSB)

Alstom requires that bolts not be reused, although reuse of bolts on this component was previously noted by Alstom on 19 October 2020.

A post-accident review of the torque gun data revealed that data for one of the three splined axle securement operations was missing. This missing data was later attributed to the BM2 No. 11 wheel position after employees physically checked the bolts securing the splined axle stub in BM3 No. 17 wheel position and BM3 No. 19 wheel position and determined that the required torque was applied.
