Transportation
Safety Board
of Canada

617-08/20
TSB File R20H0079

SUBJECT: RAIL SAFETY ADVISORY LETTER 08/20
Cracked wheels on Ottawa Light Rail Transit vehicles

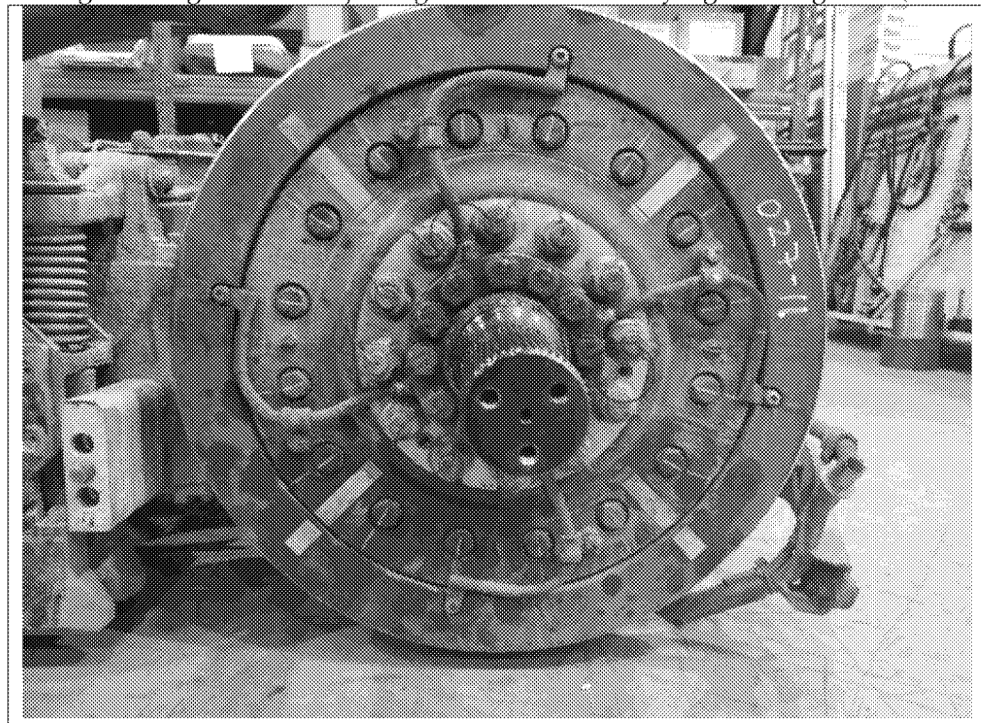
Besides the 12 lug bolt holes, each wheel hub contains 4 grounding cables and 3 smaller threaded holes to accommodate jacking screws. To remove a wheel from the axle, the lug nuts are removed then jacking screws are applied and push against the axle hub in order to separate the wheel hub from the axle hub. One jacking screw location on each wheel is usually obscured by a grounding cable (Figure 5).

Figure 5. Outboard view of mounted wheel showing 12 lug nuts, 3 jacking screws (circles) and 4 grounding cables. One jacking screw is obscured by a grounding cable (Source: TSB)

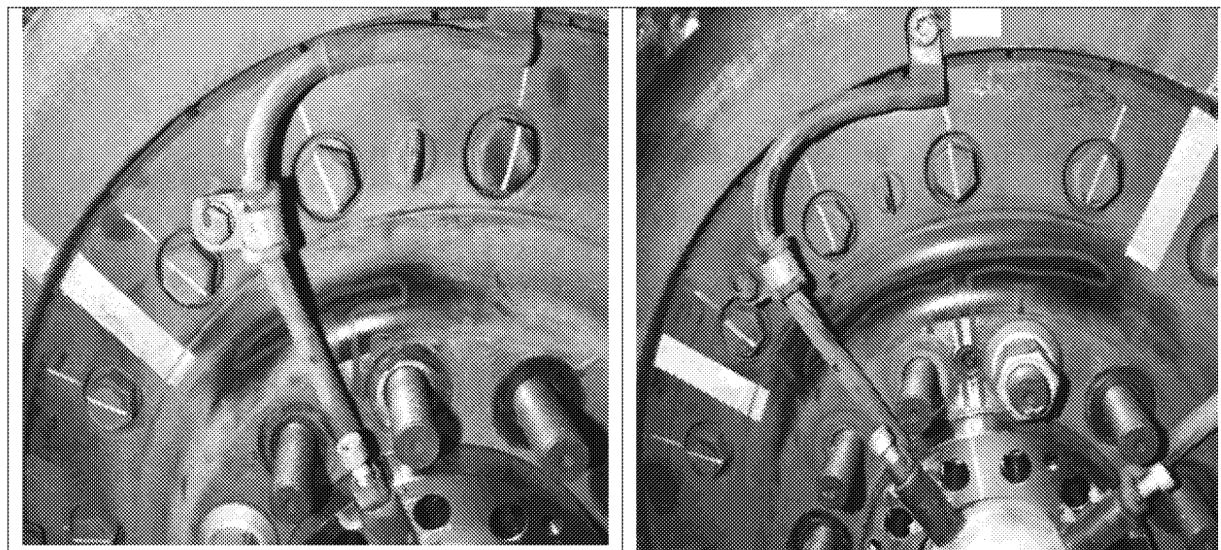
On 02 July 2020, LRV 1113 motor bogie 3 (BM3) was undergoing retrofit at the Alstom facility in Sorel-Tracy, Quebec. During the retrofit, Alstom personnel observed that the wheels located in the L17 and R20 positions had cracks on the outboard face of the wheel hub (Figures 6 and 7).

Figure 6. LRV 1113 L17 wheel (Source: Alstom)

Figure 7. LRV 1113 R20 wheel (Source: Alstom)

The bogies with cracked wheels identified from LRVs 1108, 1133, 1114 and 1128 were subsequently sent to the TSB laboratory for teardown examination and failure analysis. Concurrently, preliminary finite element analysis performed by Alstom suggested that jacking screws that protruded from the rear surface of the wheel hub may have contributed to the development of the wheel hub cracks.

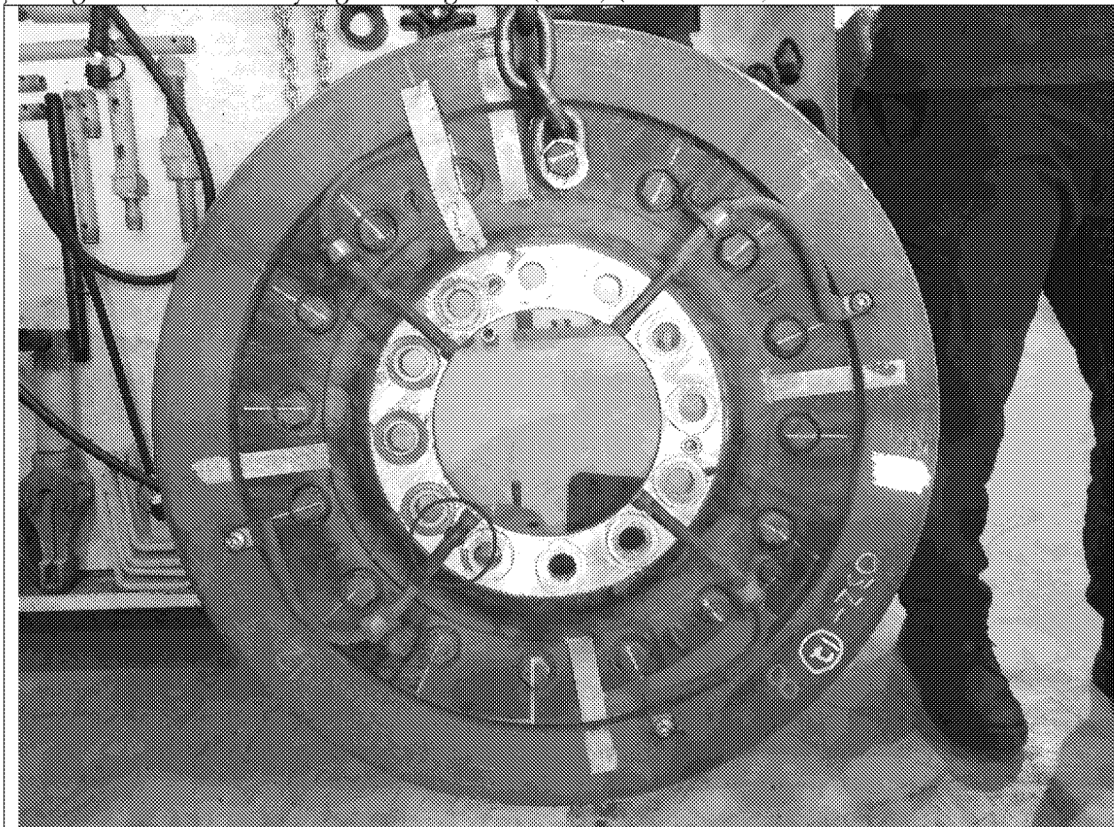
With regards to cracking in the area of the resilient wheel hubs, cracks were confirmed in the 2 wheels that were originally reported to have cracks, LRV 1133 R12 and LRV 1108 L1.

- For LRV 1133:
 - Although the R12 wheel was reported to have 1 crack, additional visible cracks were observed in the area of all 3 jacking screws (A, B and C).
 - The crack observed in the area of jacking screw C was obscured by a grounding cable (Figure 8).

Figure 8. R12 wheel on LRV 1133 with reported wheel hub crack identified (tape and arrow) and 1 jacking screw obscured by a grounding cable (circle) (Source: TSB)
