Subject: Final Derailment Report of LRV 1116 on March 14th, 2021

LRV 1116 MSF Yard Derailment Investigation Report	Document Reference: OTT-ENG-REP-66 Version B	Application date: 2021-06-28
Written by:	N. Sembeyev / Bogie Warranty Engineer Y. Liu / Project Engineering Manager S. Hernandez / Project Quality Manager C. Khokhar / Engineering Technician		
Verified by:	L. Goudge / Train System Engineer	Ensures that the technical/ process accuracy has been checked.	
Approved by:	R. France / Project Manager	Orders, by his signature, the implementation of the document.

On 14 March 2021, at approximately 13:19, Ottawa Confederation Line LRV 1116 derailed at low speed in the maintenance and storage facility Yard (MSF) during a routine move from the storage area to the handover platform.

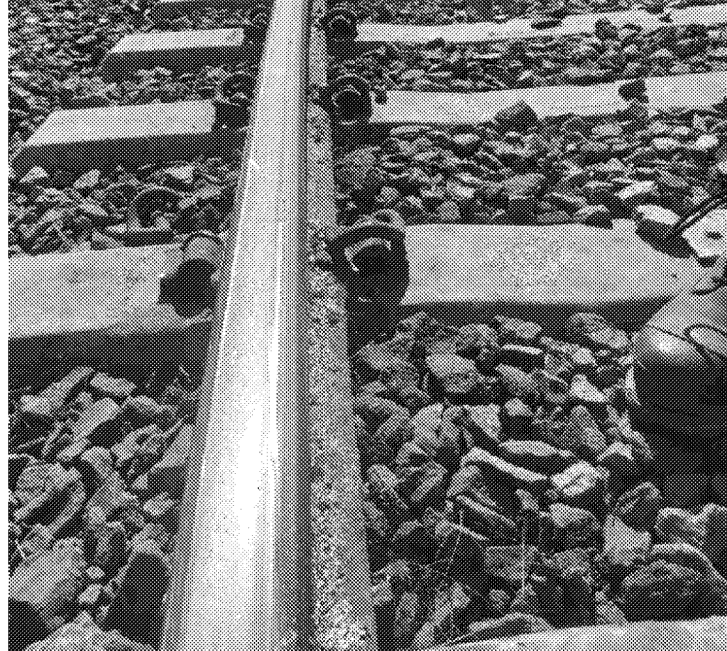
Figure 3. Wheel flange marks on top of rail

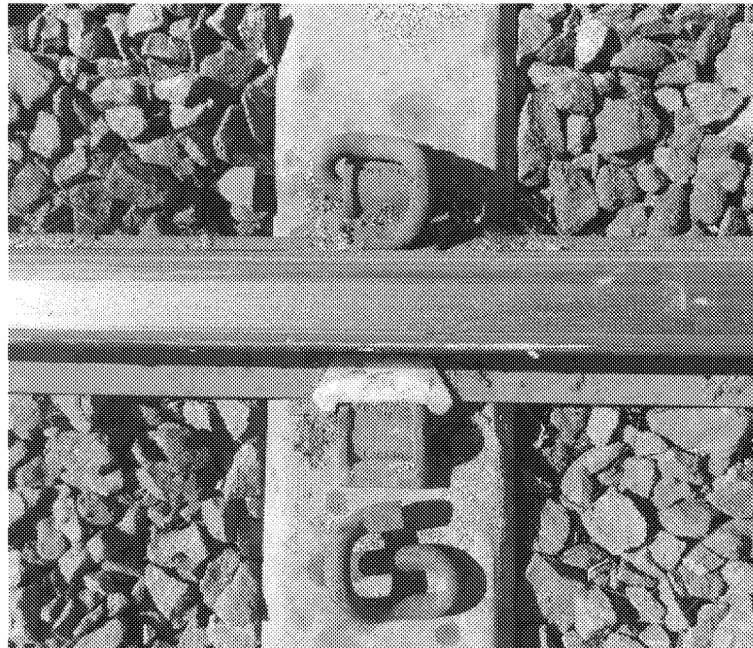
Outer edge of the rail showed signs of scoring from contact with the gearbox all along the rail

Figure 4. Signs of scoring

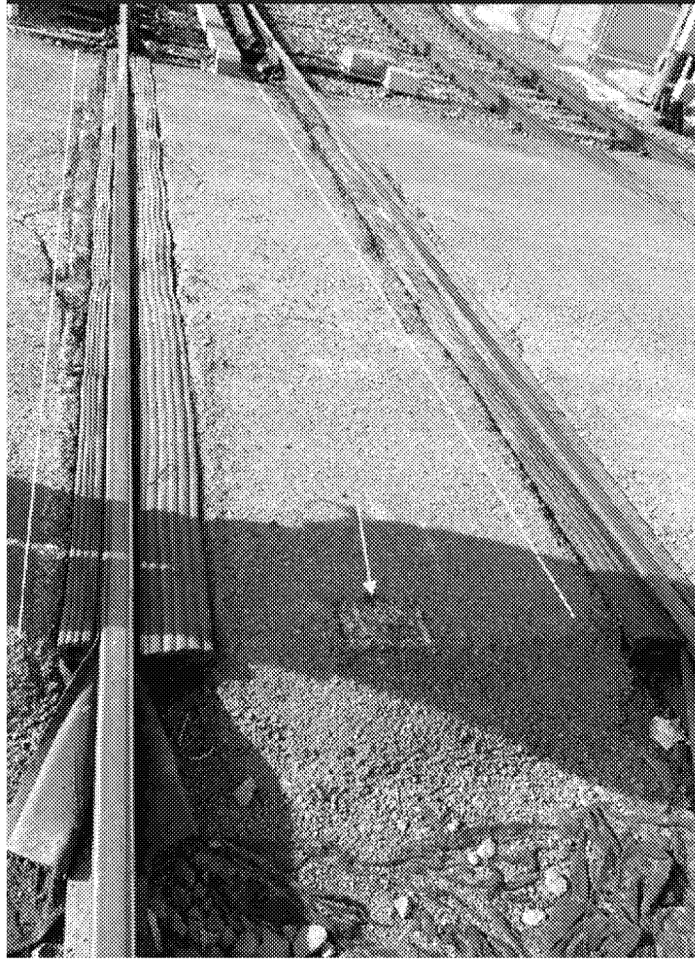
There were noticeable damage to the pavement at the crossing due to contact from the bogie speed sensor harness bracket

Figure 5. Damage to pavement

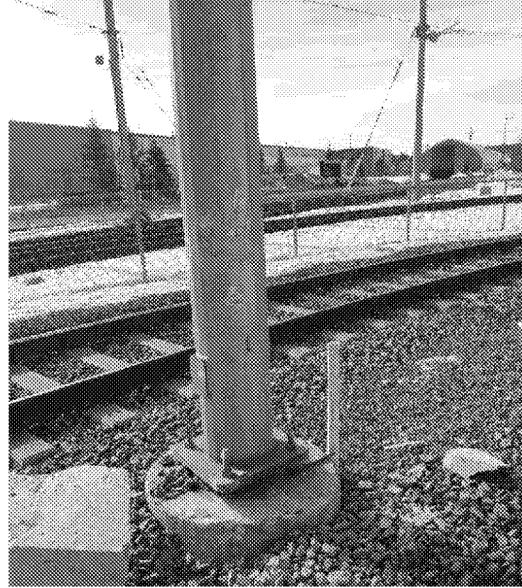
The first OCS pole showed signs of contact with LRV. The integrity of the pole was verified to be OK.

Figure 6. Damage to OCS pole

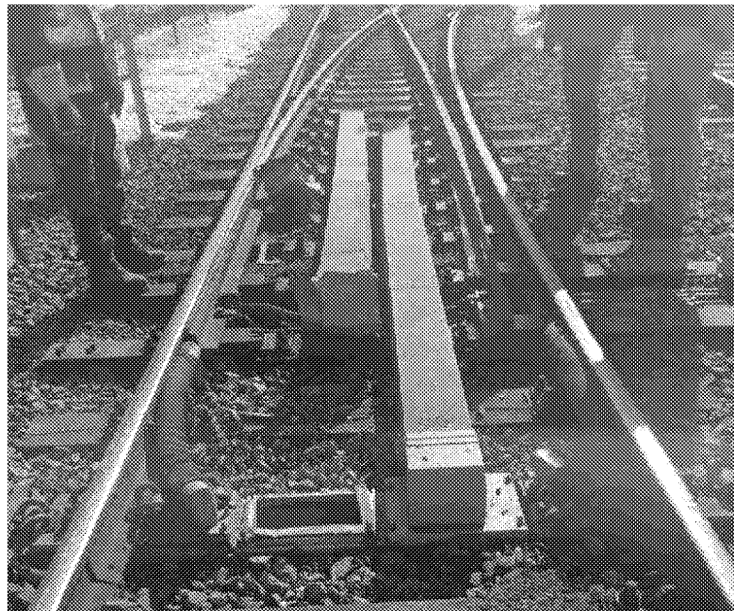
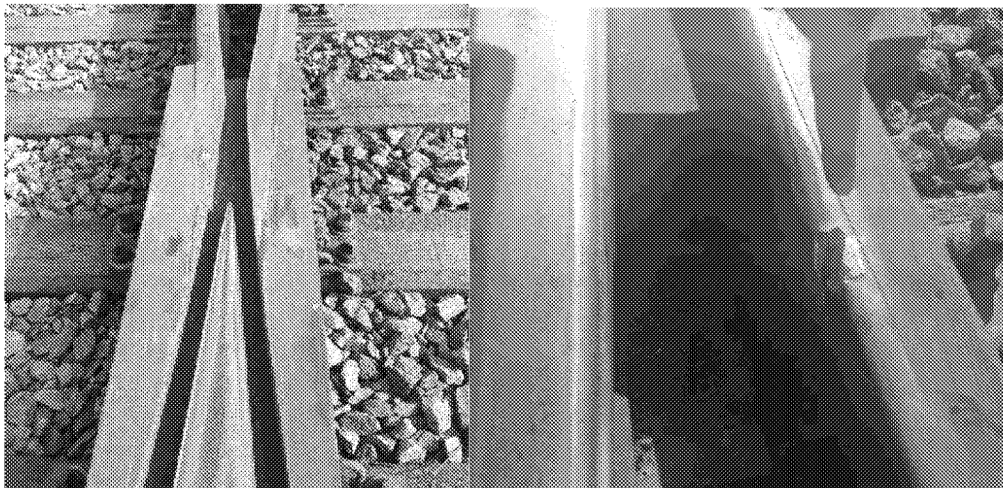
Switch 511 showed minor damage on the frog and duct work.

Figure 7. Switch 511 damage

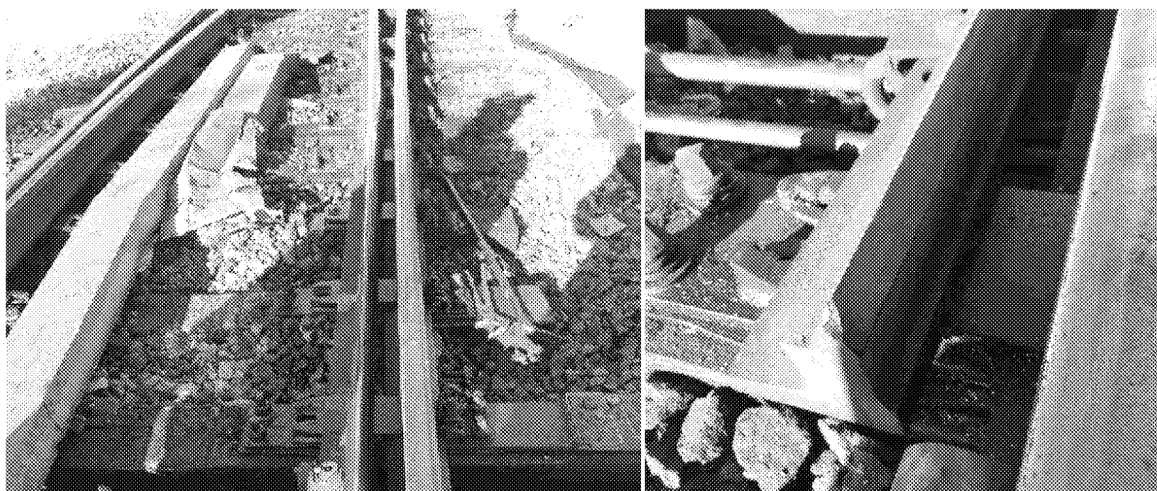
Switch 510 showed significant damage:

- The switch heater ductwork / nozzles was damaged significantly.
- The switch point was chipped.
- One switch short throw rod was damaged
- Various brackets, hardware, and fasteners showed minor damage

Figure 9. Switch 510 Damage

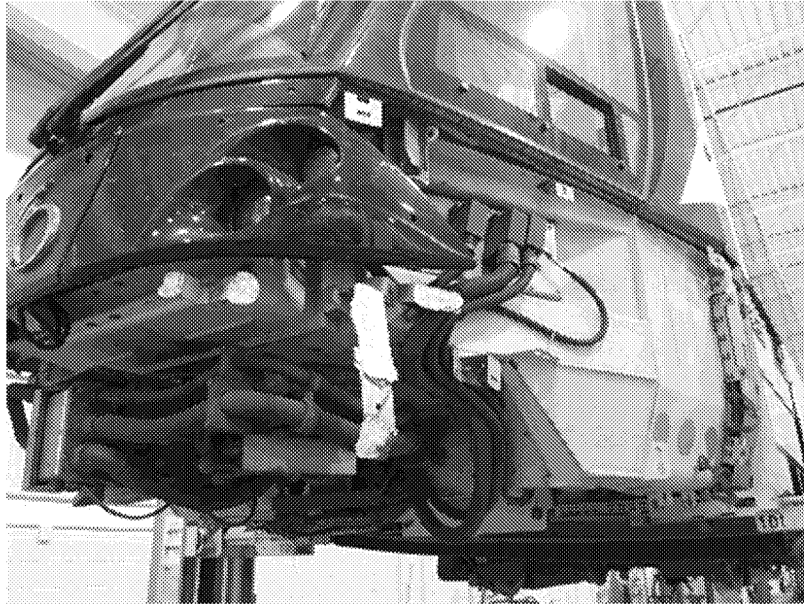
Figure 10. LMC1

- Cab front end fixed panel and bumper damaged

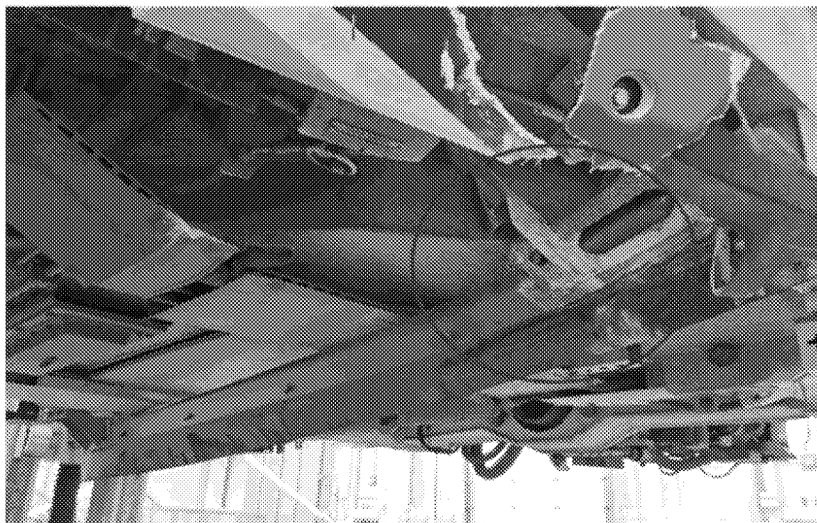
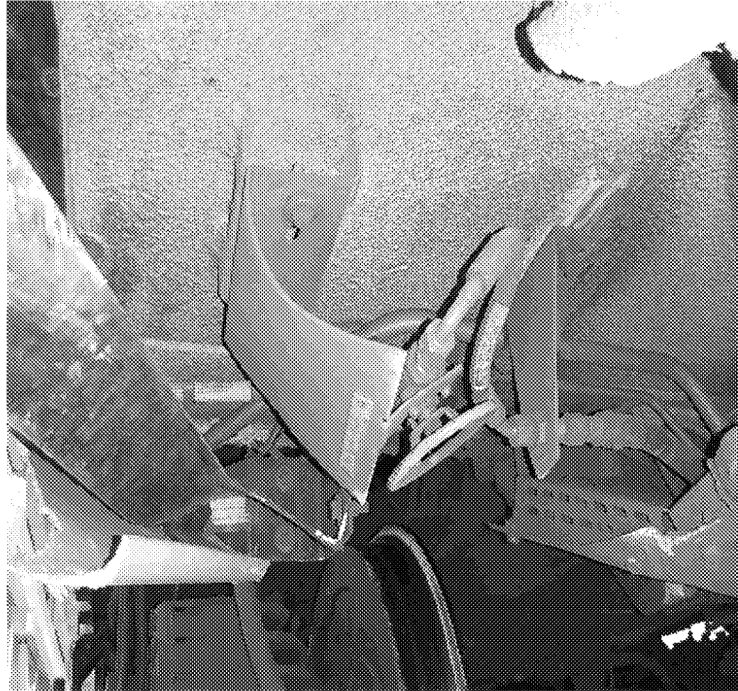
- Chassis welded snow plough support bracket damaged.

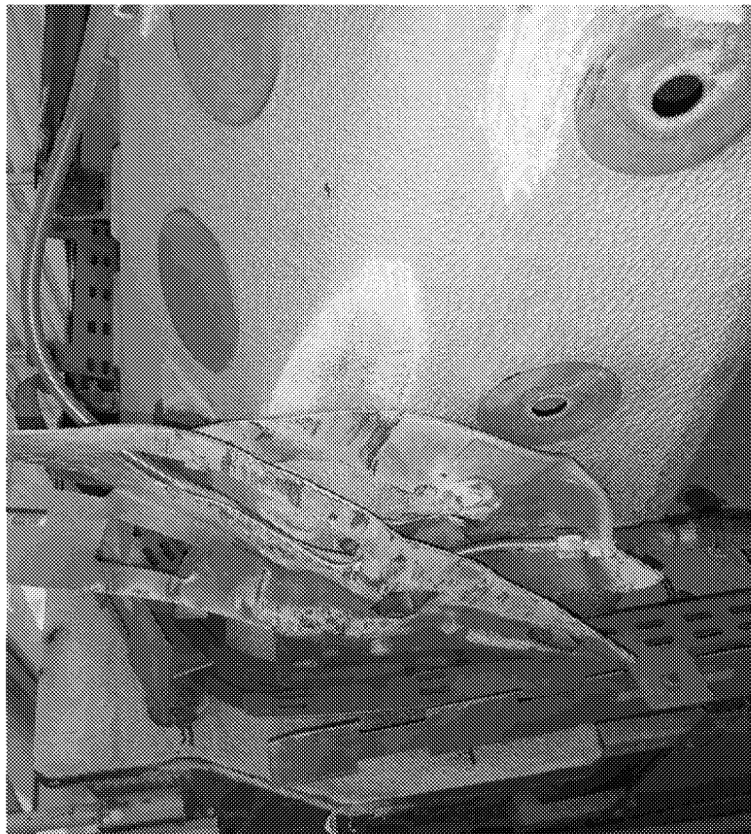
Figure 13. LMC1

- Impact on cab underframe and coupler pneumatic/hydraulic pipes

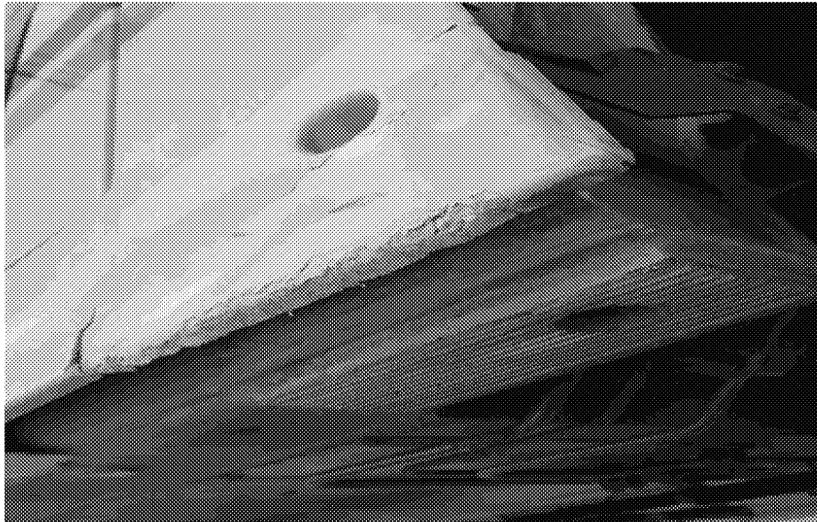
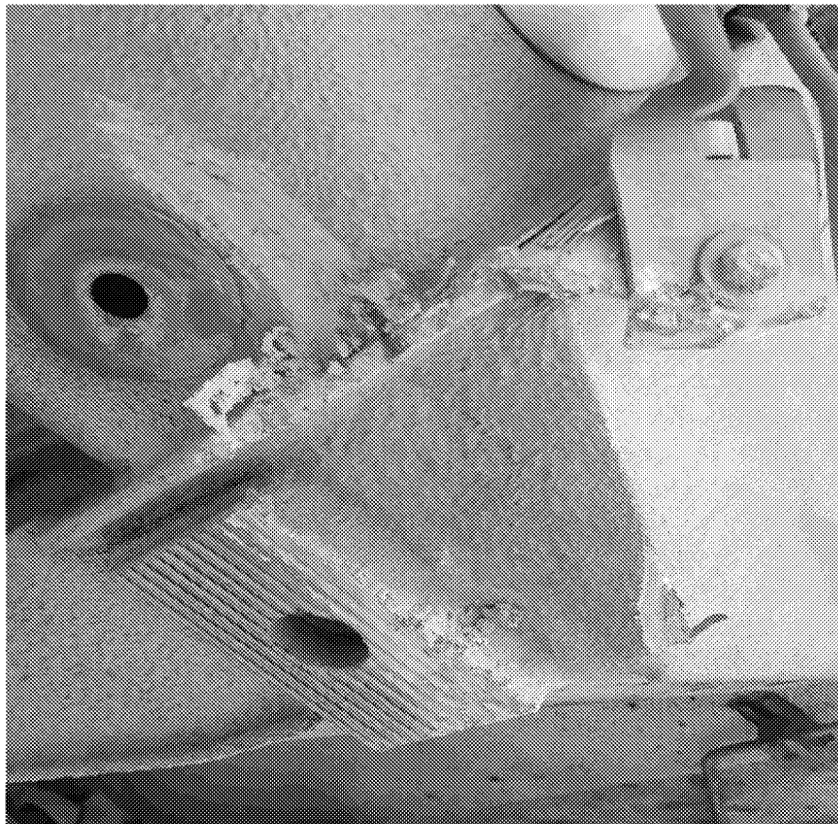
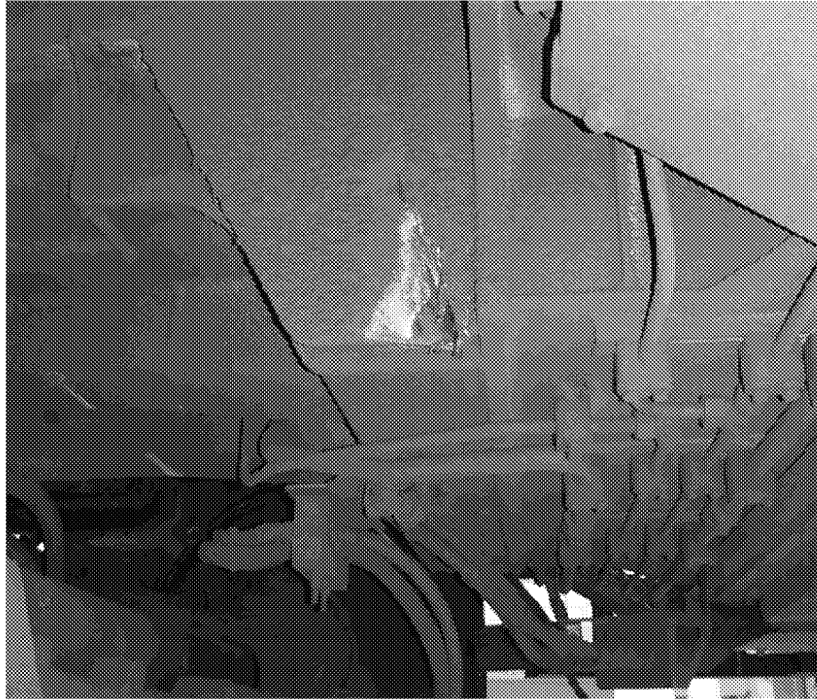
- Impact on LMC1 Underframe and lifting points

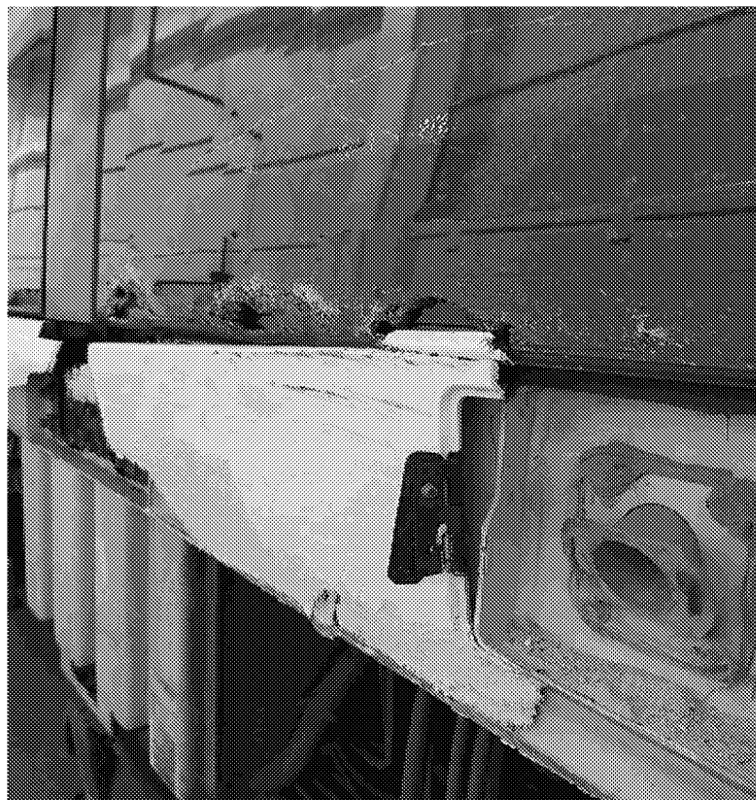
Figure 17. LMC1

- LMC1 right-side broken window # 2 and side panels

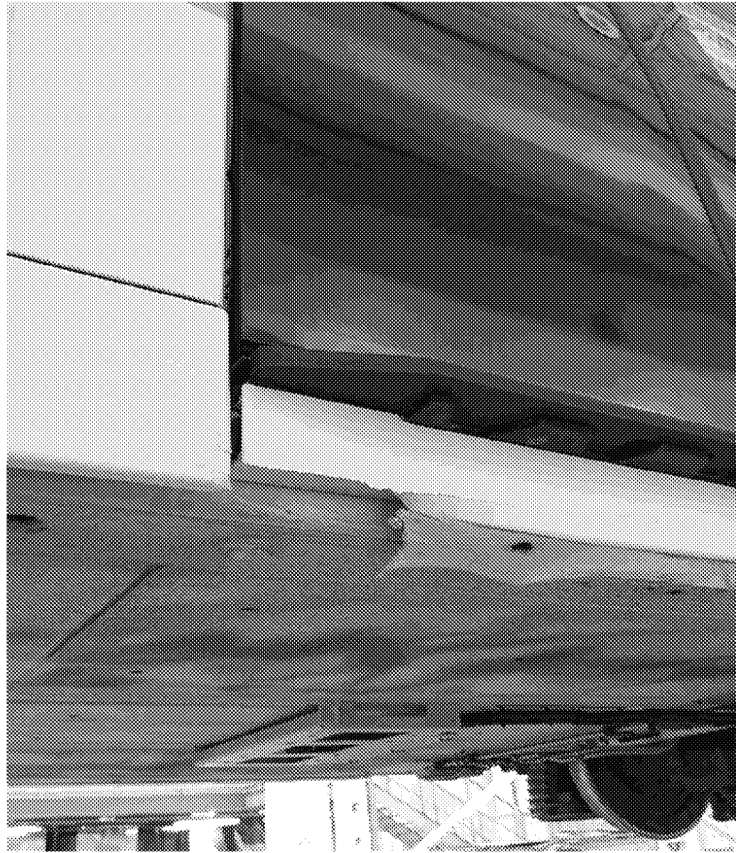
Figure 18. LMC1

- LMC1 right-side door#2 damaged door threshold cover

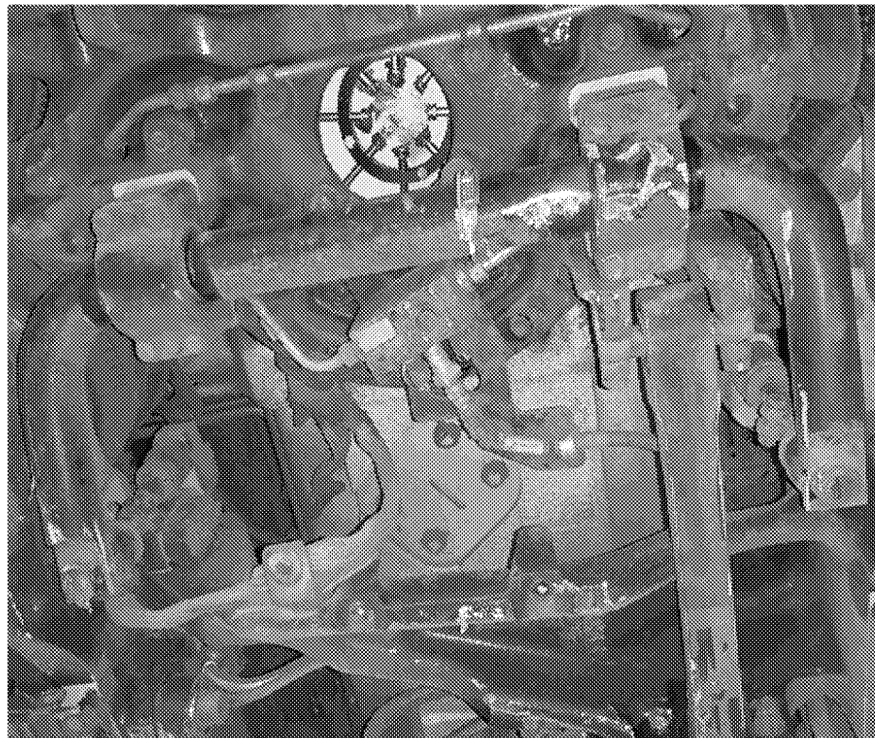
Figure 21. Bogie BM1

- LMC1 BM1 impact on anti-roll bar

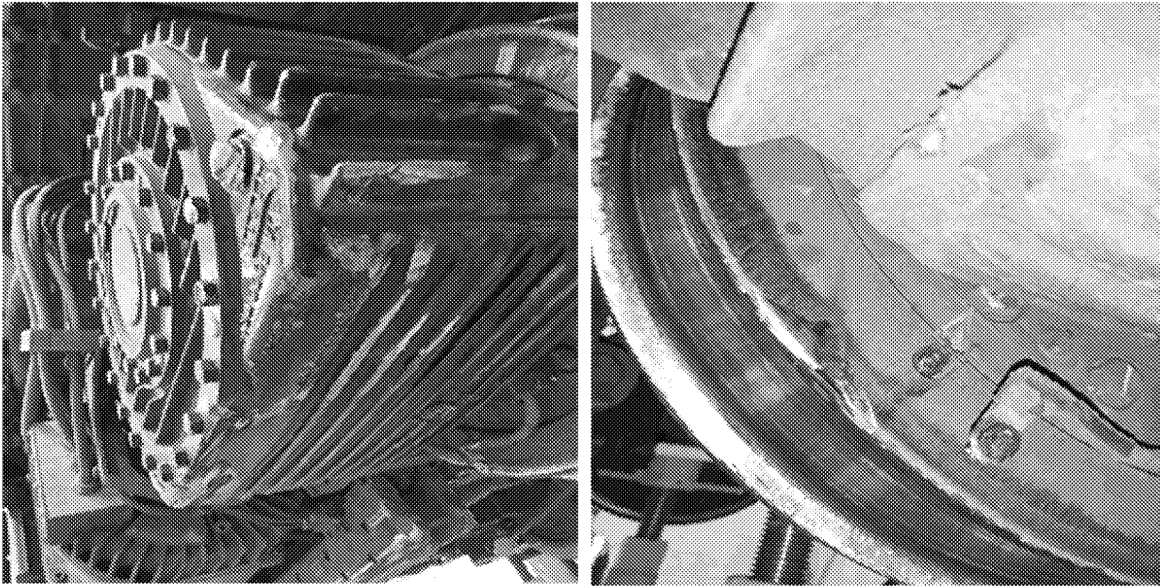
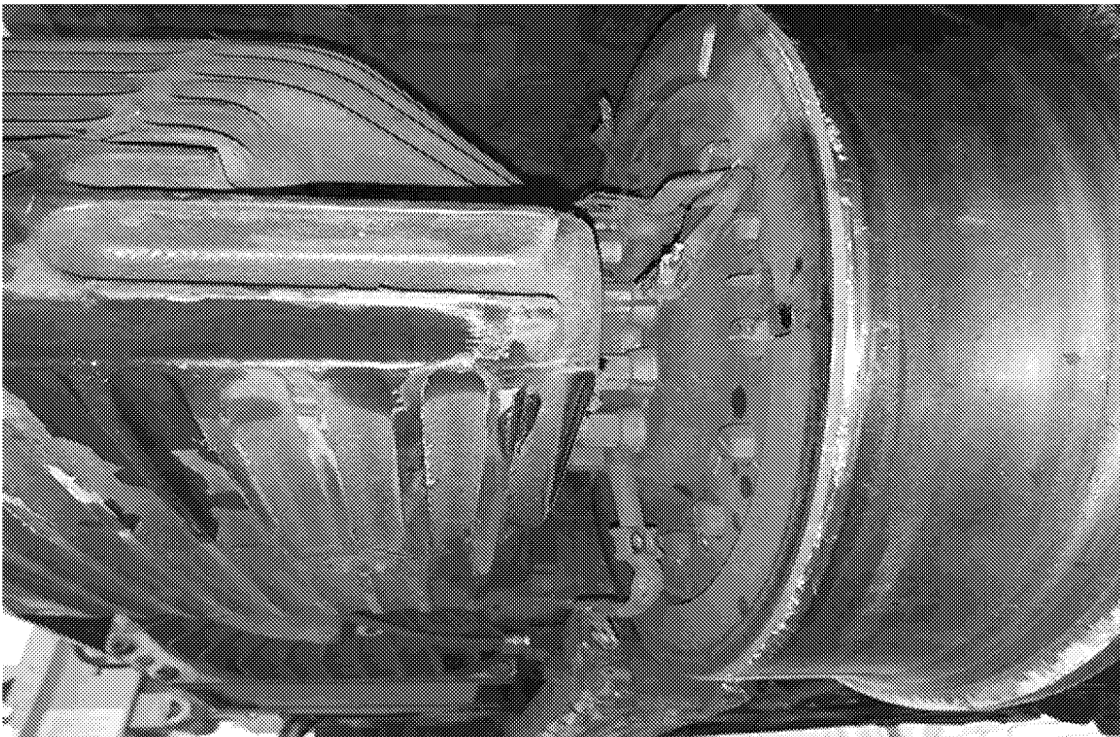
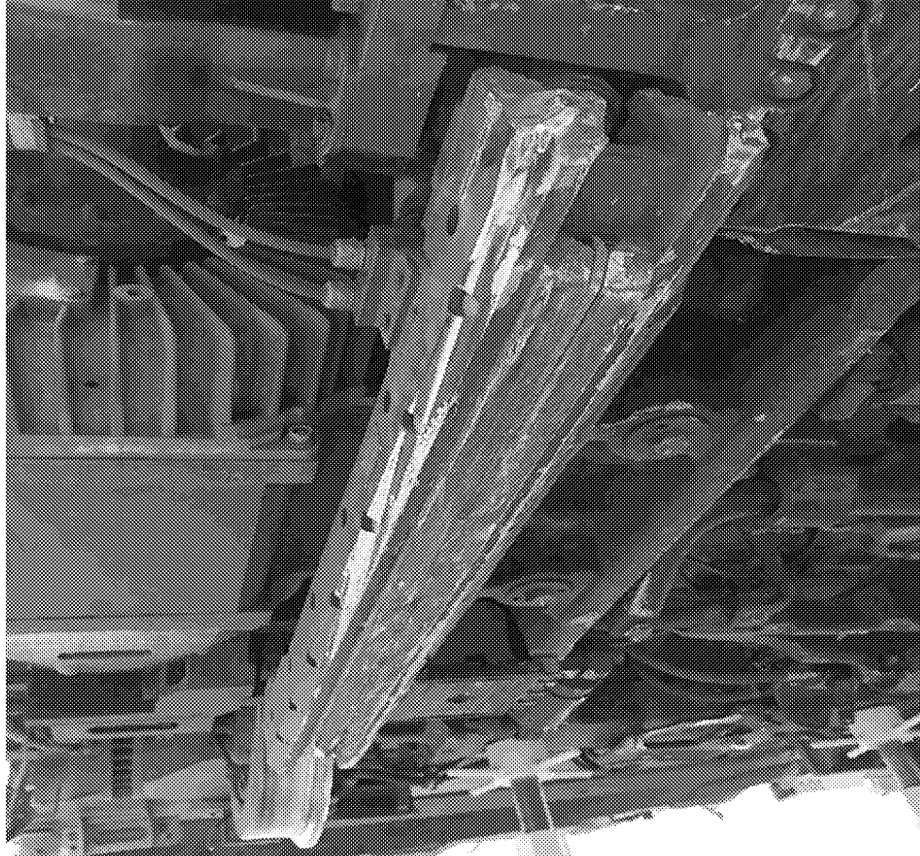
- Damages to wheel shunts and gear box. BM1 axle 2 left side

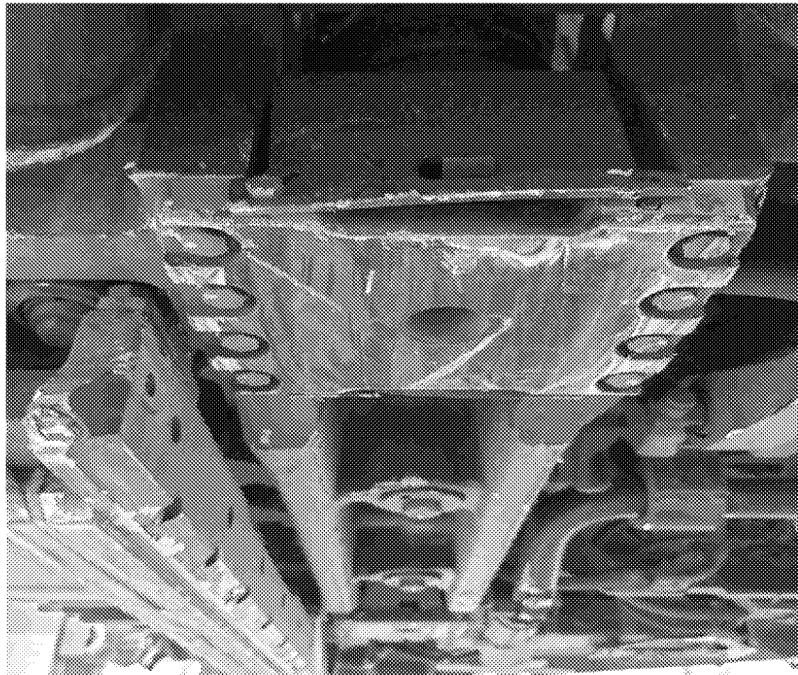
Figure 25. Bogie BM1

- Impact on BM1 primary suspension spring seat and baffle

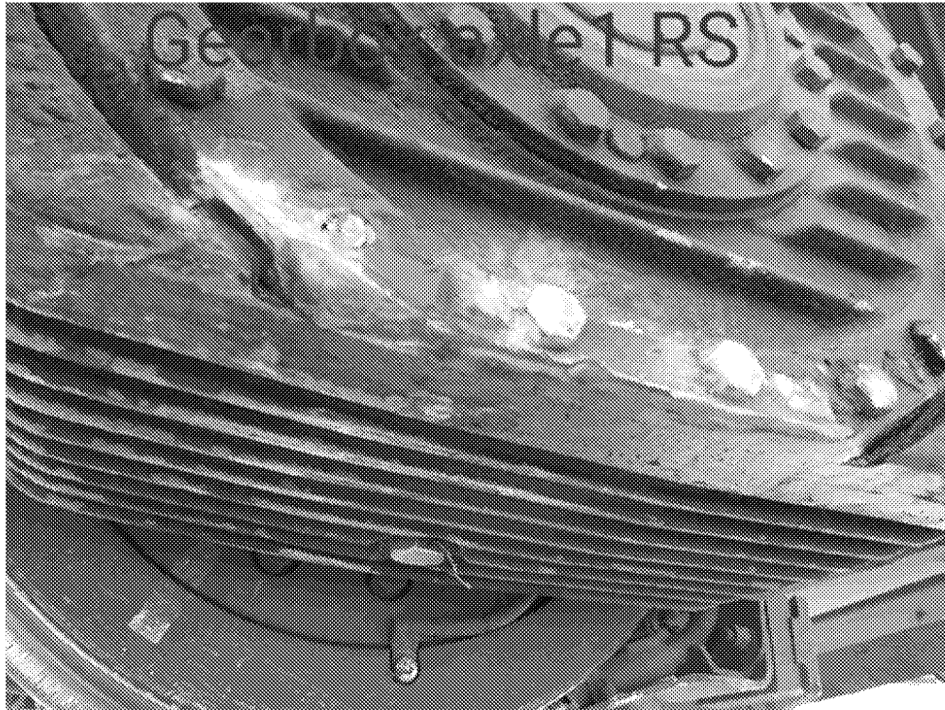
Figure 26. Bogie BM1

- Damage to BM1 right-side gearbox

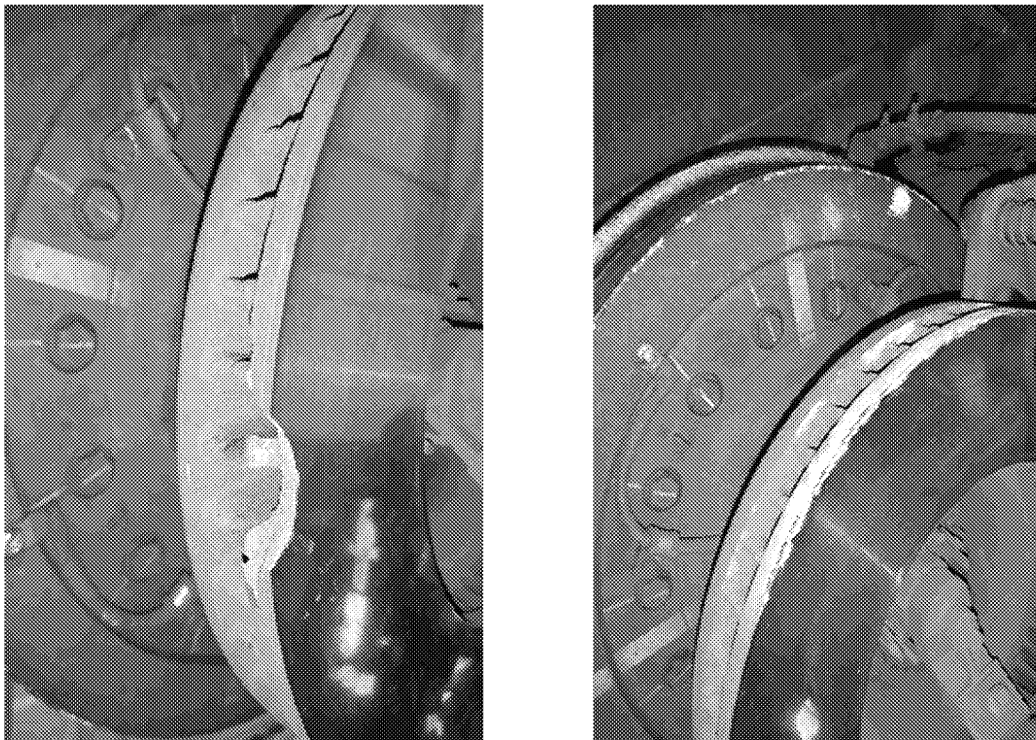
Figure 27. Bogie BM1

- Damages to BM1 axle 2 brake disc

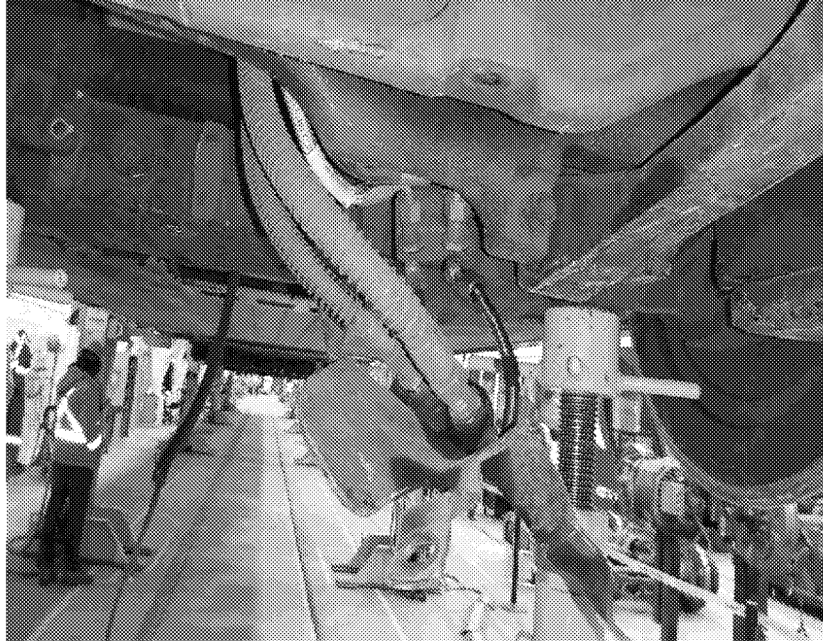
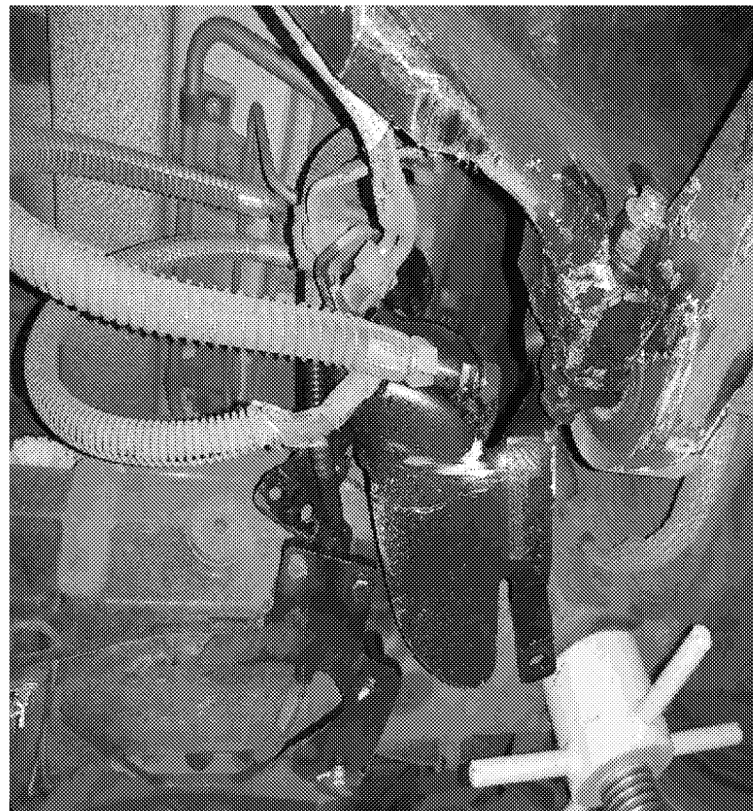
- Damages to BM1 loom brackets and hydraulic hoses

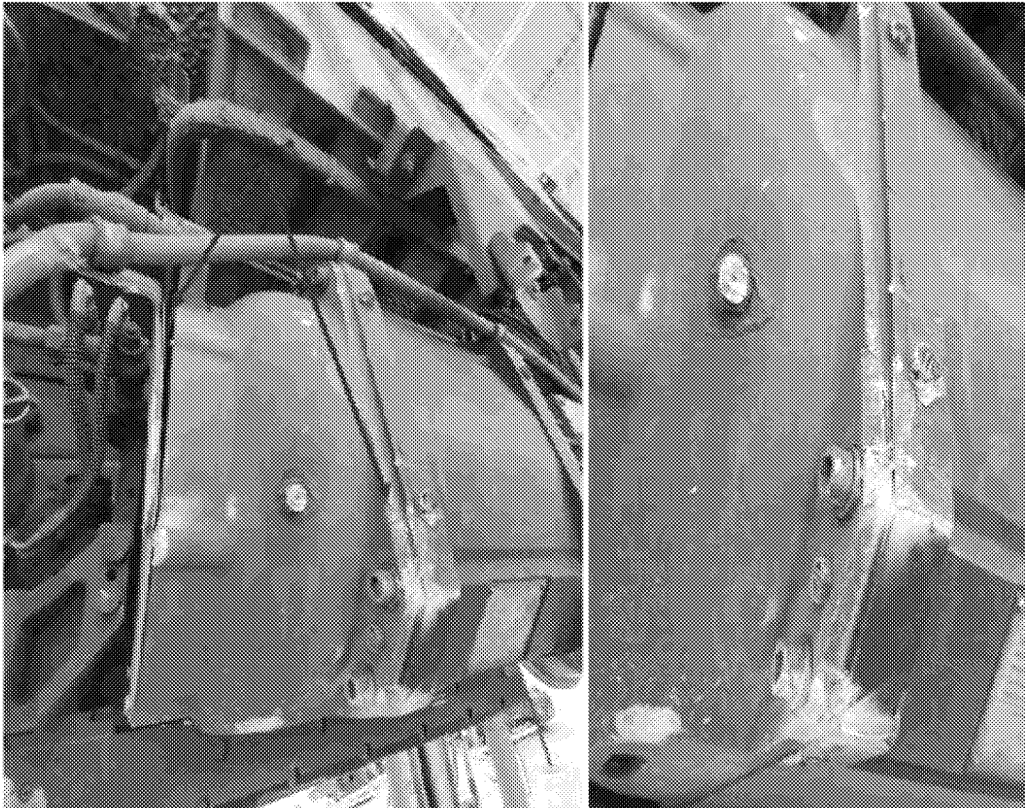
Figure 30. Bogie BM1

- Damages to BM1 right side Motor

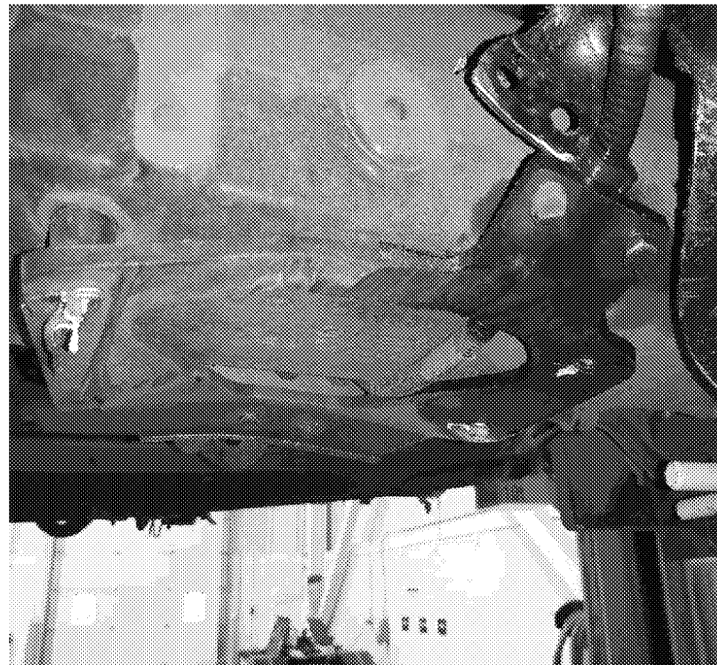
Figure 31. Bogie BM1

Damages to BM1 low tension clamp bracket

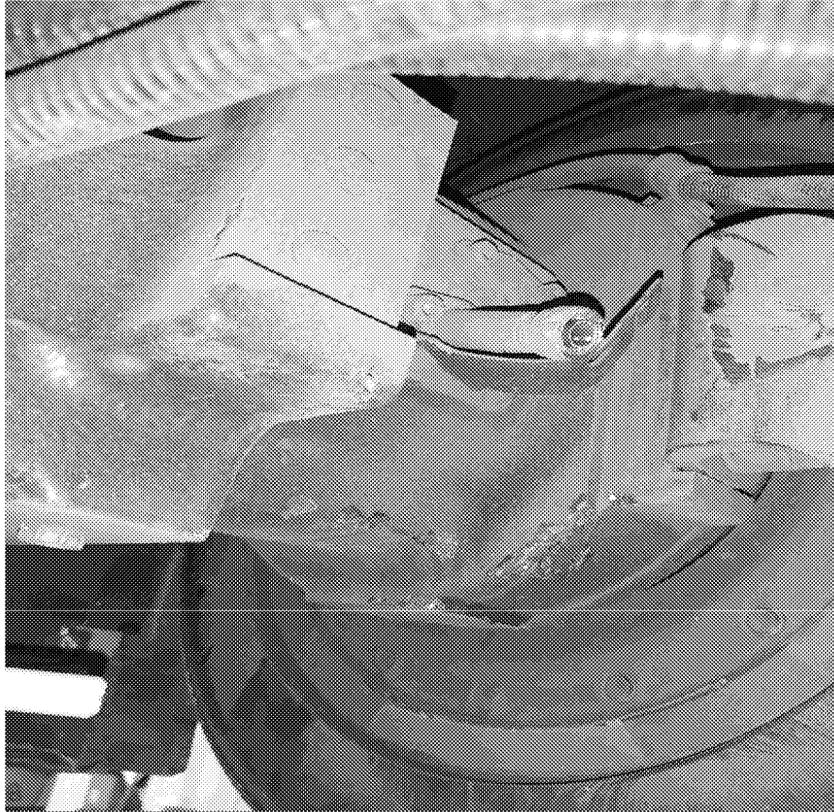
Figure 32. Bogie BM1

- Speed sensor harness and connector ripped off. Support bracket bent. Scrapes on the exterior axle housing.

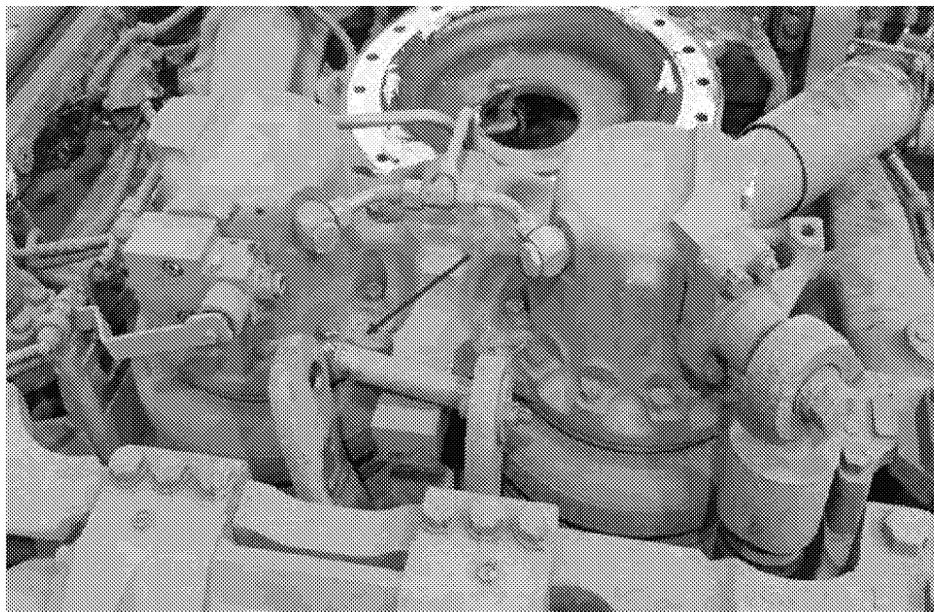
Figure 33. Bogie BM1

- BM1 Bolster component bent and pin displaced

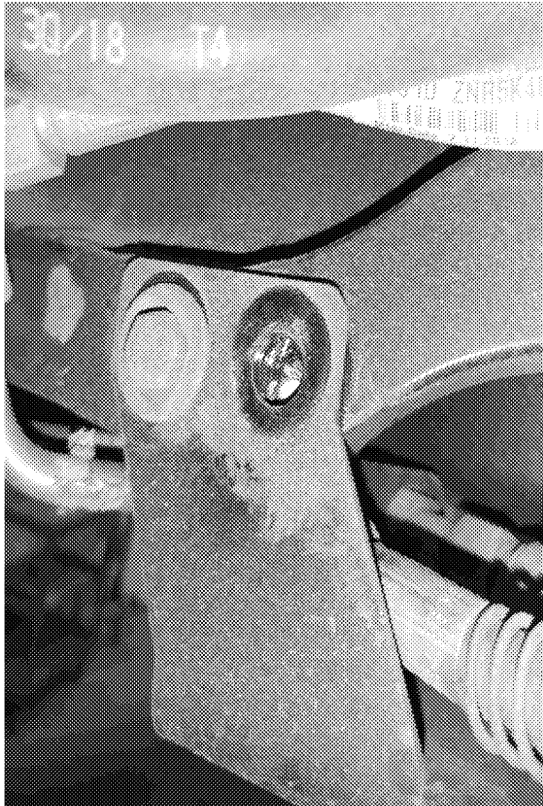
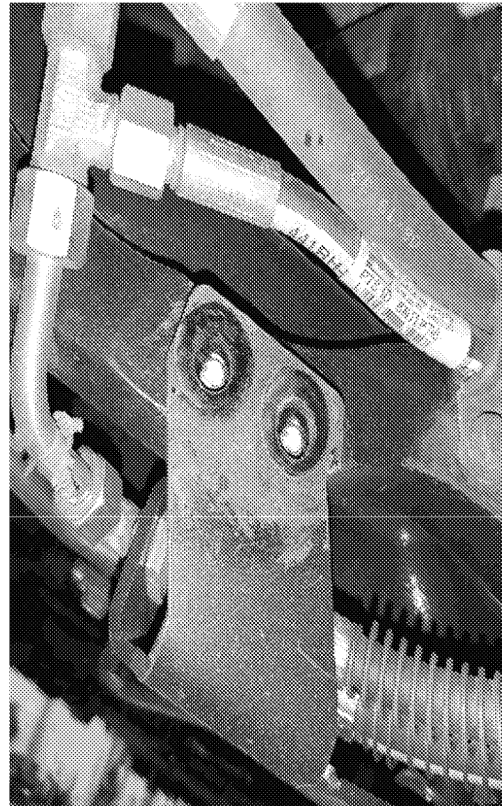
Figure 35. Bogie BP1

- Broken bolts on Loom brackets with the thread stubs stuck in bolster frame

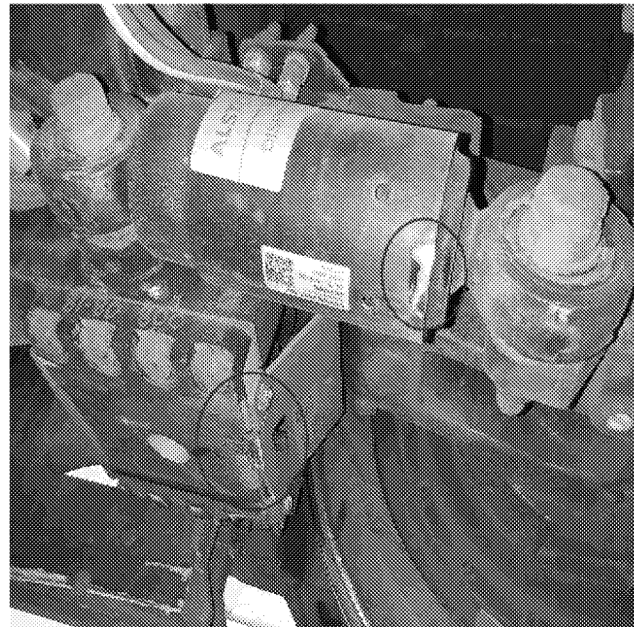
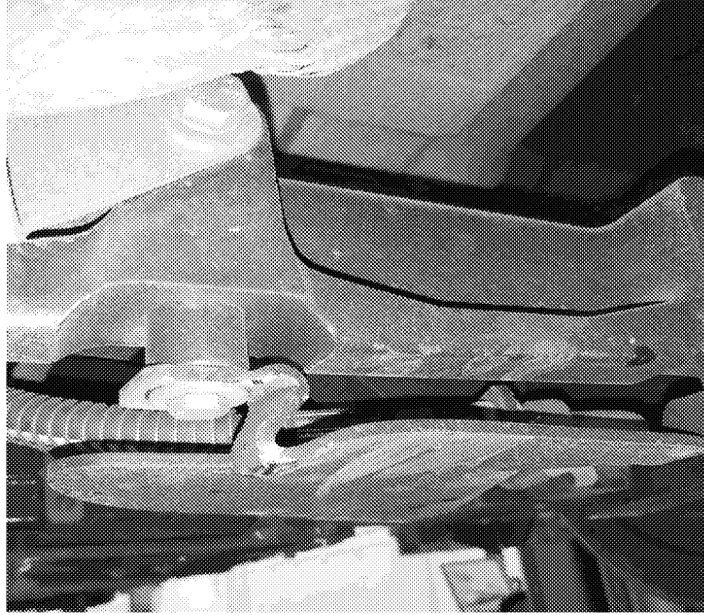
- BP1 impact on baffle and anti-pitch damper

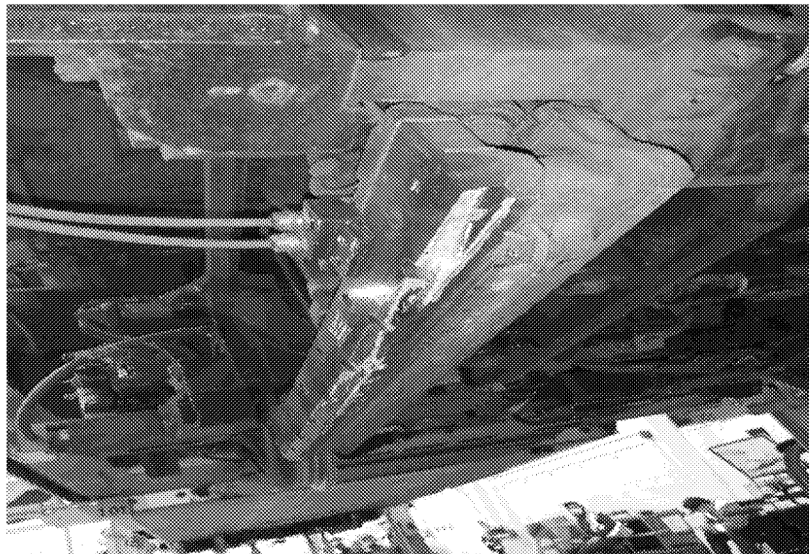
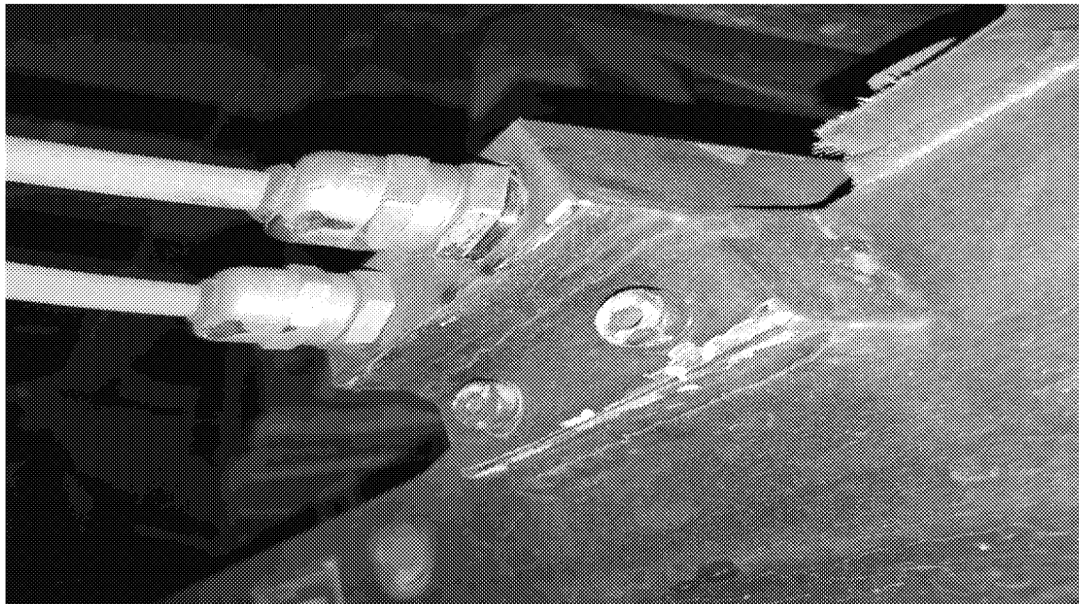
- Impacts on Magnetic Track Brakes and cable connection

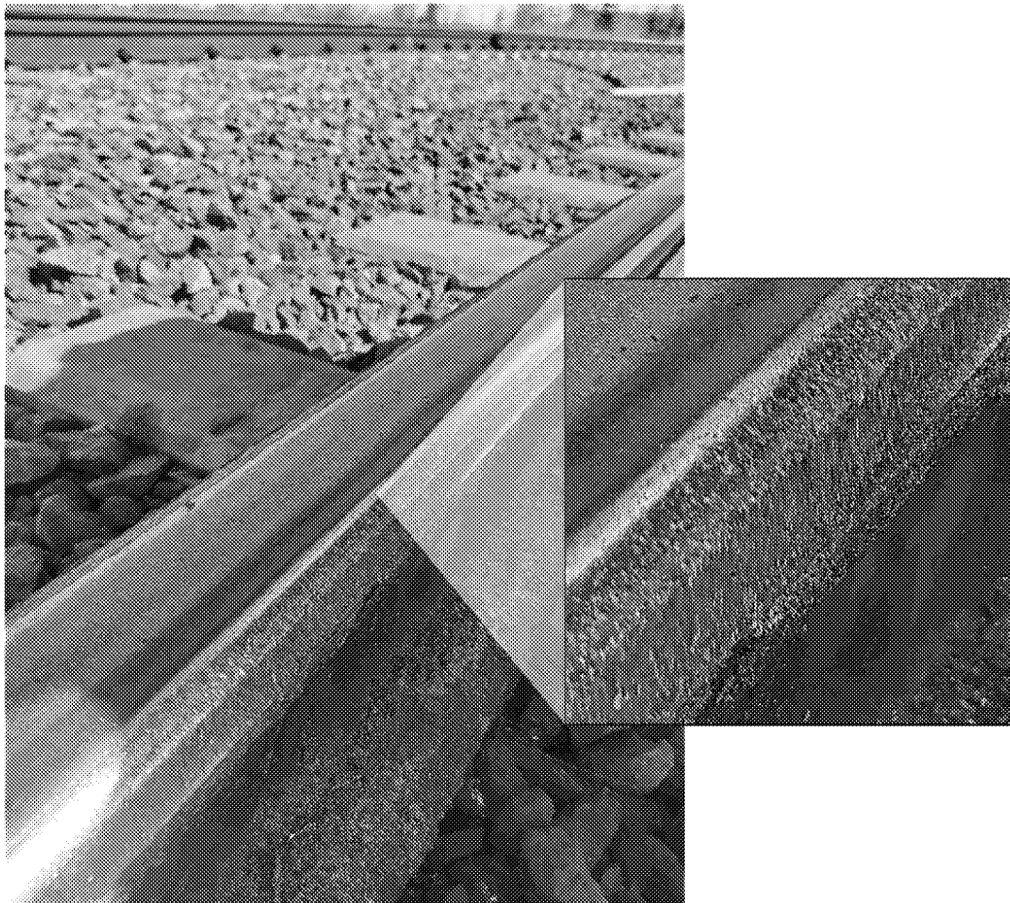
The gauge face of the track through curve 19 showed significant vertical scoring, as shown in the figure below:

This pattern of wheel flange showing suggests that there is still excessive friction between the wheelset and the rail, as documented in both of the previous two derailment reports (Ref: OTT-ENG-

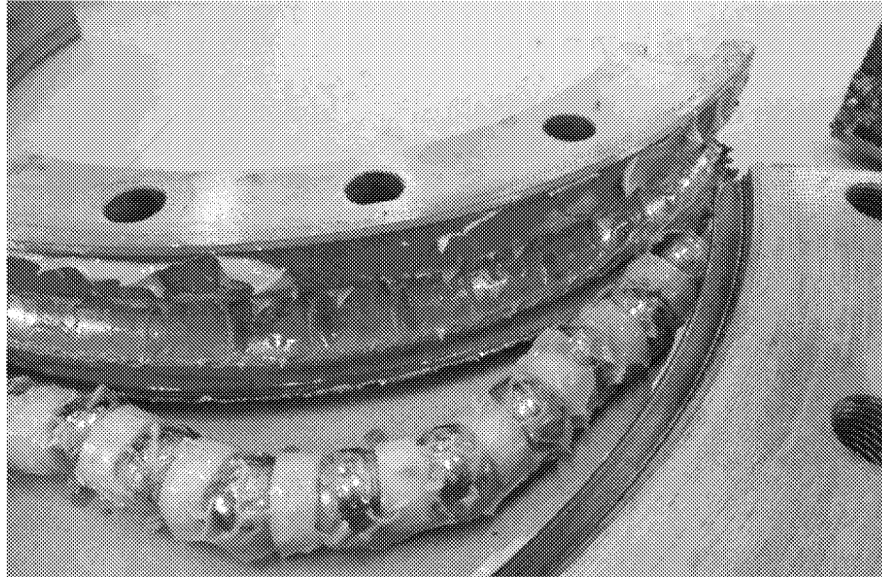
The slewing ring of BM1 bogie (s/n 507092) was cut in two parts in order to observe its state without rotation: the rolling elements are in good condition and not blocked, there is sufficient amount of grease, no presence of corrosion.

Figure 42. Condition of slewing ring s/n 507092 (BM1 bogie) after the cut in 2 parts
