Subject: Final Derailment Report of LRV 1116 on March 14th, 2021

LRV 1116 MSF Yard Derailment Investigation Report	Document Reference: OTT-ENG-REP-66 Version B	Application date: 2021-06-28
Written by:	N. Sembeyev / Bogie Warranty Engineer Y. Liu / Project Engineering Manager S. Hernandez / Project Quality Manager C. Khokhar / Engineering Technician		
Verified by:	L. Goudge / Train System Engineer	Ensures that the technical/ process accuracy has been checked.	
Approved by:	R. France / Project Manager	Orders, by his signature, the implementation of the document.

On 14 March 2021, at approximately 13:19, Ottawa Confederation Line LRV 1116 derailed at low speed in the maintenance and storage facility Yard (MSF) during a routine move from the storage area to the handover platform.

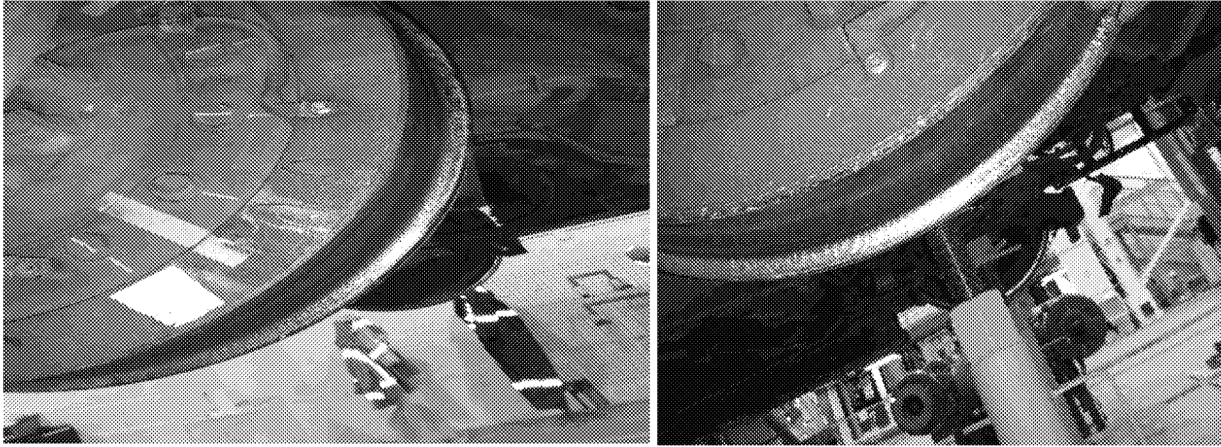
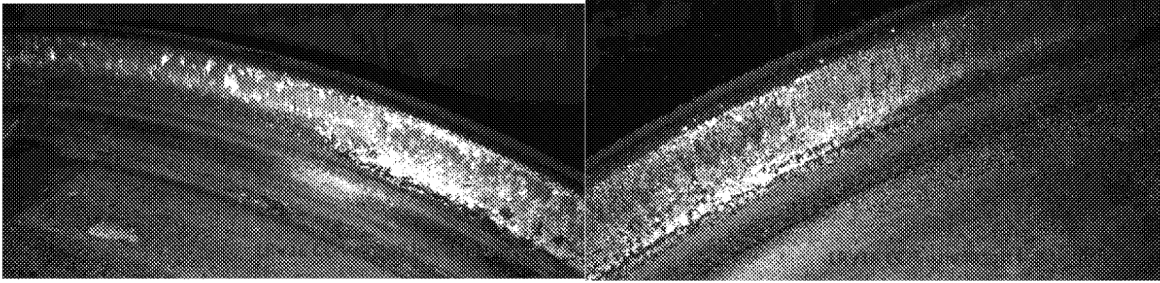
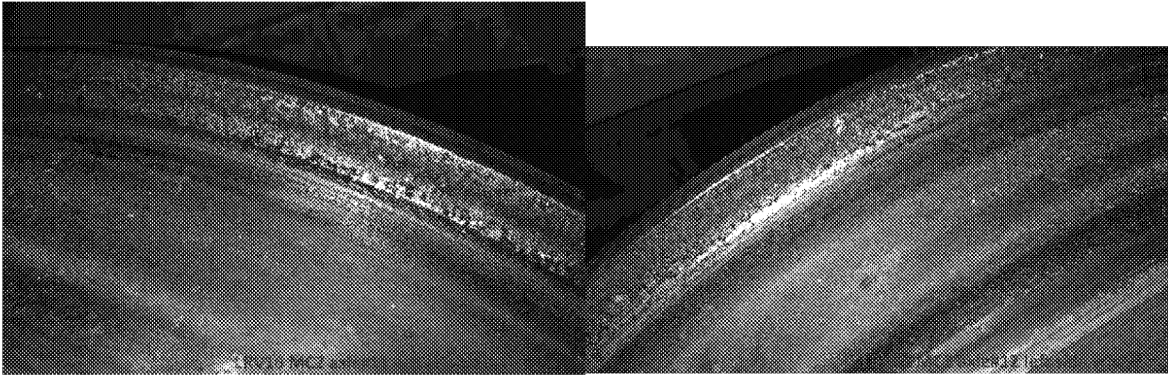
These scoring marks seems to match well with the roughness observed on the rail on the gauge face as shown in Section 4.1.5. The level of flange roughness exceeds the $R_a = 12.5 \mu\text{m}$. The flange scoring is suspected to be from the lack of lubrication / grease on the rail/wheel interface in the curves with sub-40m radius in the MSF.

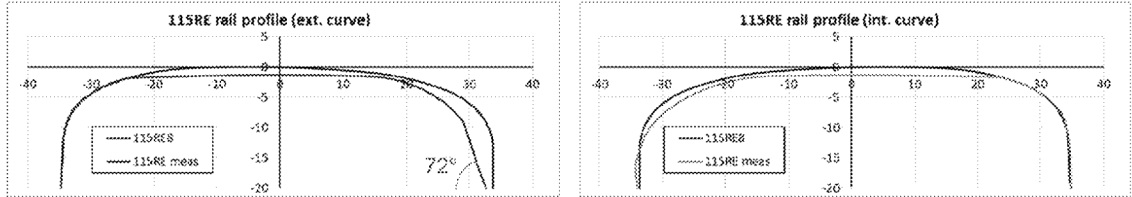
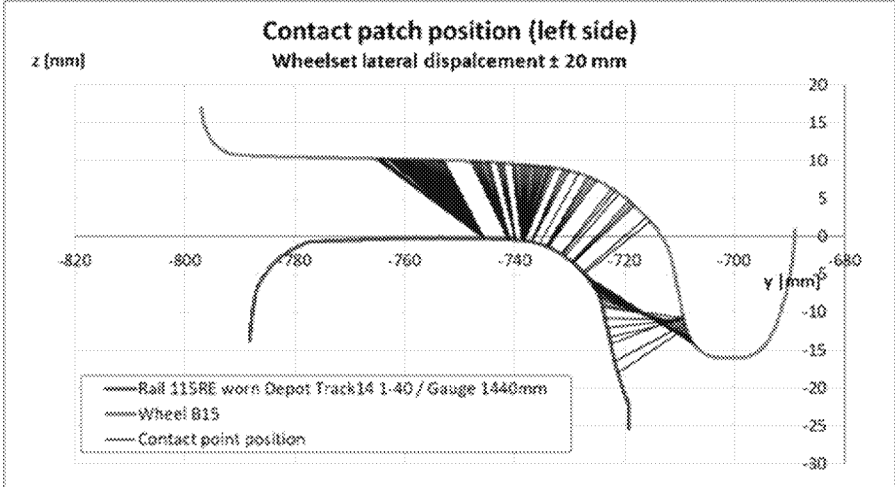
- The rail profile shows a rather flat head not corresponding with theoretical 8" crown radius. This leads to direct contact of rail corner with the flange root increasing the equivalent conicity
- Worn outer rail shows a reduced slope of around 72 degrees compared to 90 degrees of new profile. Thus, angle of rail gauge face has predominant influence on wheel/rail contact angle (wheel flange angle becomes secondary).

However, the measured rail profile has low impact on the derailment: the safety margin is decreased by 4% compared to the reference conditions. L/V ratio is 0.74 at L/V limit of 0.98. Wheel raise is 3.3 mm.

Figure 53. Measured rail profile of track 14 compared to theoretical rail profile 115RE-8

Figure 54. Contact patch analysis of B15 wheel profile with 115RE measured worn rail profile of track 14

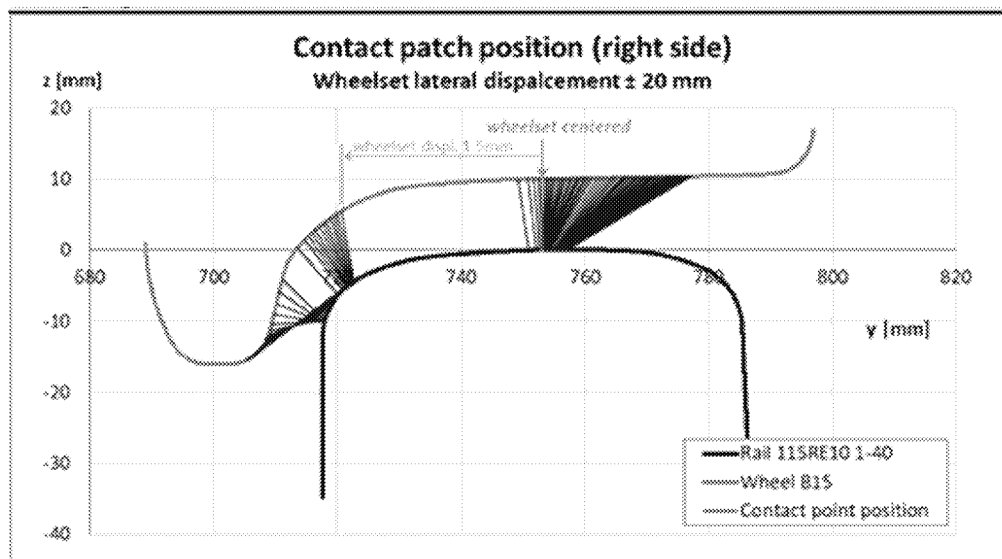
- Equivalent conicity is modified.
- Wheel/rail contact is modified – the contact with flange root starting from 1,5 mm of lateral displacement. This could lead to contact on top of flange, causing increased roughness and have a potential impact on friction coefficient. This may also negatively impact the lifespan of the wheel and/or rail.

Figure 59. Contact patch analysis of B15 wheel profile with 115RE measured new rail profile

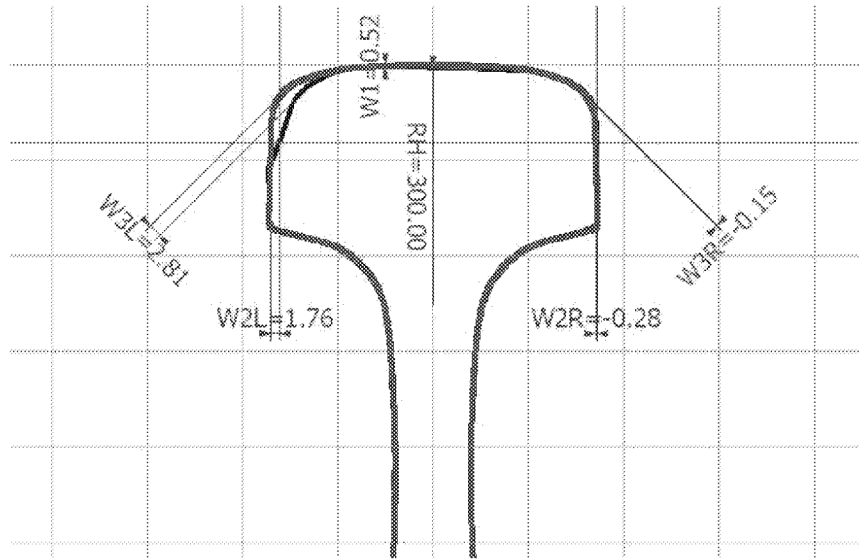
From the Calipri measurement (Figure 3) on the outer rail for flange climb location (Chainage#14+386), it is showing the wear at gauge point is 2.04mm, according to the measurement on 17 March 2021.

Figure 3 - Wear at Gauge Point on Outer Rail

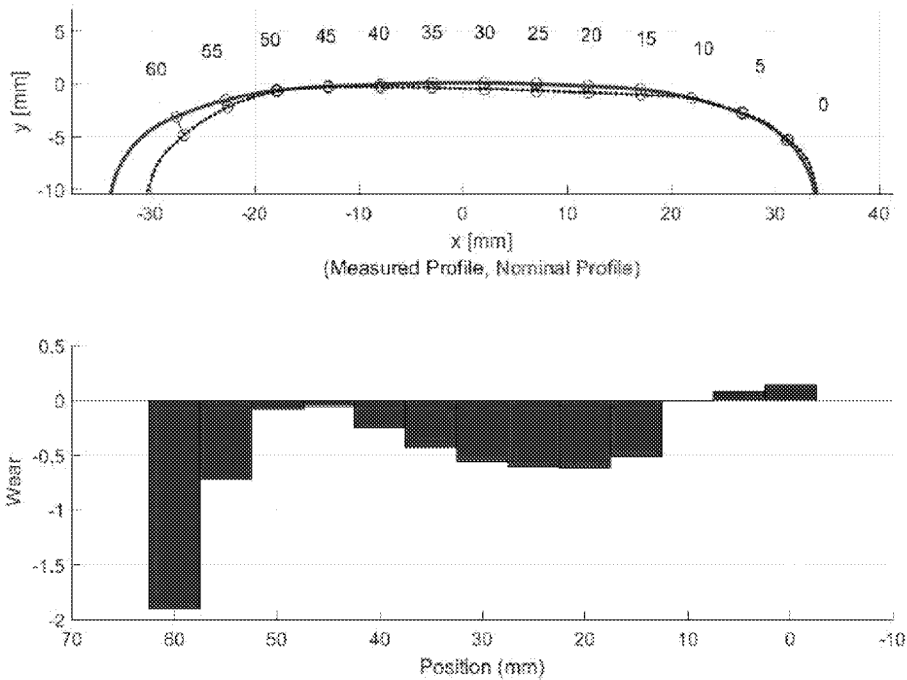
The position of wear (Figure 4) is showing the big wear is at the gauge side of the head. There is also some wear from the top surface of head. The positive wear from field side is because the manufacturing deviation, which means the material is bigger than AREMA's 115 lbs. RE Rail.

Figure 4 - Position of Wear on Outer Rail

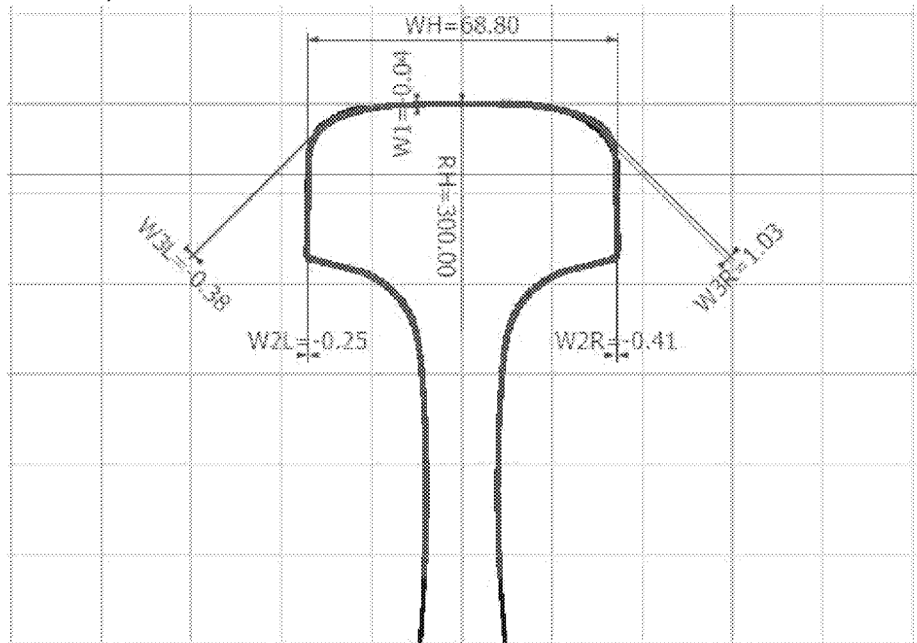
From the Calipri digital measurement (Figure 5) on the inner rail at flange climb location (Chainage#14+386), it is showing the wear at gauge point is 0.66mm, according to the measurement on 17 March 2021.

Figure 5 - Wear at Gauge Point on Inner Rail

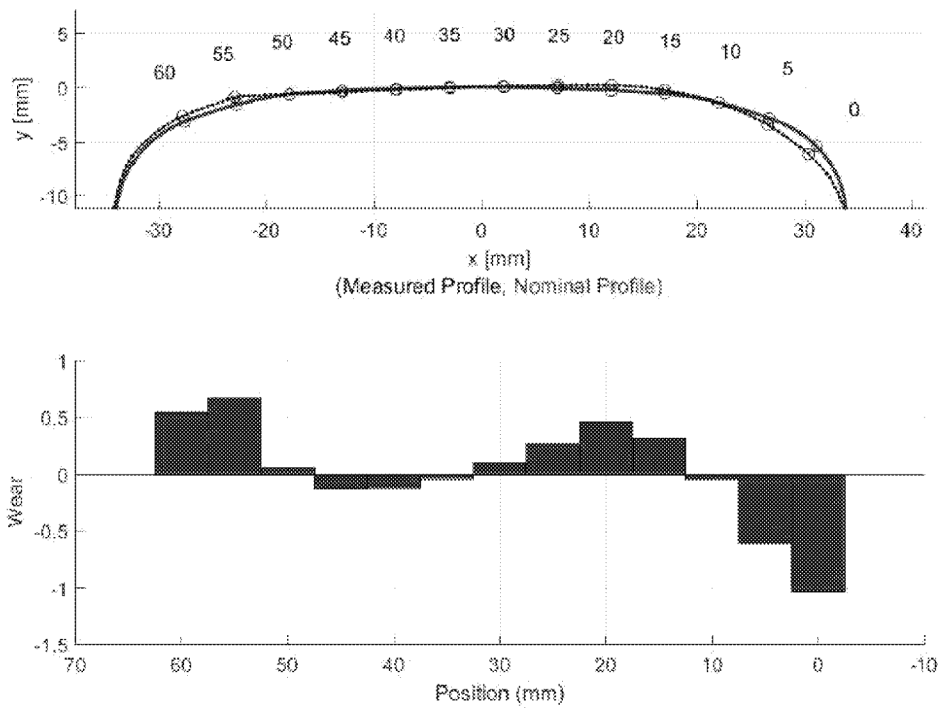
The position of wear (Figure 6) is showing the bigger wear is at the gauge side of the head. The positive wear from field side is because the manufacturing deviation, which means the profile is slightly larger than AREMA's 115 lbs. RE Rail.

Figure 6 - Position of Wear on Inner Rail
