Subject: Derailment of LRV21 - 8D Summary

Subject: Derailment of LRV21 on the 19th of September 2021

WITHOUT PREJUDICE
Ottawa Safety Alert
LRV21 Derailment
8D#218742

218742 NAMSER OTTAWA - Derailment of LRV21

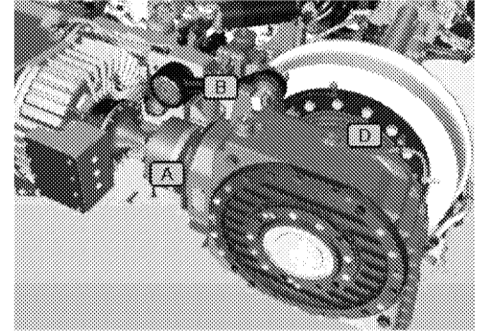
Gearbox impact on signal pole and projection of the gearbox = broken link B

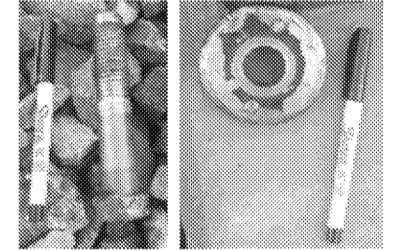
Parts felt-off from the inside of the coupling = broken link A

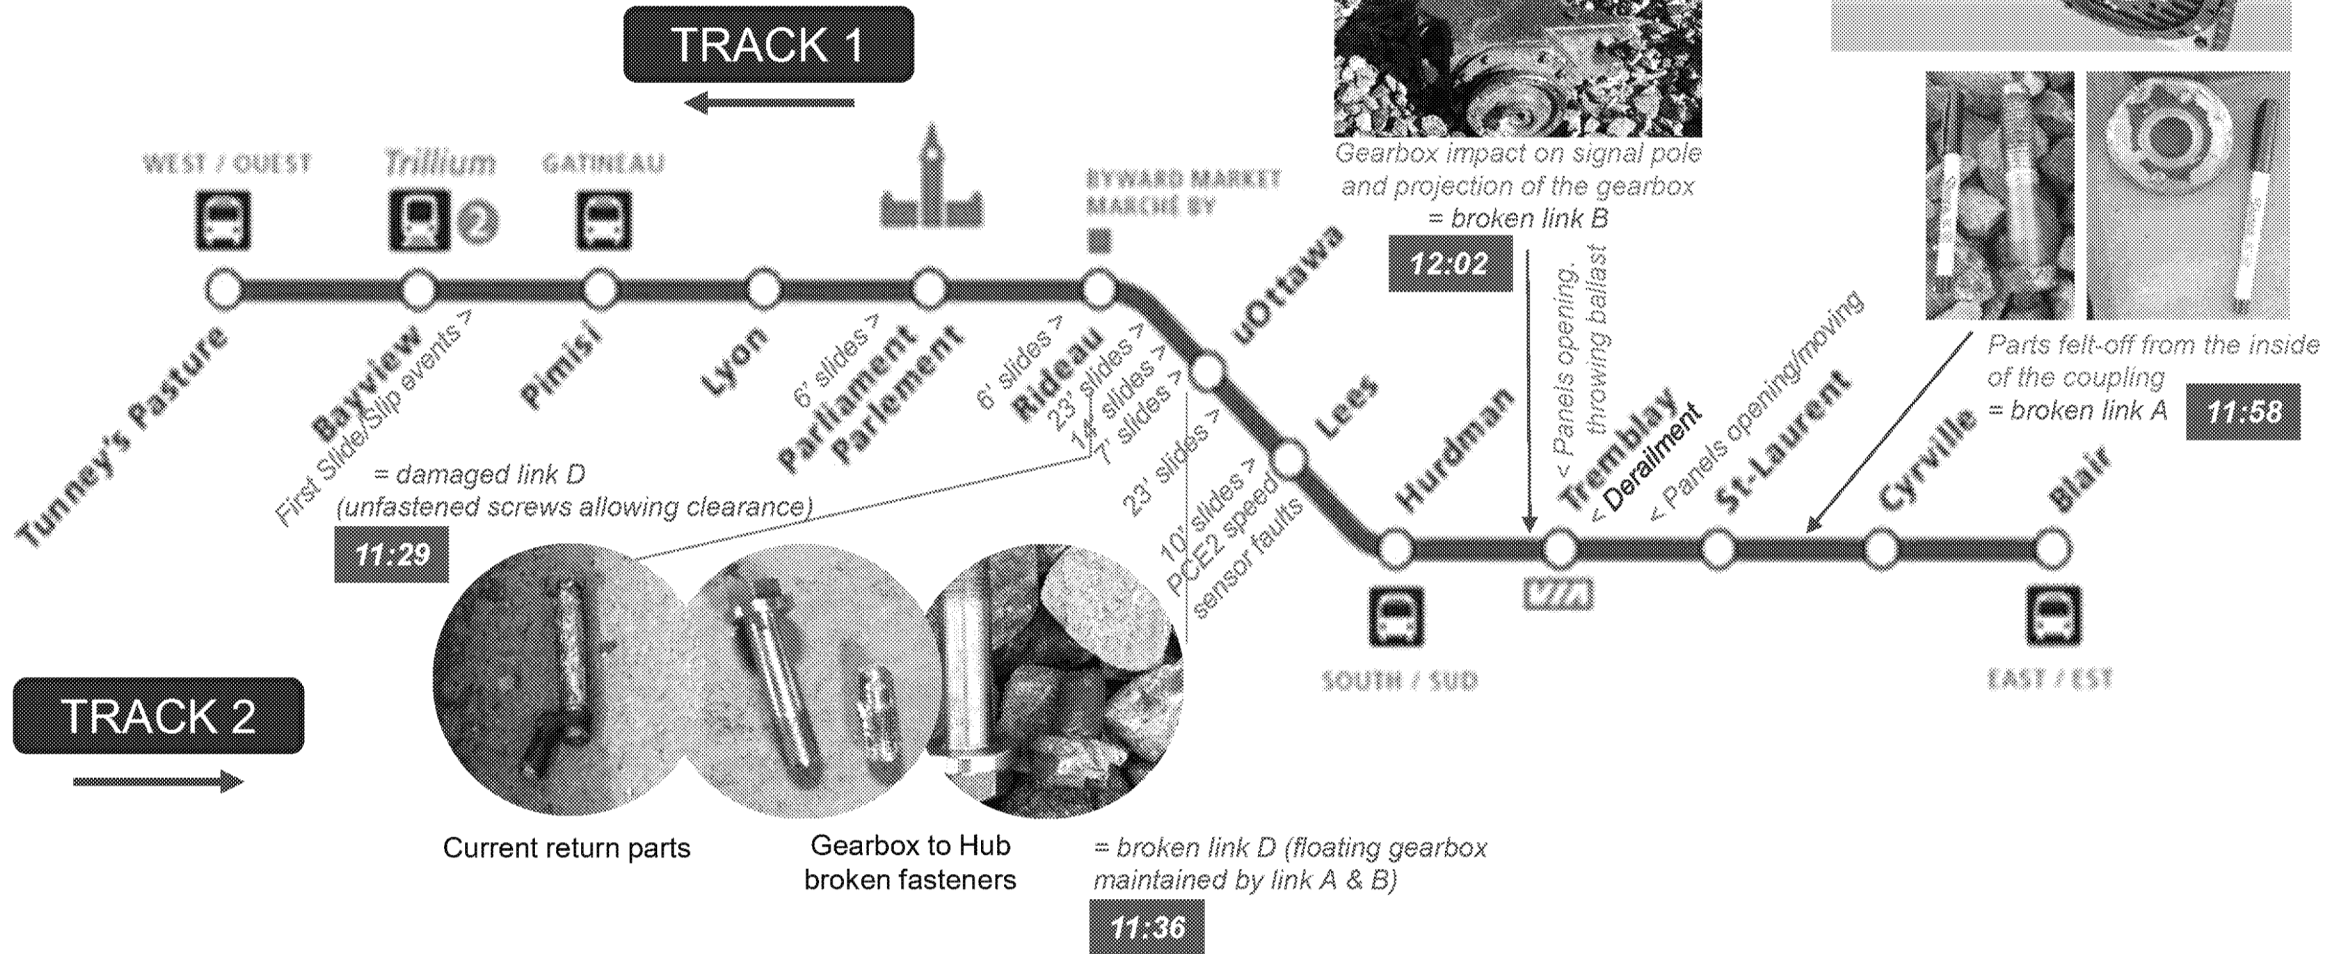
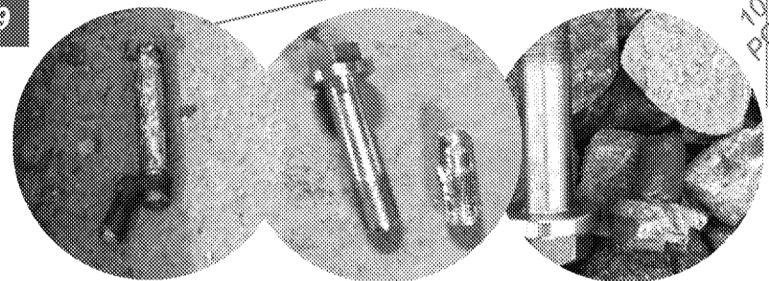
Gearbox to Hub broken fasteners

= broken link D (floating gearbox maintained by link A & B)

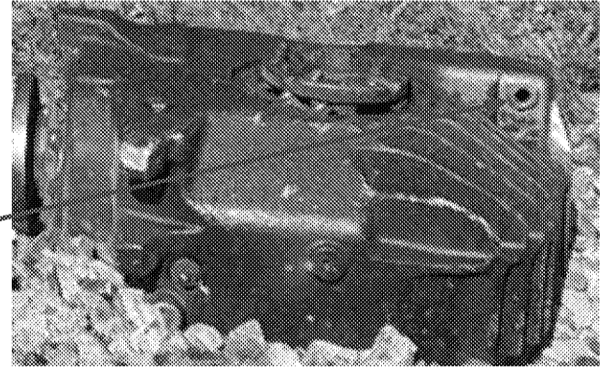
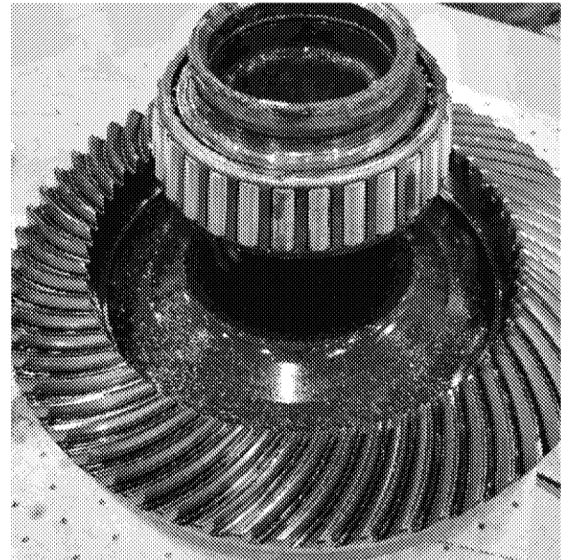
- External Inspection of gearbox disconnected from BM2
 - Gearbox damage on exterior showing multiple strikes
 - Missing gearbox oil screw
- Internal inspection of gearbox on BM2
 - All gears are in good condition
 - No trace of internal structural damage
 - Trace of something that looks like rocks in the remaining oil
 - No trace of rock damages on any pinions/gears
- Pre-incident inspection:
 - Gearbox was in good condition prior to the derailment
 - Free turning of all components

Gearbox is removed from the potential root cause

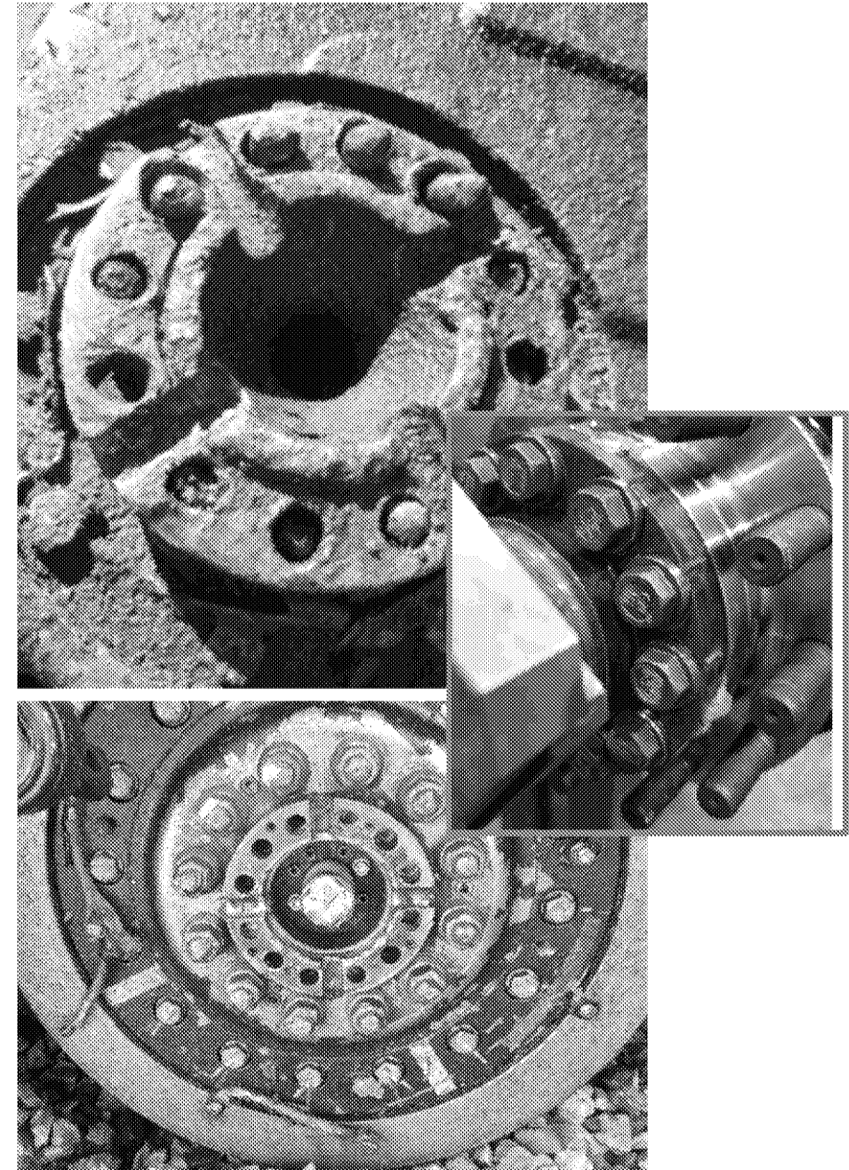
- The gap inspection and repair procedure (when needed) was introduced immediately following the derailment of LRV 19 on August 8th. The inspection and repair were new activities for the team.
- LRV 21 failed the gap inspection criteria on 3 axles (2 axles on BM3 and 1 axle on BM2). The 3 axles had to be repaired with new cartridge bearing assemblies and shafts. It was only the 6th time that a repair was needed.

Inspection Results on gap check leading to 2 bearing hub repairs on LRV21

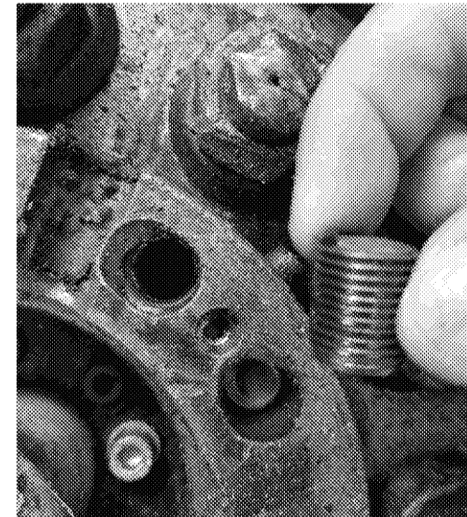
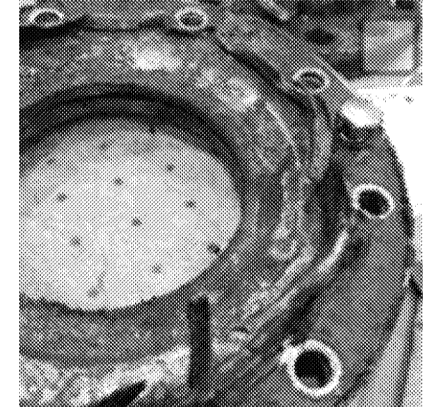
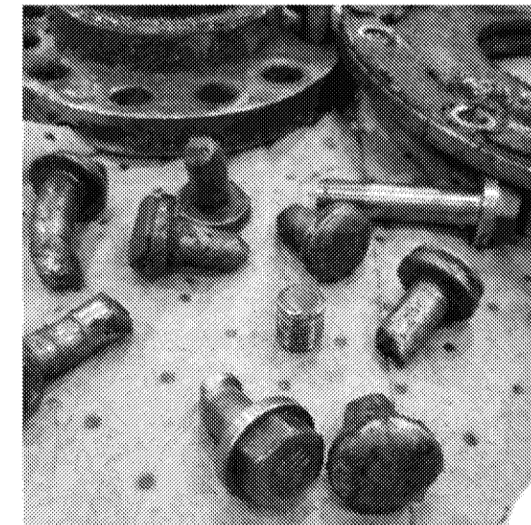
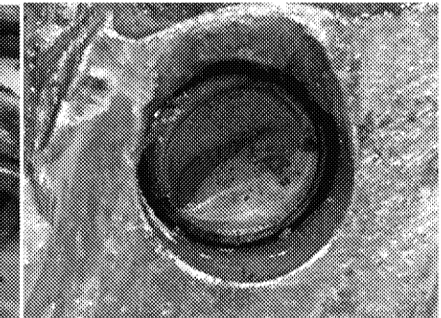
Global view of the broken bolt of LRV21 Axle #6

- Inspection of **BM3** from LRV21
 - Proper marking/torqueing of the 2 x BM3 gearbox hub
 - With Transportation Safety Board (TSB), torque was validated with 250Nm
 - All bolts tested and passed
 - Axles from BM3 confirmed officially torqued

- Hardware of **BM2** from LRV21
 - Shape of the broken screws on the BM2 gearbox hub
 - Broken at different lengths
 - Bending of the parts observed
 - Rubbing on the gearbox frame observed
 - No signs of plastic deformation as a consequence of having been torqued

After only 800 km of travel following axles refurbishment, evidence points to the gearbox disconnecting from the axle due to its fasteners loosening and breaking (ductile rupture) caused by the in-service gearbox loads and vibrations

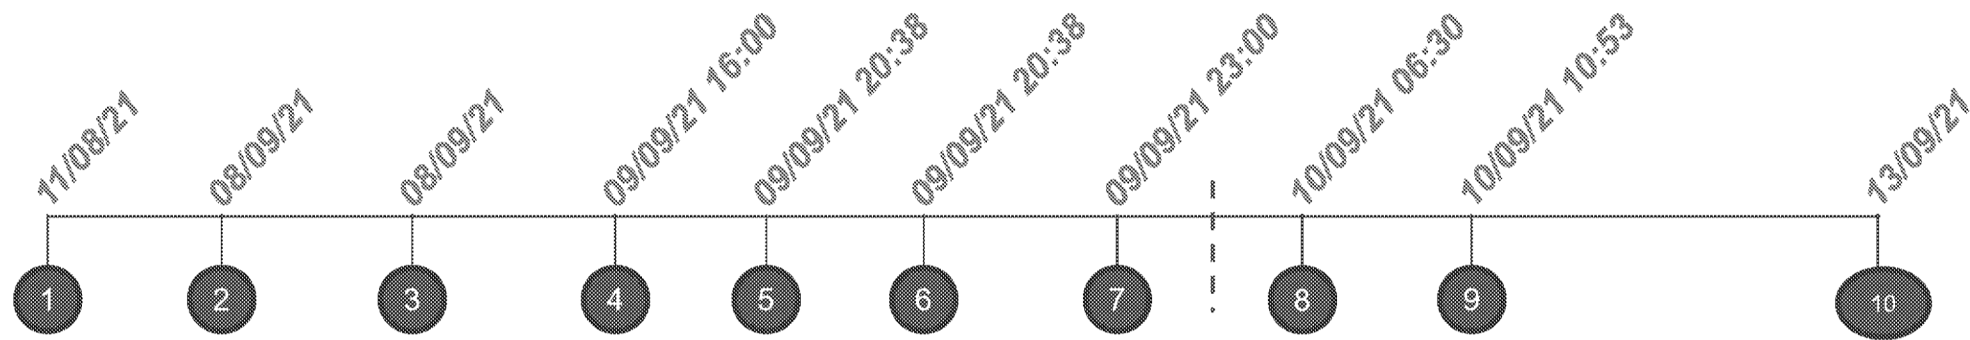
Repair Activity Timeline – LRV21 Cartridge Bearing Assembly Refurbish

1. Hub inspection failure
2. Bogies removed from car
3. Axles dismantling
4. Texelis (COH) hub change
5. Torqueing of axles
6. Self inspection (application of torque mark)
7. End of the shift
8. Start of the new shift
9. Torqueing of the brake disks
10. Car released from repair

Based on the above, and the supporting repair data, conclusion is that the 12 bolts retaining the gearbox hub on BM2 position 11 were improperly torqued and not adequately verified.
