The purpose of this report is to document the investigation to the derailment and present the containment actions, root causes, and recommended next steps.

On 8th August 2021 at 20:16hrs, Ottawa LRV 1119 derailed approximately 110m after departing from Tunney's Pasture LRT station travelling in an Eastbound direction. The LRV eventually came to a stop approximately 165m after the derailment. See Figure 1 below.

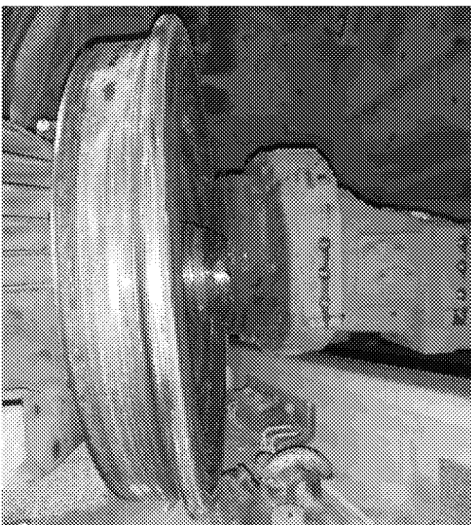
The driver was notified that the train was trailing sparks after it departed Tunney's pasture, and brought the train to a stop, Upon investigation by the driver, it was discovered that the trailing bogie of LRV 119 had derailed. When the crew attempted to re-rail the bogie, it was discovered that the wheel on the motor end of axle 2 had become detached as can be seen in the photo below.

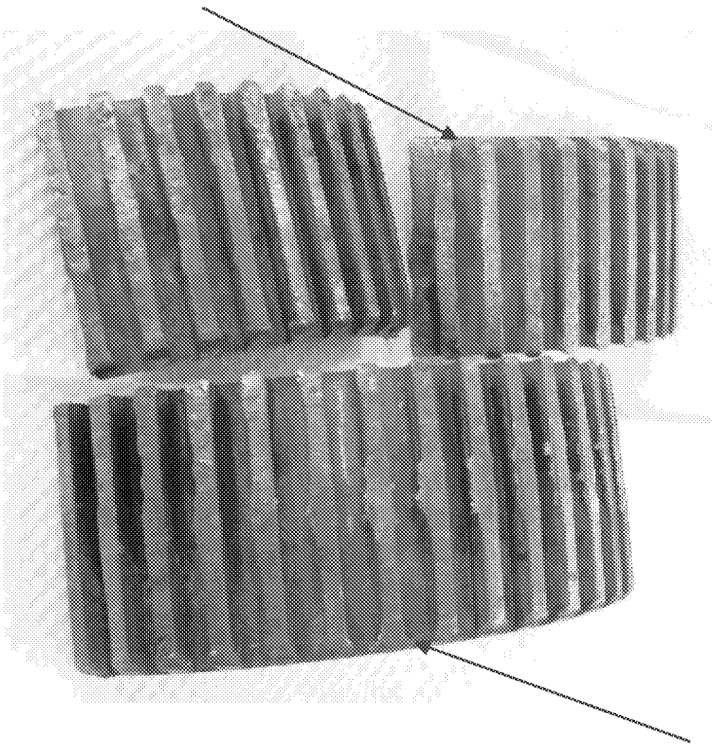
4.1.1 The "phonic" wheel item 24,

This part was found in 3 pieces between the derailment point and the resting position of the LRV.

The areas indicated in the following figure, with the arrows suggest that the smearing was against a vertical surface. The back of the cartridge is the only such surface.

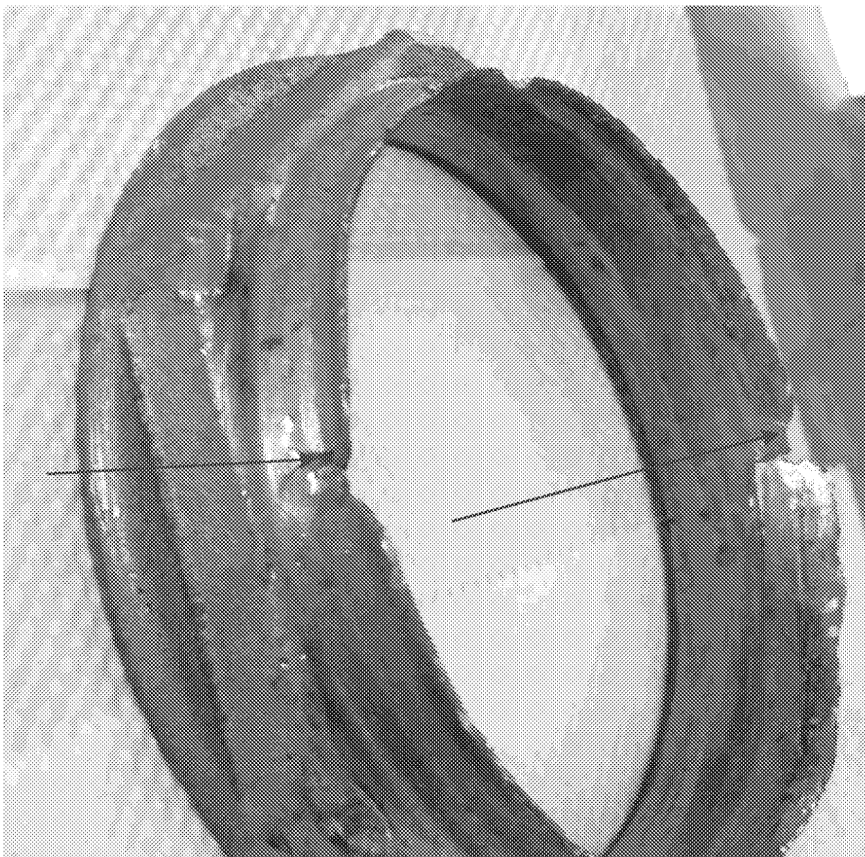
4.1.2 The bearing locking nut item 11,

The lock nut has no evidence of threads internally, and has suffered from extreme heat as all the paint is burned off.

The two swage points can be seen where the arrows are located.

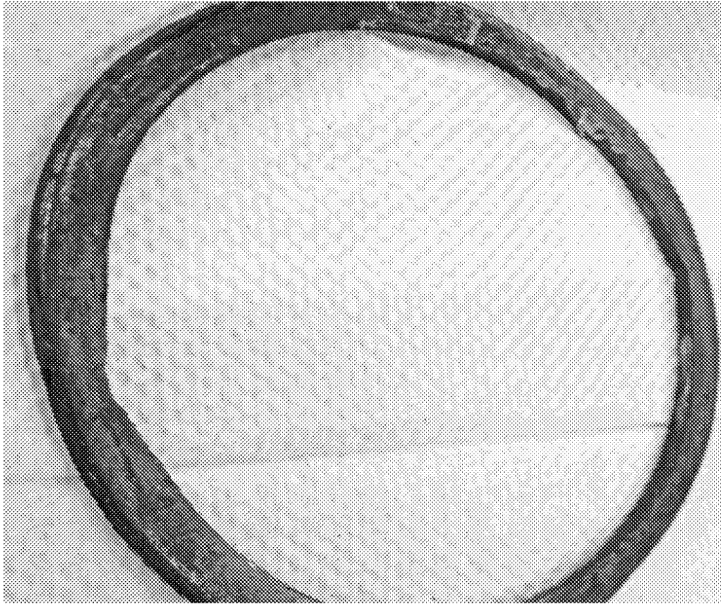
4.1.3 The thrust spacer item 14,

The anti rotation tabs that engage it in the hub are missing

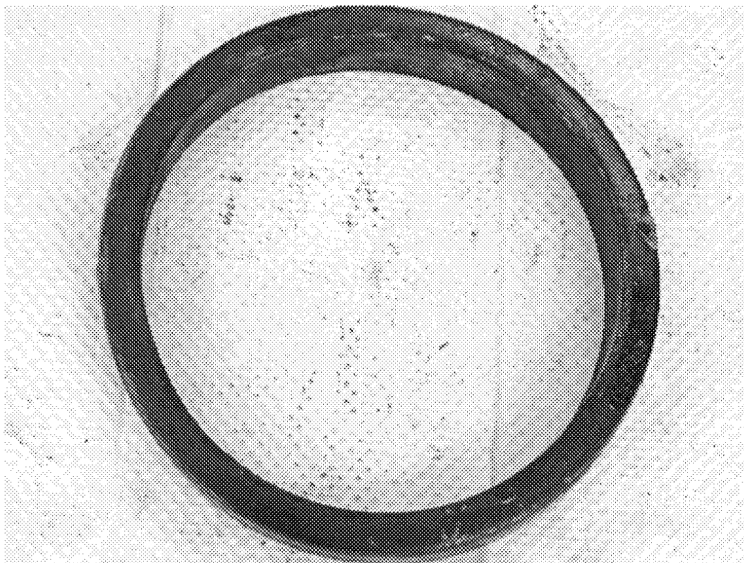
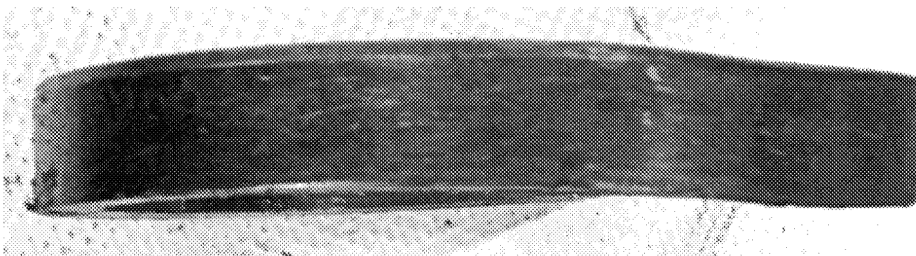
4.1.4 The spacer and inner shaft seal (item 13)

Note that this part is bent, as shown in the photo below shot from the edge of the part

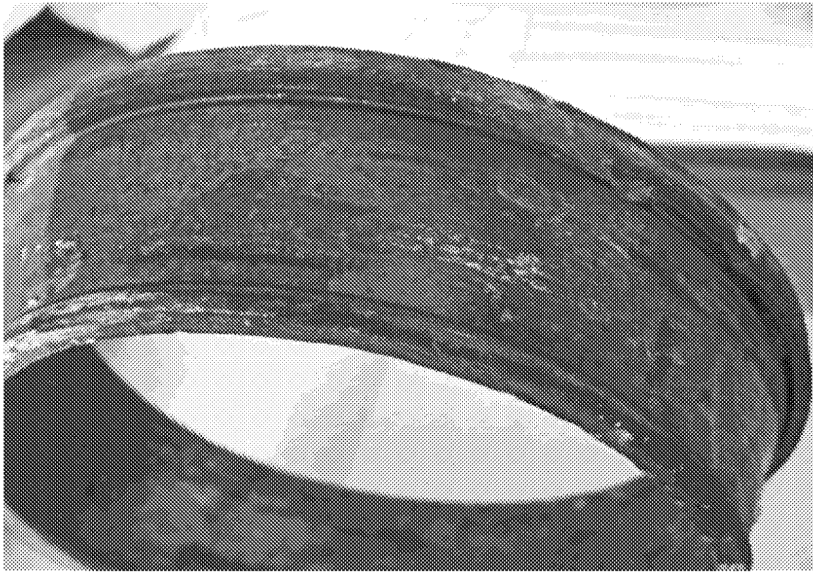
4.1.5 Inner bearing item 12 (inner race only) ,

Aside from the general shape being consistent and both shoulders present, there is not much that can be determined visually

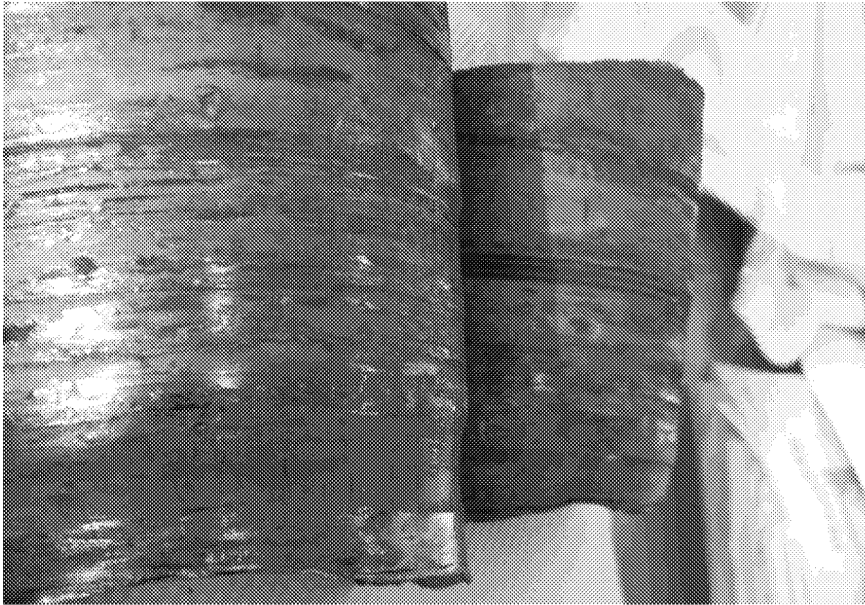
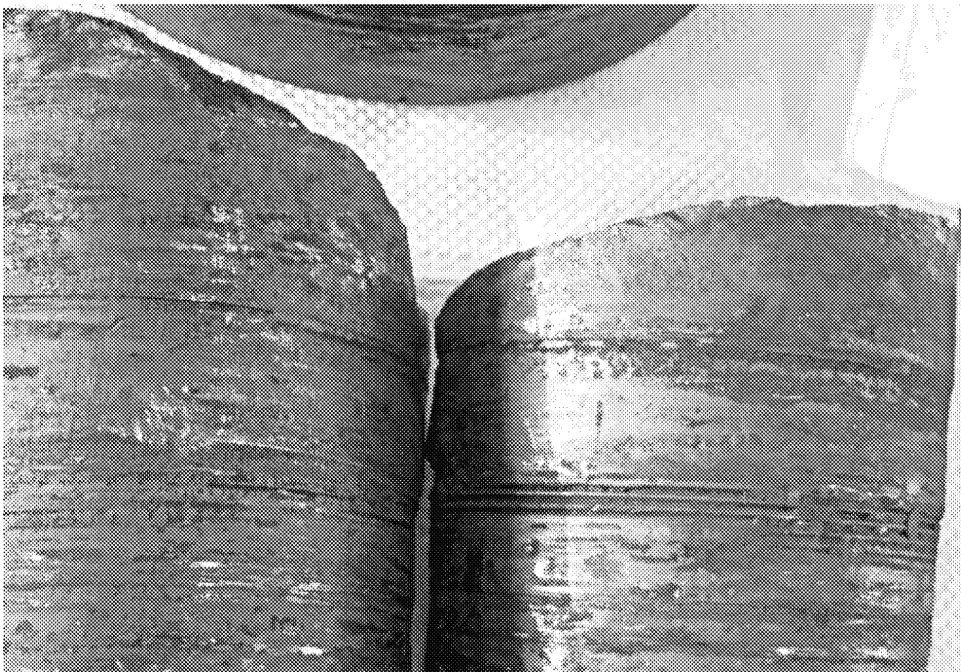
4.1.6 The small diameter portion of the hub split in half which has no item number,

the hub shows some if not all of the threads for the lock nut. It may be that the threads are not necessarily lost, but filled with metal from other parts.

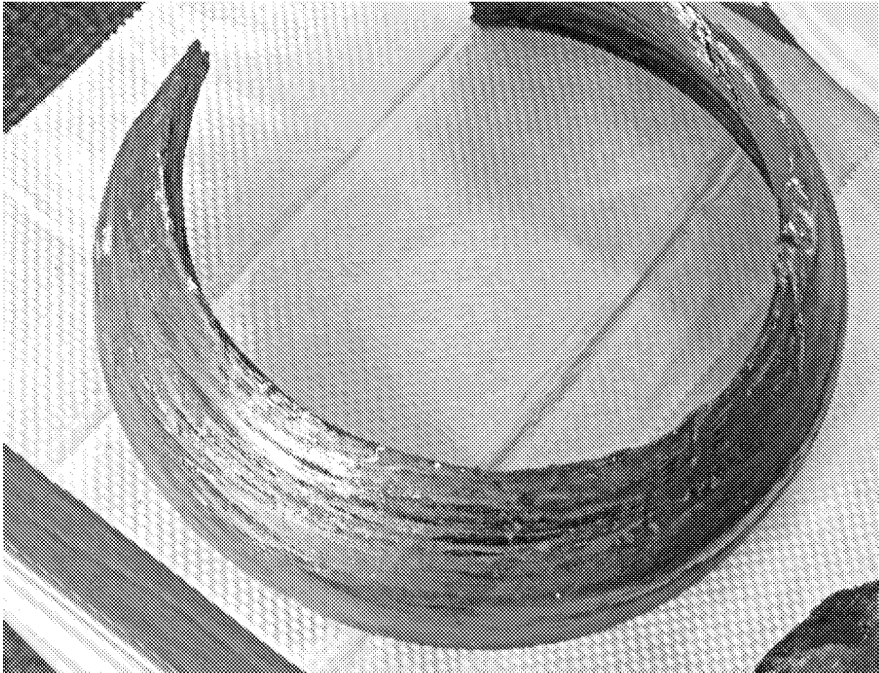
4.1.7 bearing spacer (between the inner and outer bearing) item 10

this part clearly was in hard contact with the cartridge housing. And would have been taking the main load of the axle when the bearing failed

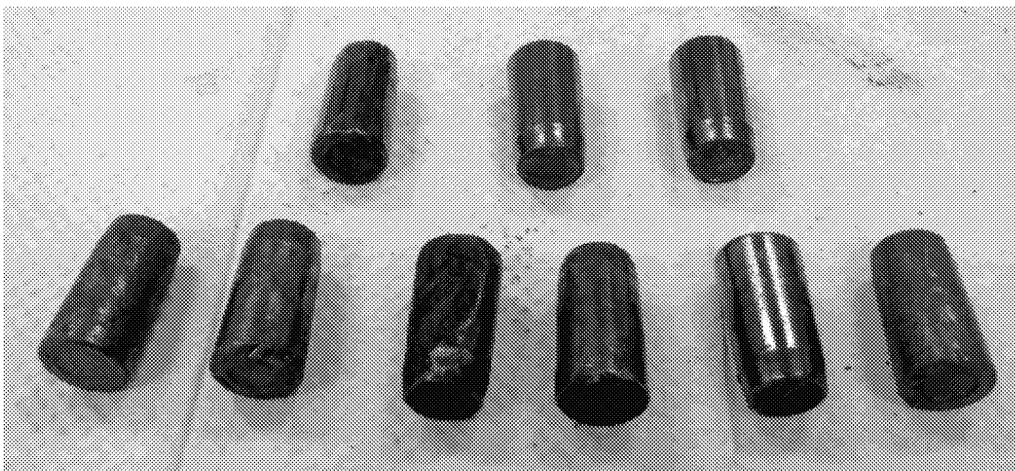
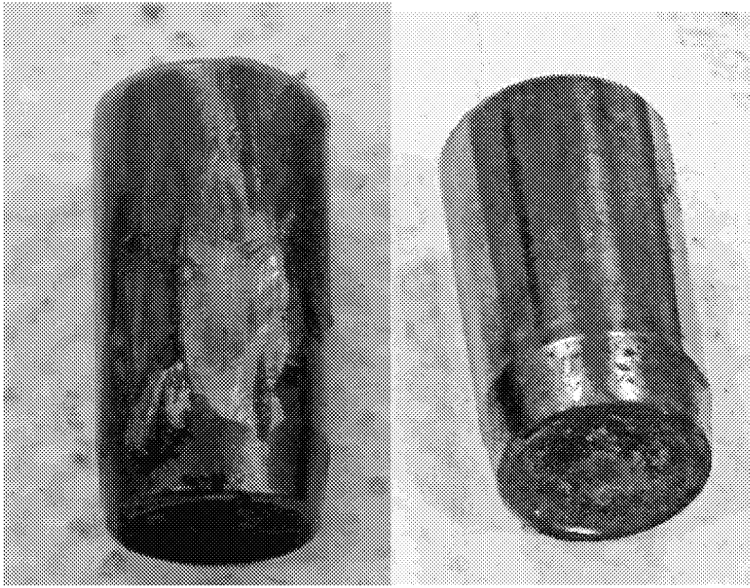
4.1.8 Bearing rollers

The bearing rollers were found in two conditions, those found near the derailment site were blue/black in appearance, and with the exception of impact marks or obvious rubbing marks where the rollers were caught between moving parts, were in good condition.

9 rollers were found at the derailment site. These are all from the inner bearing

The photo below shows the best and worst case rollers.

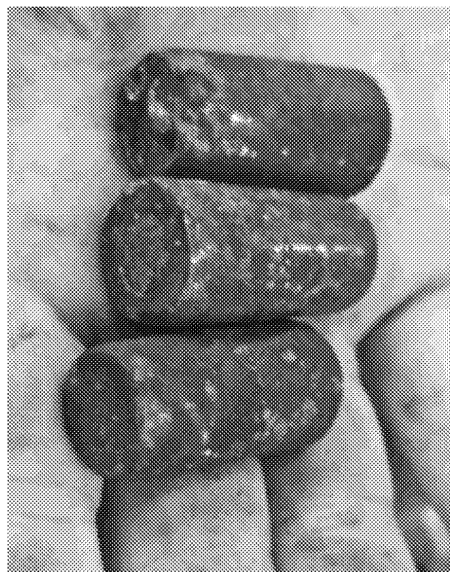
Three rollers found at switch 309

The rollers found at the fouling point of switch 309 showed much more physical damage

Note that these are all from the outer bearing. An additional bearing roller from the outer bearing was found at uOttawa. The rollers are shown below.

Regardless of location there does not appear to be any visual evidence of fatigue spalls .

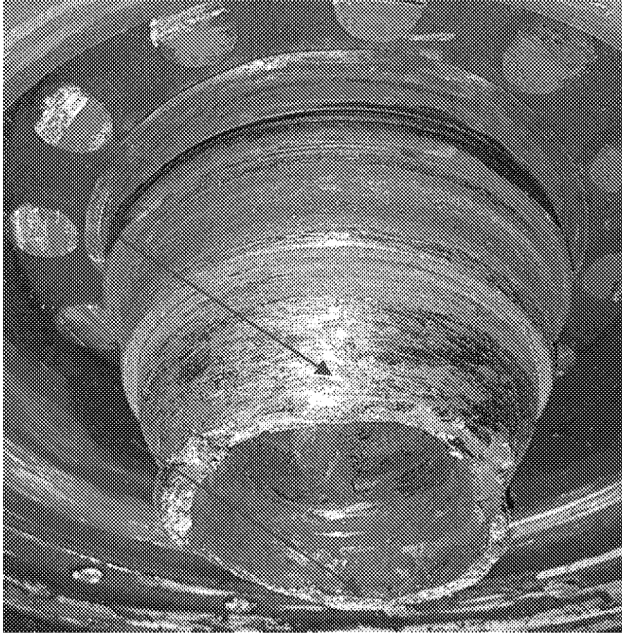
Both shoulders of the inner race are still present. There also appears to be a crack, see the red arrows below.

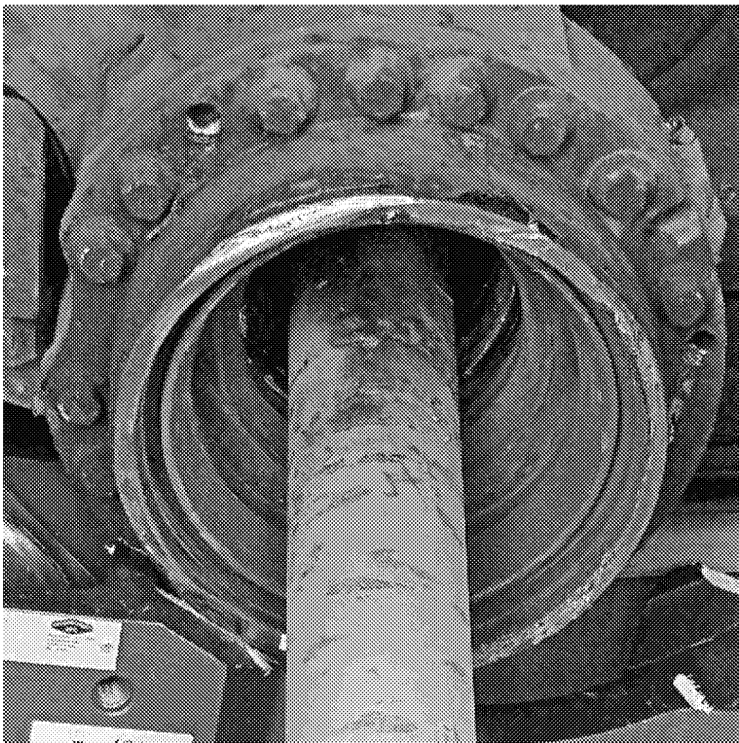
The outer housing of the hub and bearing cartridge and the outer race of the outer (large) bearing
A more detailed review would be required to make any assessment of the bearing race, however the high amount of rust may be the result of prolonged heat.

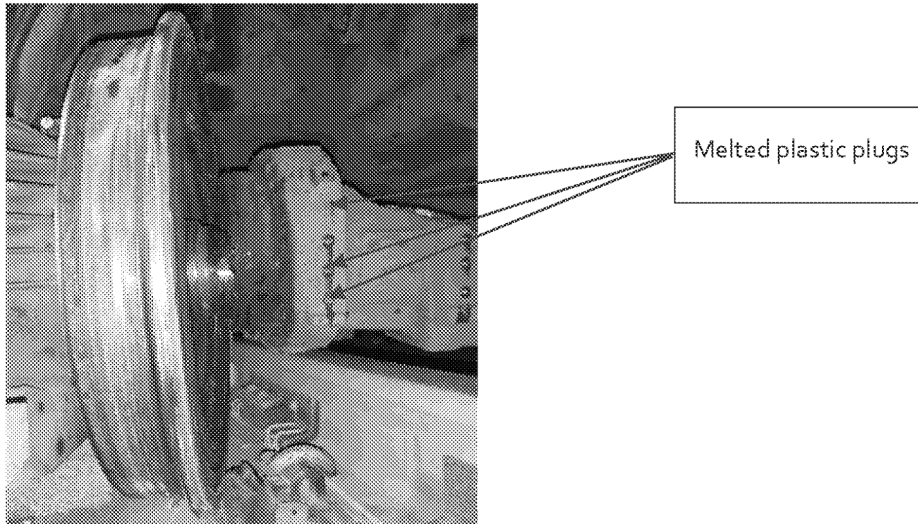
4.1.10 The axle beam

It can be observed in the photo above that the plastic plugs inserted into the beam, have melted and dripped. These plugs melt at 110 degrees Centigrade and give an indication of the temperature of the outer housing.

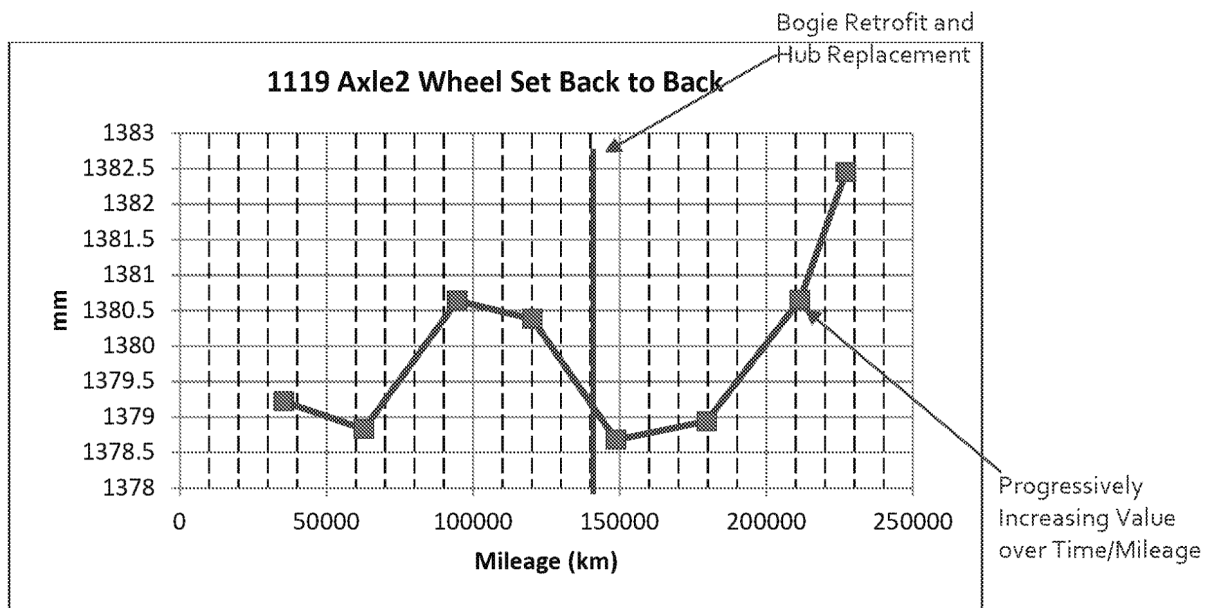
While reviewing the lathe's wheel data base for LRV 1119, in hindsight, it was found that axle 2 back to back distance was above the max tolerance of 1381mm, and axial runout of axle 7 was slightly above the max. tolerance.

Upon review of the wheel lathe data, and specifically the very high back to back values for axle 2, the past records for that axle were reviewed. The chart below shows the summary of that review

The apparent evolution over time of the back to back distance of the failed axle indicated that there was an issue with the clearance of the cartridge bearing assembly increasing over time. This is consistent with the physical findings from the failed hub.

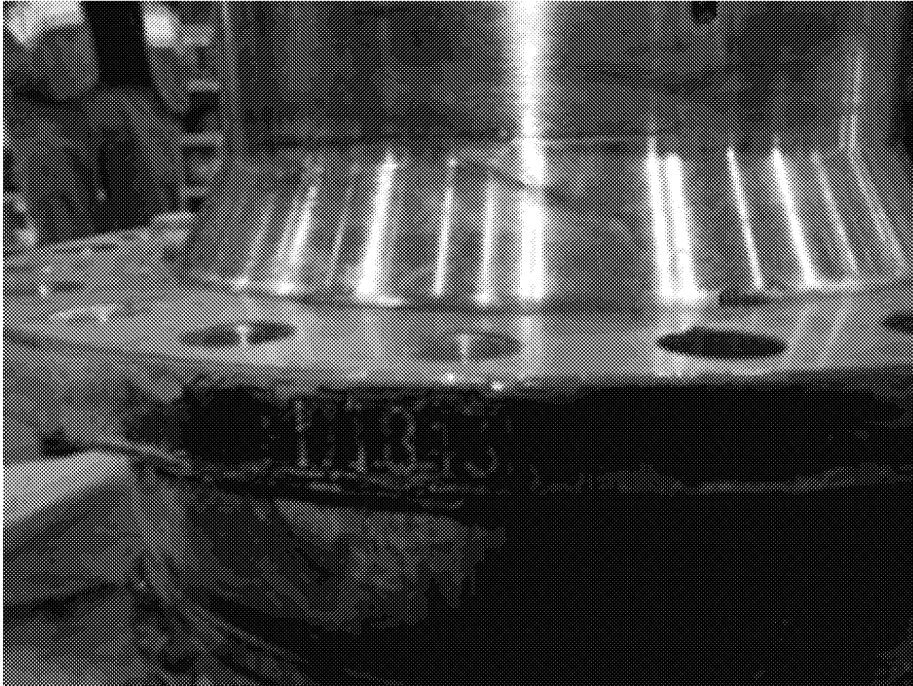
With the hub removed, there were some marks on the exterior of the bearing capsule / hub assembly that might indicate the assembly was hot at some time in the past, this can be seen in the figure below. It has been reported that there is some heating applied to the assembly to insert the bearing race, therefore this may simply be an artifact of the assembly process.

Discoloration of the bearing cartridge

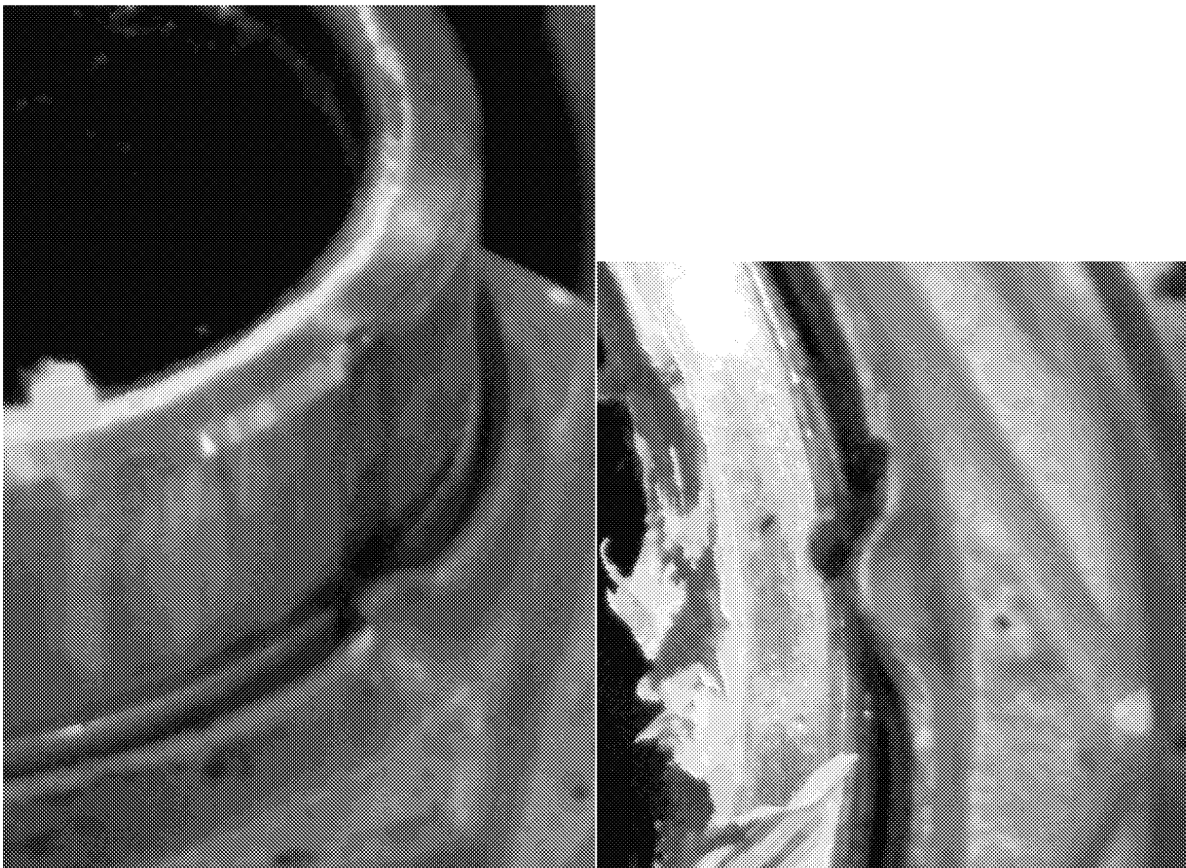
With the speed sensor target removed, the depth of the mechanical swaging could be better evaluated, and can be seen in the figure below

Swaging marks on the bearing retention nut

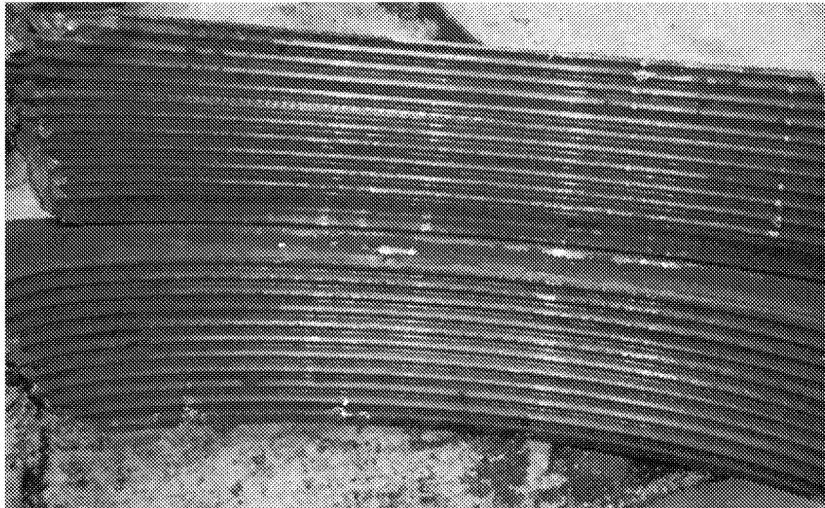
The threads are shown below. There is a considerable amount of fretting corrosion present. Note that the lighting at the time led to a slightly exaggerated or enhanced depiction of the corrosion

Bearing retention nut thread condition

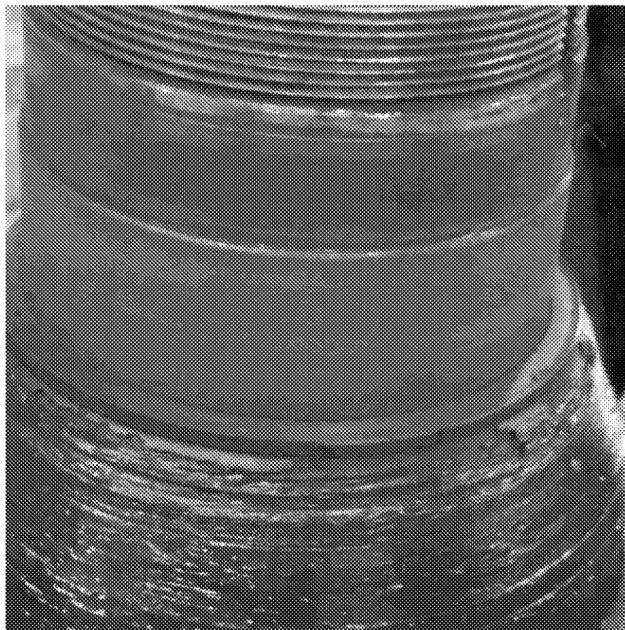
The shaft threads on the hub are in a similar condition, as is the shaft under the shaft seal seat and the inner race of the bearing, as shown below; again the lighting at the time has exaggerated the level of the corrosion

Hub condition below the bearing shaft seal and nut

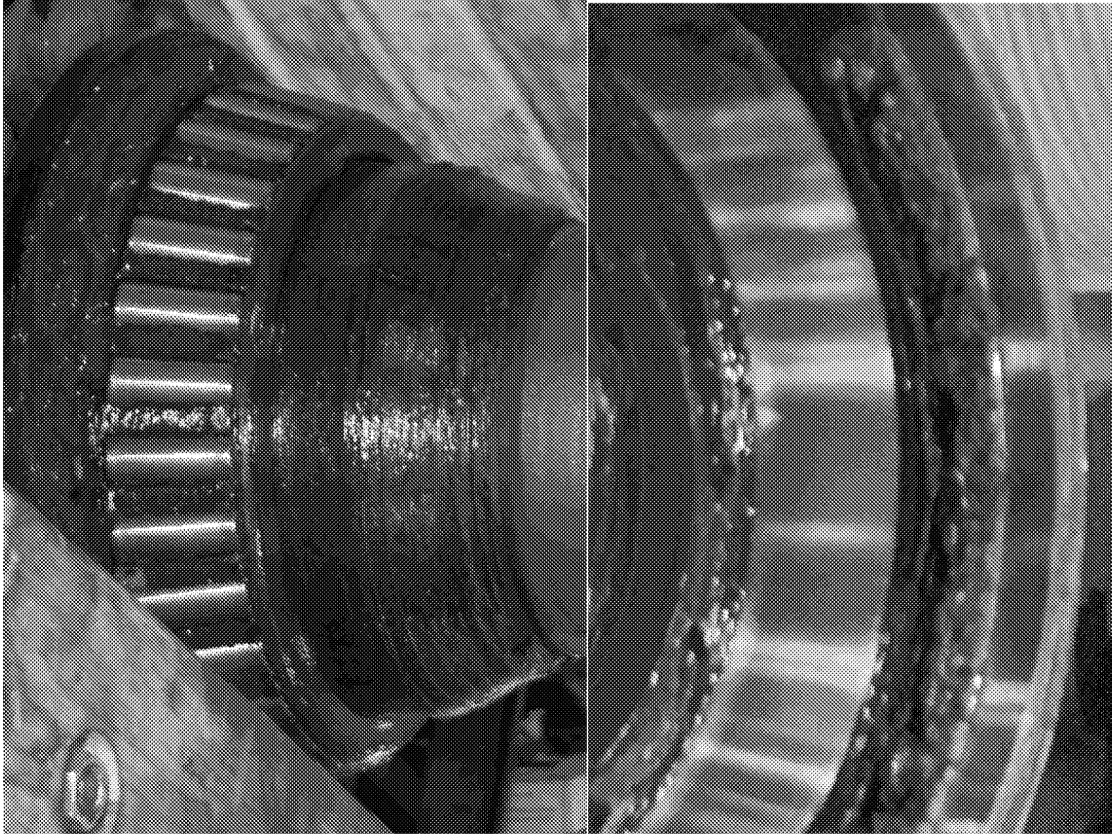
The bearing condition was reviewed starting with the large outer bearing. This is shown in the following figure. Overall the condition is quite good, there is no serious discoloration of the rollers and the grease is quite clean near the bearing.

Outer bearing race and rollers

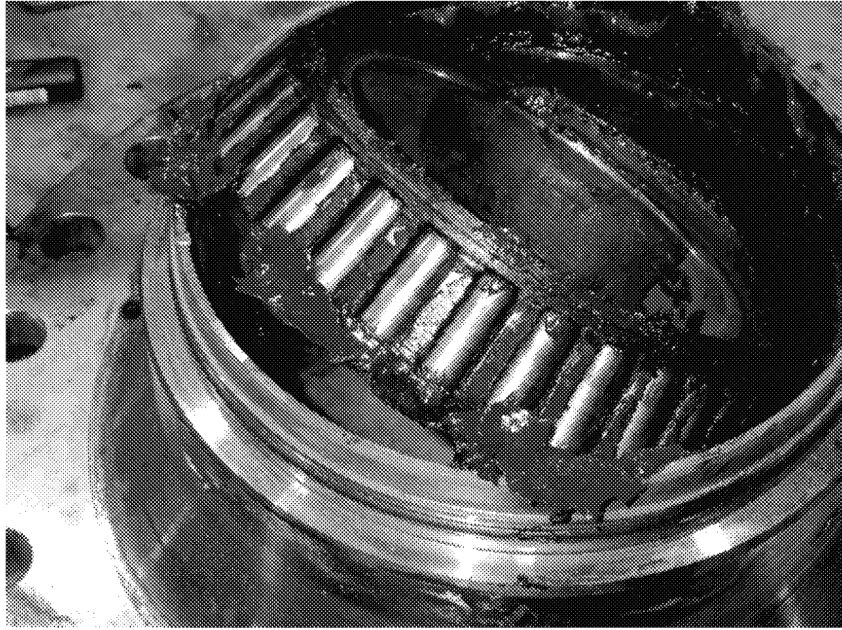
The small inner bearing condition was not as good. There is some possible discoloration present on the rollers and the condition of the grease is the complete opposite of the larger bearing, as can be seen in the figure below

Inner (small bearing)
