Ottawa LRT Independent Review Report

April, 2022
Confidential

City of Ottawa
c/o Singleton Urquhart
Reynolds Vogel LLP
150 King St West, Suite
2512
Toronto, ON
M5G 1J9

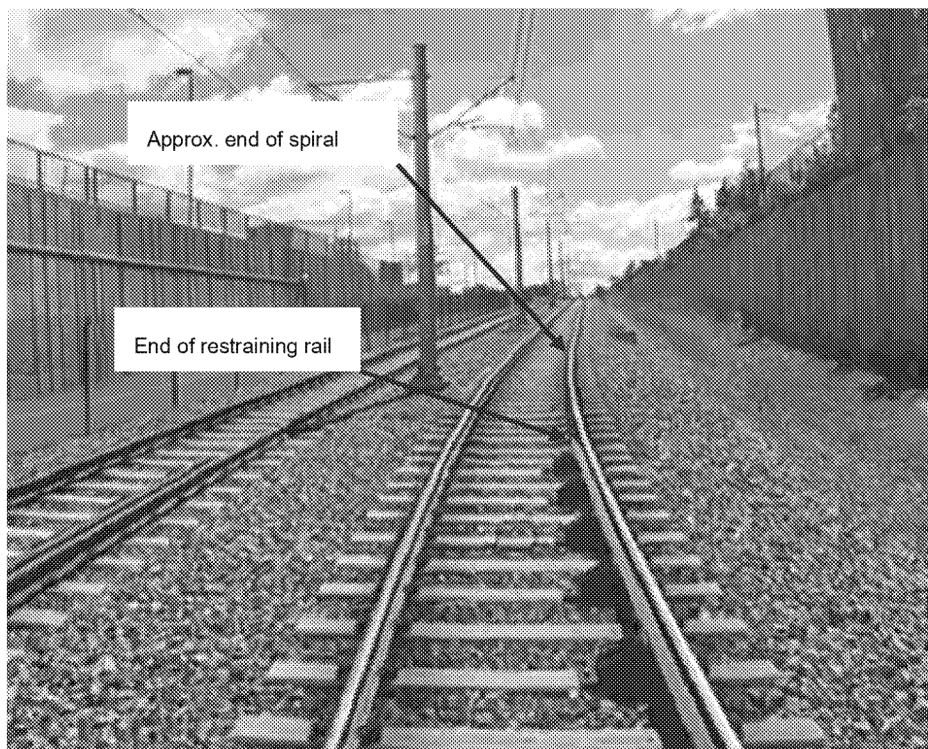
Figure 3.5: Cab footage showing termination of the restraining rail within a spiral

There will be an inherent stiffness differential within track that has three or four rails secured to ties with it being higher than that of a typical two rail arrangement and therefore increased ability to resist against forces as temperatures increase. There will also be additional weight to consider through these sections of track which will make the track more resistant to lateral loading.

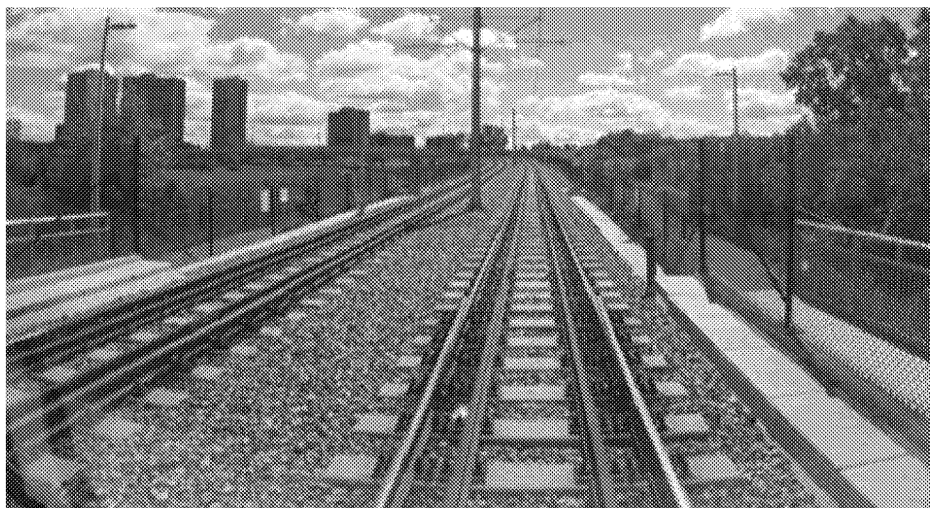
Figure 3.7: Expansion joints installed in a “facing” position on the eastbound line

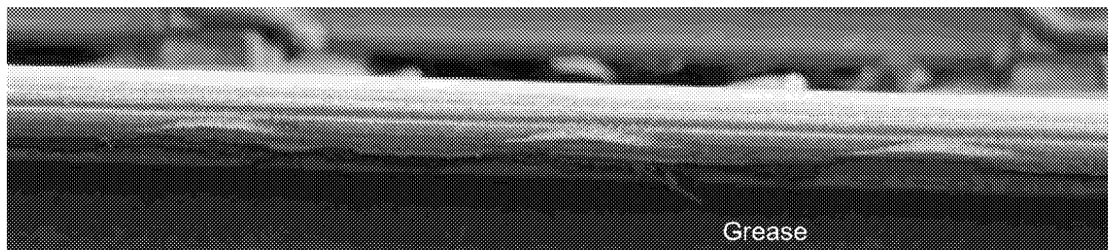
Figure 3.13: Corrugation on High Rail of Curve 230 at 105+655

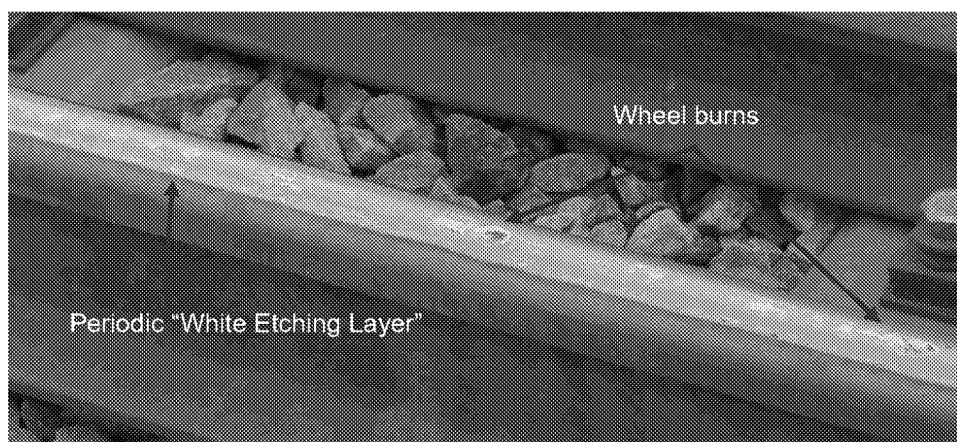
Figure 3.14: Wheel Burns and Periodic Patches on Rail at Blair Terminus

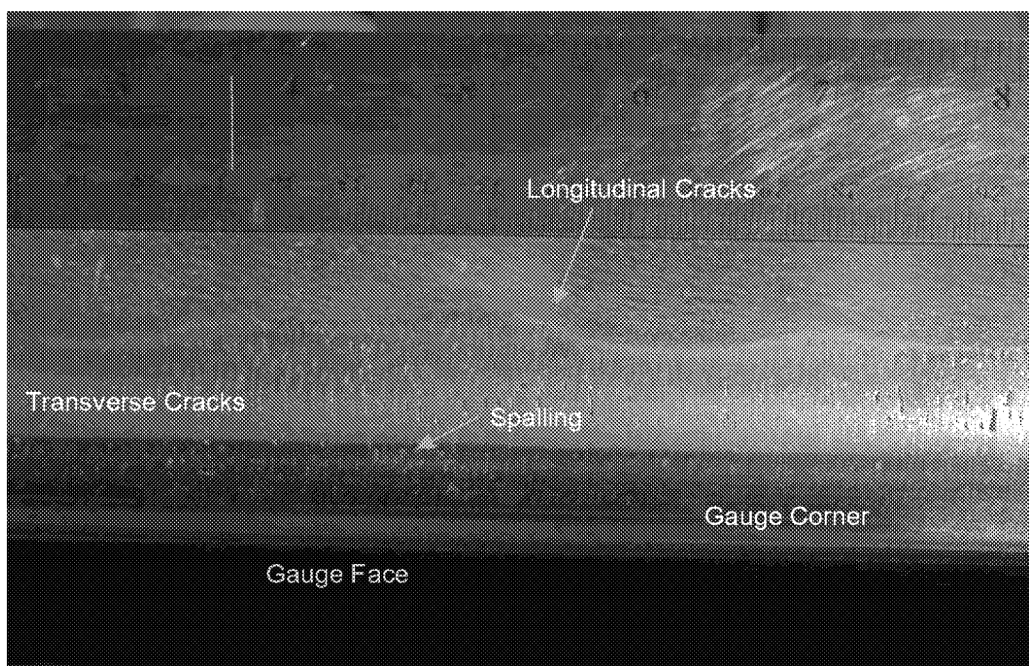
Figure 3.17: Rolling Contact Fatigue on Low Rail of Curve 210 at 104+725

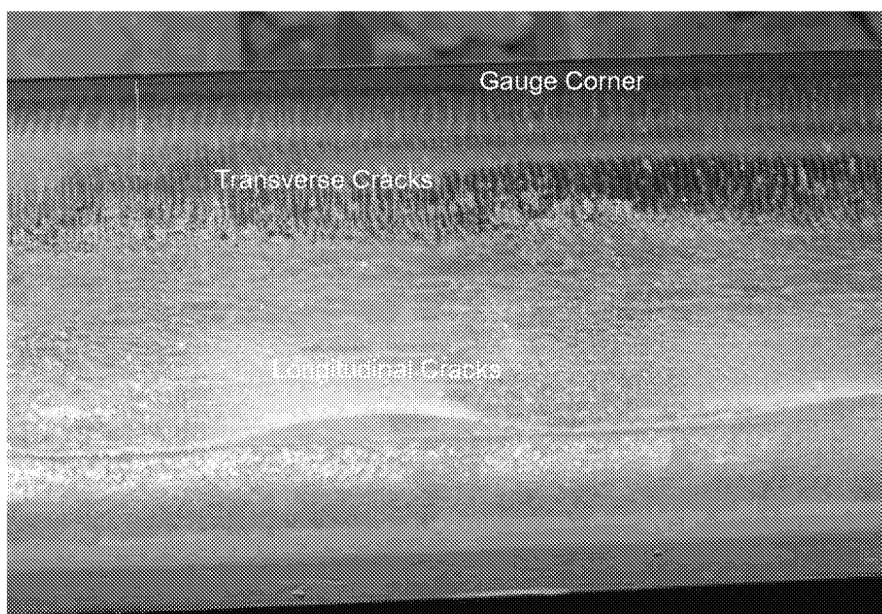
Figure 3.18: Rolling Contact Fatigue on Low Rail of Curve 220 at 105+115

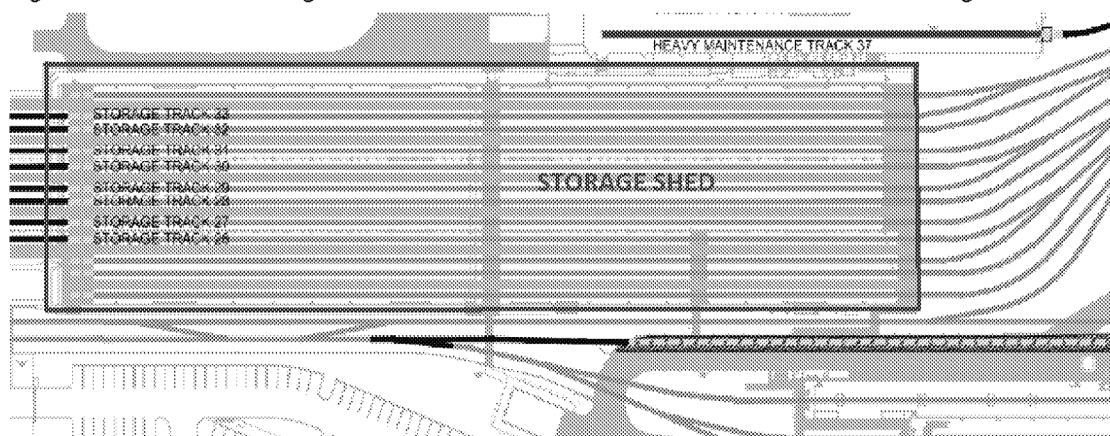
Figure 3.55: Storage Shed

The storage shed consists of 12 stub ended tracks (**Figure 3.55**). The initial vehicle storage building had capacity to hold four LRVs on each track. An extension was added to the vehicle storage shed extending eight of the tracks allowing them to store a maximum of six LRVs on each of the eight extended tracks.

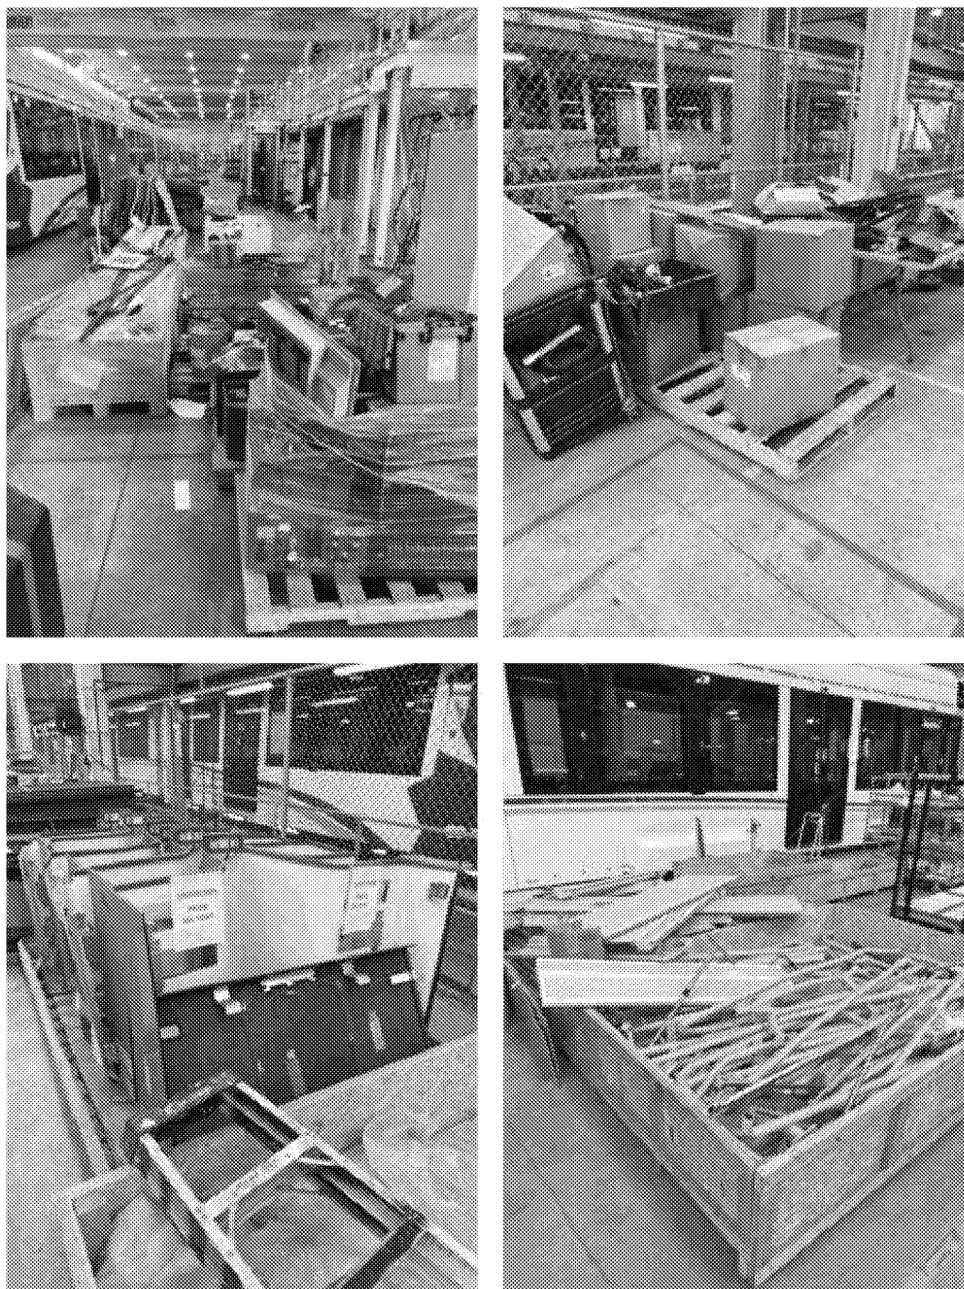
Figure 4.1: (a) (b) (c) (d): Parts Laying Out on the Floor Shop of MSF1 Next to Tracks 1 - 4

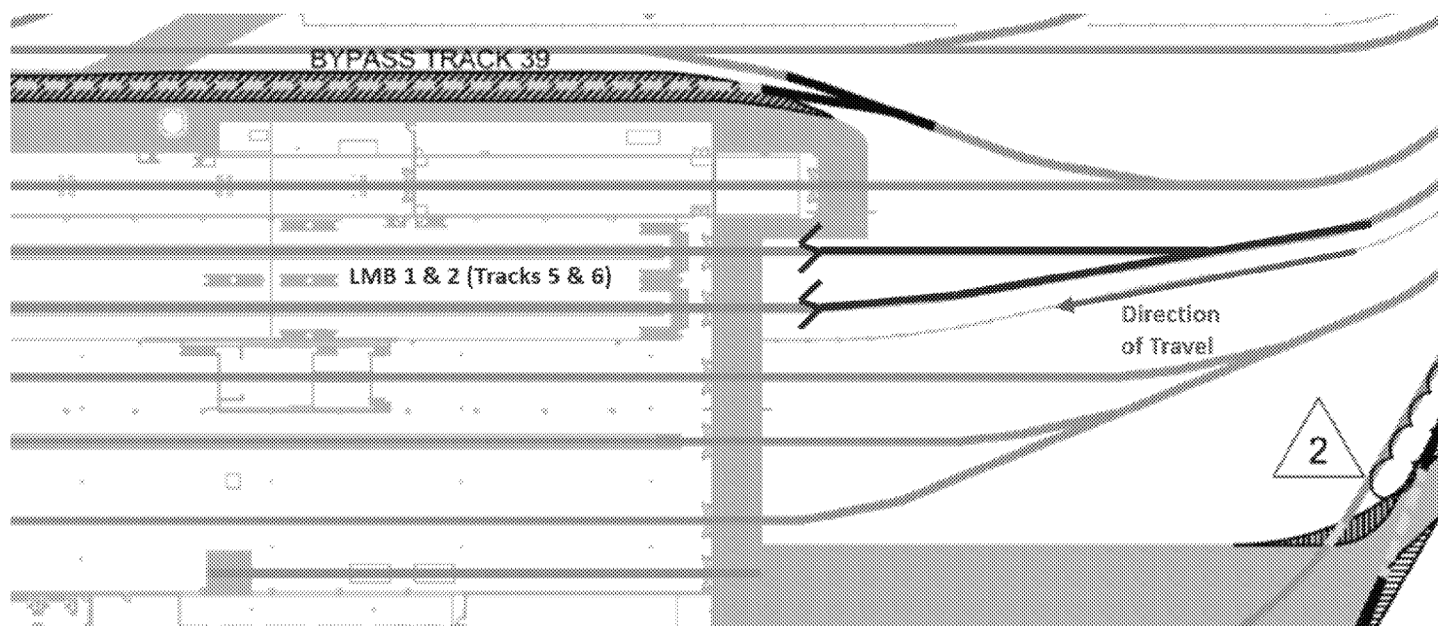
Figure 4.5: MSF1 Access Issue to LMB 1 and 2 from East Side of Facility

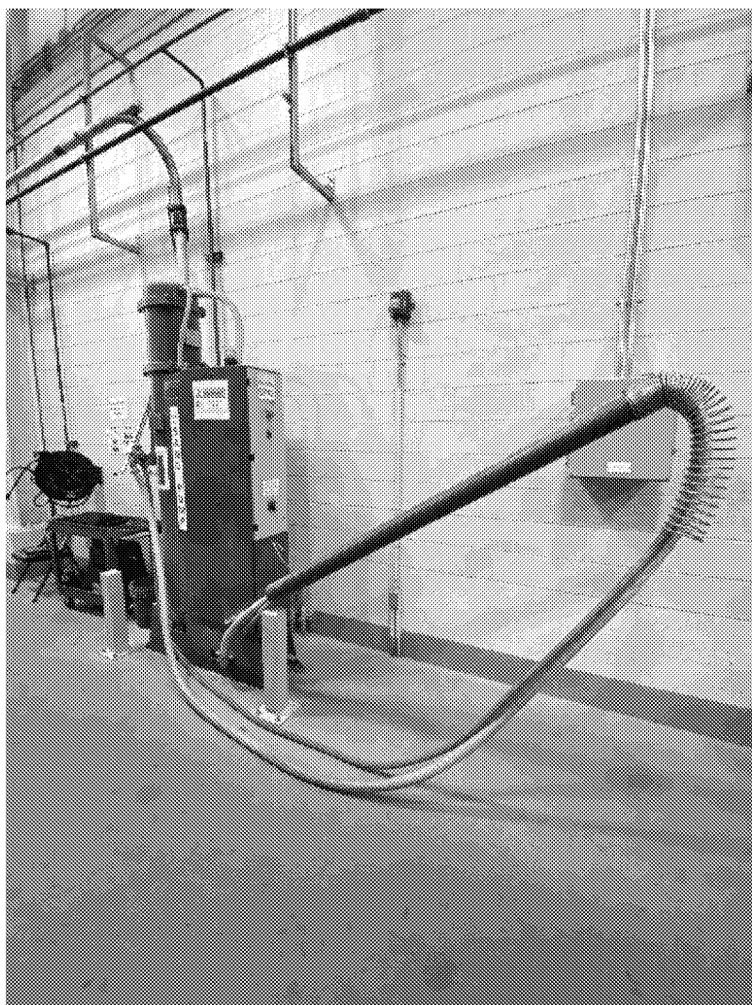
On track # 7, 12 sanding pumps are located, six on each side of the vehicle (**Figure 4.6**). Due to the location of the sanding pumps, the device was fitted with longer hoses to be able to reach the sanding box ports on the vehicle. The extra length on the hoses causes sharp edges and substantial rubbing with the floor, causing the hoses to break. This issue is controlled by the use of sacrificial conduits. The Mott MacDonald team was informed that the system suffers from constant clogs due to presence of moisture in the sand.

Figure 4.6: Sanding Pump at Track #7

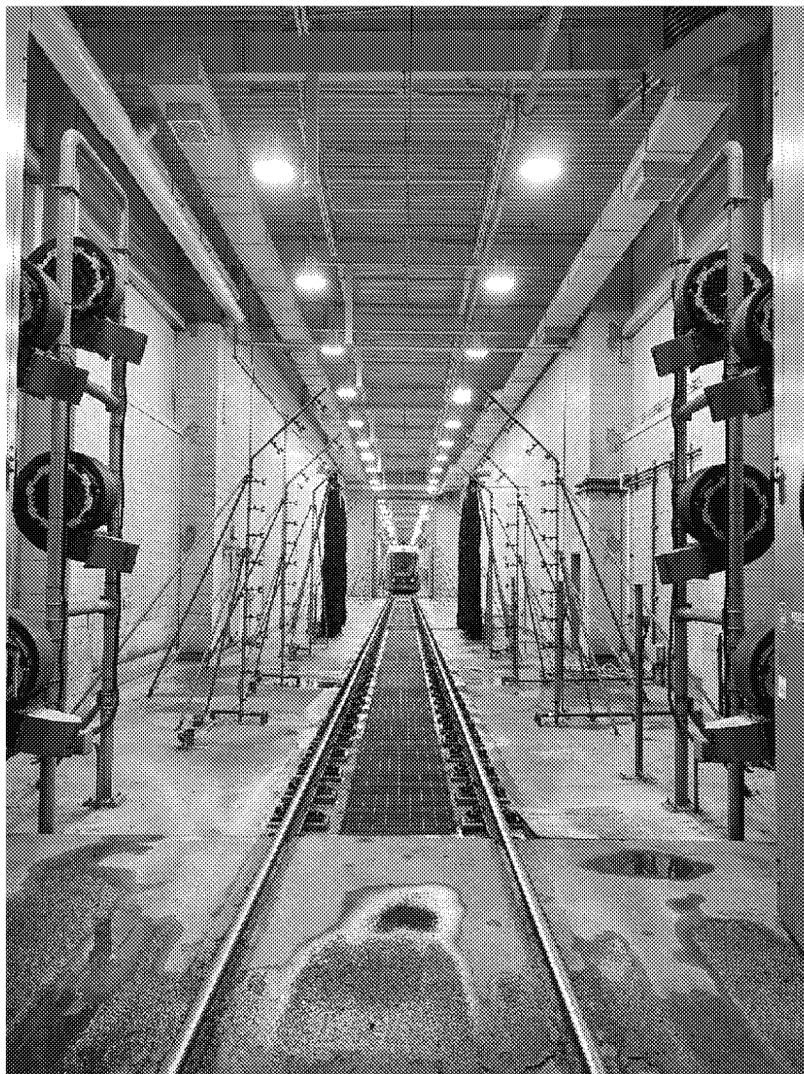
The carwash system is located on track #8 (**Figure 4.7**). The system can wash a consist of two vehicles without having to decouple the train, however, the system does not wash the front and rear cabs of the consist. Based on the Mott MacDonald team observations, the rinsing and blower systems' performance are not optimal, leaving the vehicle wet and with detergent residue as it leaves the carwash track. This may also create problems during the winter when water on the bodysides and doors may freeze resulting in possible door seals sticking and creating door reliability issues.

Figure 4.7: Carwash System at MSF1

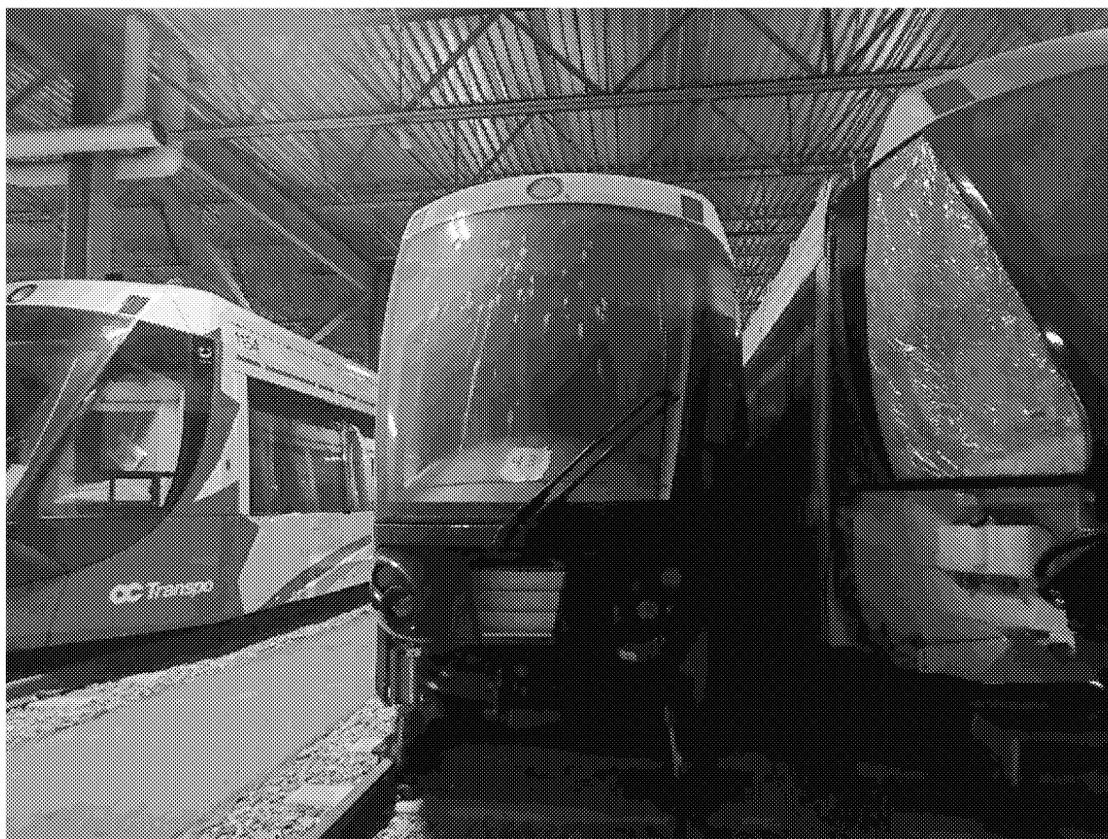
Additionally, if vehicles are parked next to another vehicle there is insufficient space for the vehicle side panels to be opened and for personnel to walk along the restricted access side of the vehicles, which is a safety concern (**Figure 4.11**).

Figure 4.11: Limited Space Available Between Vehicles at the Storage Shed

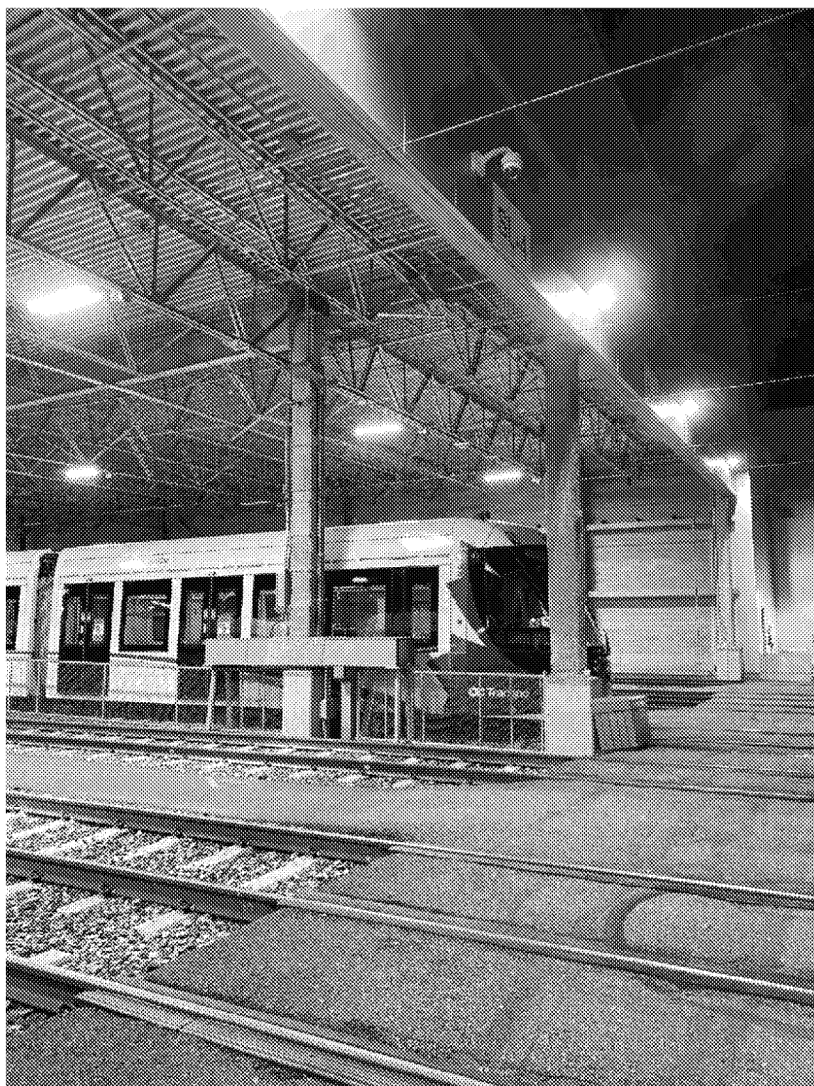
Another aspect that affects the movement of vehicles, especially during winter season, is the lack of doors at the storage shed (**Figure 4.12**) which is going to worsen the vehicle storage situation especially for those that are stopped long term due to missing parts and equipment especially for those that are open to the elements because of missing windows/panels. During winter conditions, snow can accumulate and enter the shed which makes the working area for staff both unpleasant and hazardous.

Figure 4.12: Lack of Doors at Storage Shed

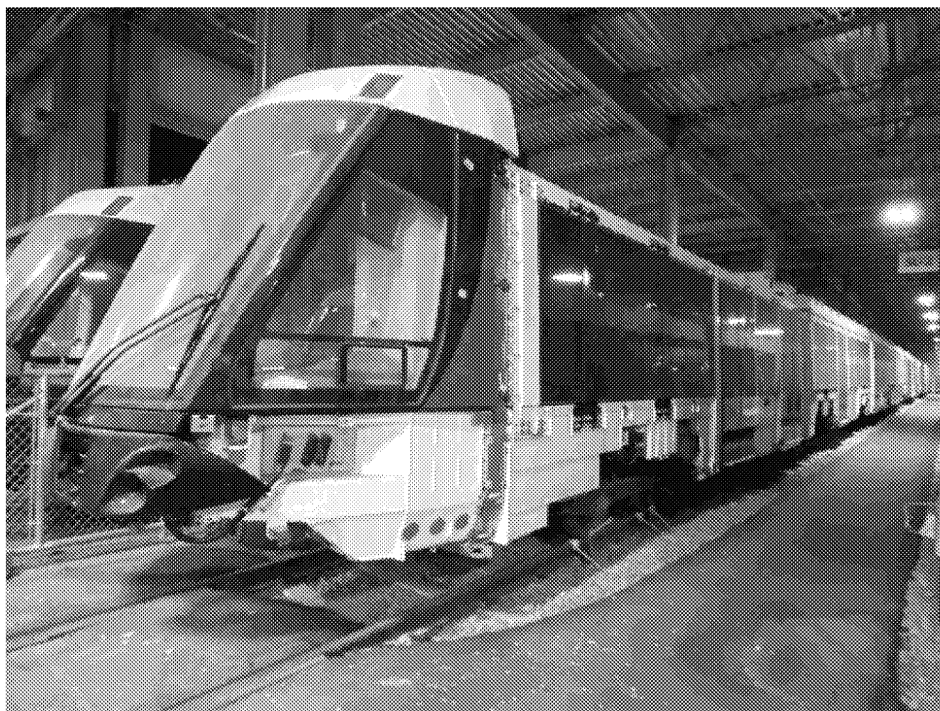
Mott MacDonald was informed that 1146 was the last vehicle to be built at Belfast Road before production was moved to Brampton. This vehicle does not have trucks installed and is missing exterior panels. The interior appears complete, but interior panels are open, which suggests that the interior equipment is either incomplete or has been partially removed. The interior and exterior bellows are not installed, with plywood covering the end portals. One of the cabs in the vehicle is missing the cab side windows, chip board panel covered by plastic are currently in place instead of cab windows.

Figure 4.13: Vehicle Missing Side Panels, Coupler, Skirts and Roof Shrouds

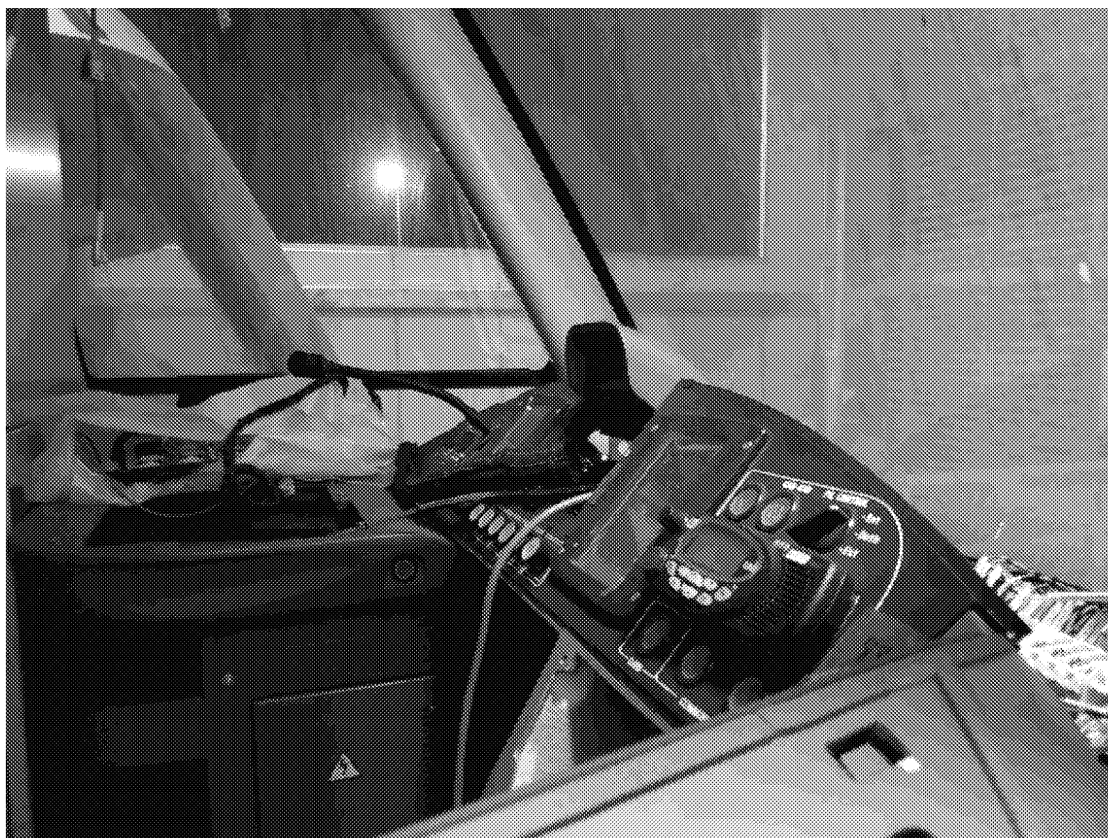
Vehicles 1135 and 1136, which are labelled as “1102 old” and “1108 old,” are the least complete vehicles. Neither have trucks installed. Both have incomplete exterior and interiors. At least one end of 1102 old does not have a coupler. 1108 old does not have a cab partition installed.

Figure 4.14: Vehicle Missing Cab Components

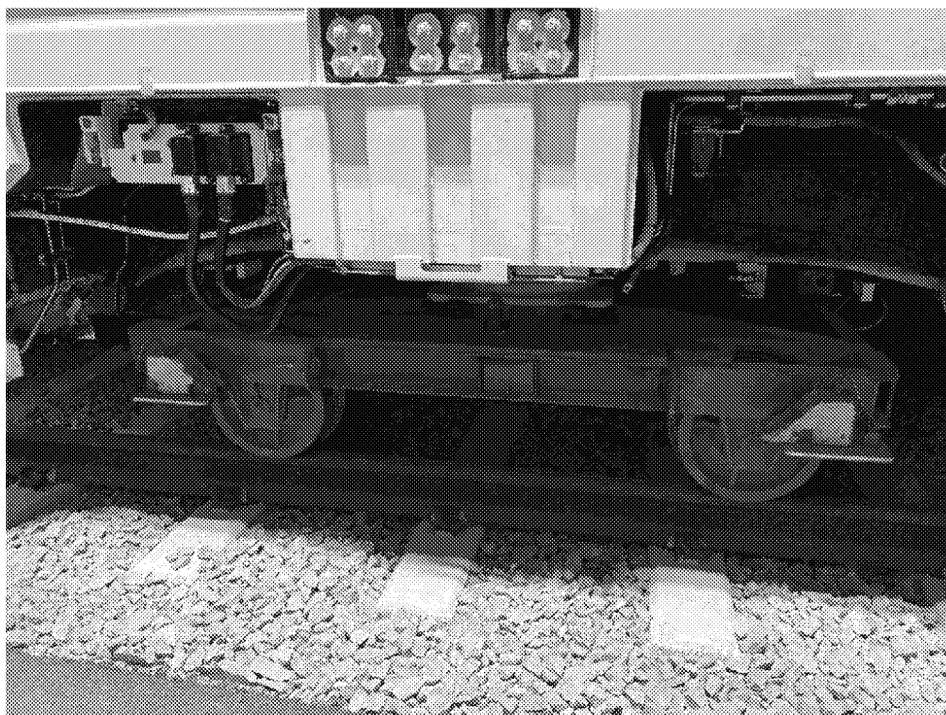
When asked about 1135 and 1136, Project Co indicated that these vehicles were used for qualification testing early in the project. When asked about returning them to a service ready state, we were told by Project Co staff in the MSF that there was the possibility that they would simply be replaced with new vehicles from Brampton as part of Stage 2. It is unclear how or why these vehicles were dis-assembled to this state after testing, or how configuration management has been exercised on the components removed. It is clear from the dust that these vehicles have not been moved for some time.

Figure 4.15: Vehicle Missing Trucks

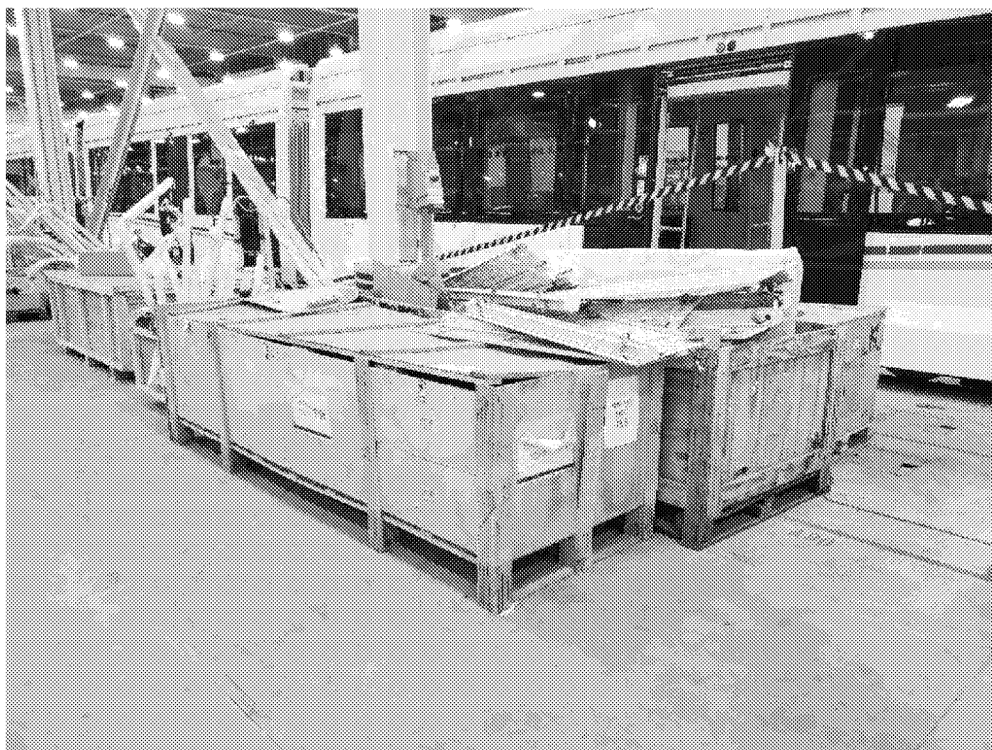
On the floor of MSF1 are a number of pallets, and crates. Some of these are labelled "removed from TS 8." While unconfirmed, it could be inferred that at least some of these interior panels, stanchions and interior panels may have come from 1108 old.

Figure 4.16: Crates in MSF1 Labelled "REMOVED FROM TS 8"

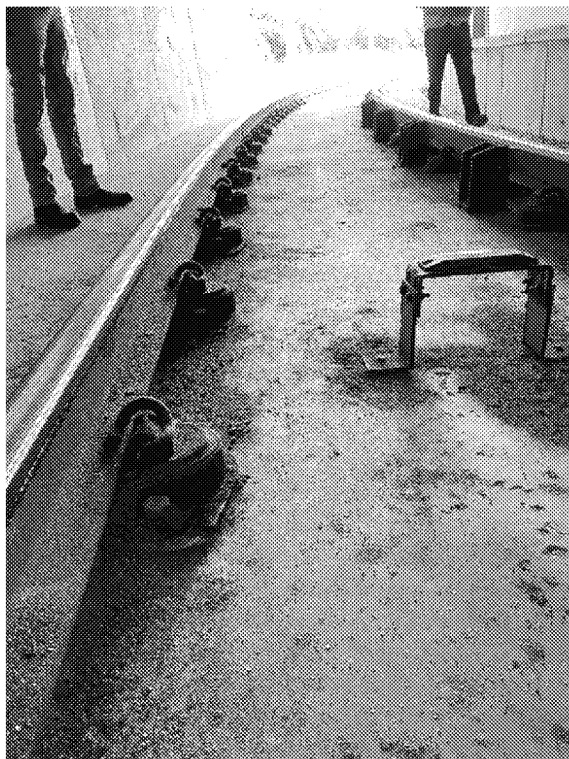
According to Alstom, grease is applied manually only on the yard at curve C19. However, evidence of grease on top of the rail is evident at other locations, specially at the end of the East Connector, where vehicles stop before proceeding to enter the main line. Due to the gradient at this location (Approx. 4-5%), and the presence of grease on top of the rail, wheel spin/slide occurs causing the automatic sanding system to activate. The continuous wheel spin/slide occurrences due to lack of traction between wheel and rail caused by the presence of grease on the rail is the reason for the large amount of sand accumulated at this location, refer to **Figure 4.21** to **Figure 4.23**.

Figure 4.17: Grease Contamination at East Connector

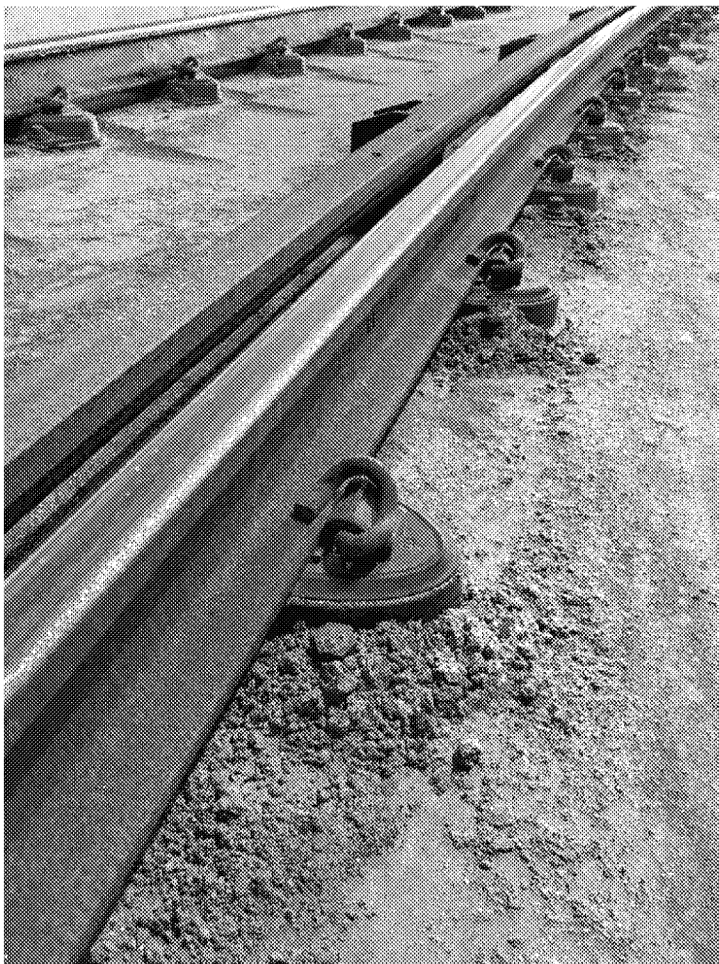
Figure 4.19: Sand accumulated at East Connector Due to Excessive Wheel Spin/Slide Caused by Presence of Grease on Top of Rail

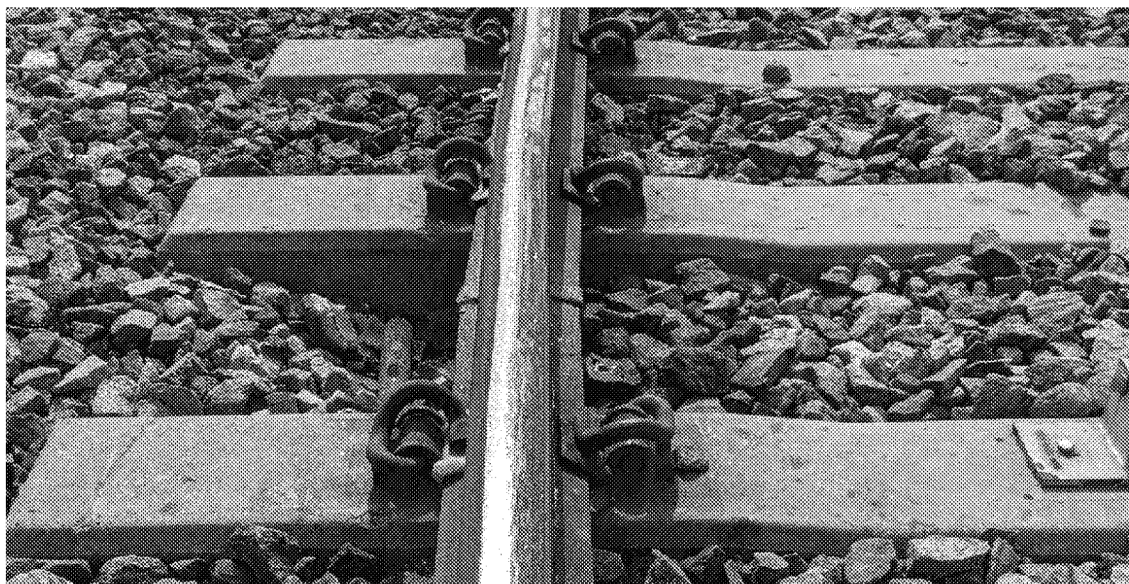
It is important to note that tight to gauge track on the small radius curves could lead to potential wheel flange climb resulting in derailment. The severe kinks in the rails will also prevent a smooth transition of the wheels on the outer rail and when combined with the tight track gauge may also contribute to potential derailment risks.

Figure 4.21: Kinks at Weld Location (C19), Including Grease Contamination of the Top of Rail

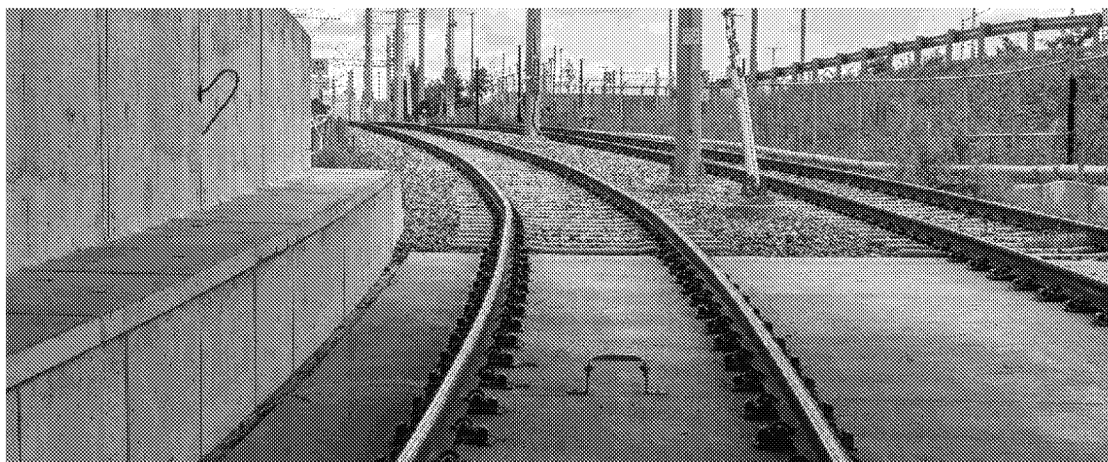
In addition to issues associated with the track gauge as listed in Section 4.4.1 above, general issues with the track geometry were found, most notably at the transition between ballast track and DFF track at the E/B and W/B Connector tracks (**Figure 4.26** and **Figure 4.27**).

Figure 4.22: EB Connector, Track Geometry at Interface Between Ballast Track and DFF Track

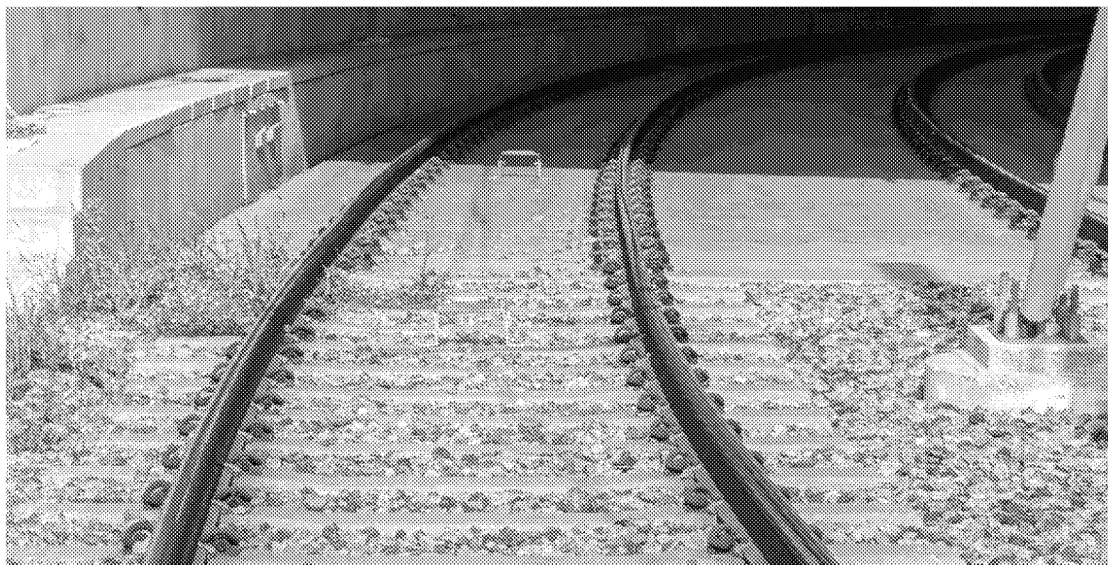
Figure 4.23: WB Connector, Track Geometry at Interface Between Ballast Track and DFF Track

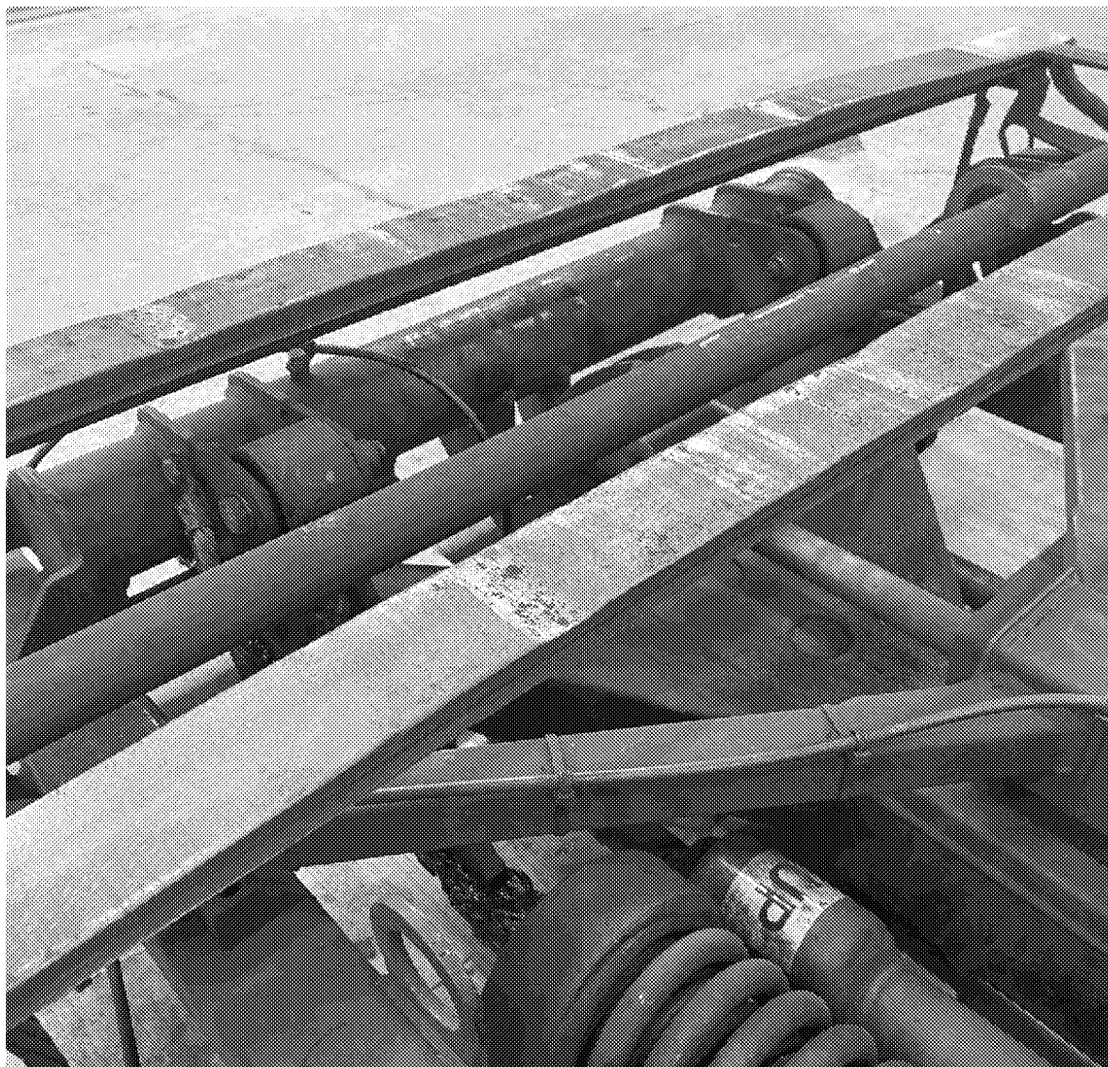
Figure 4.24: Grooved Wear on Pantograph

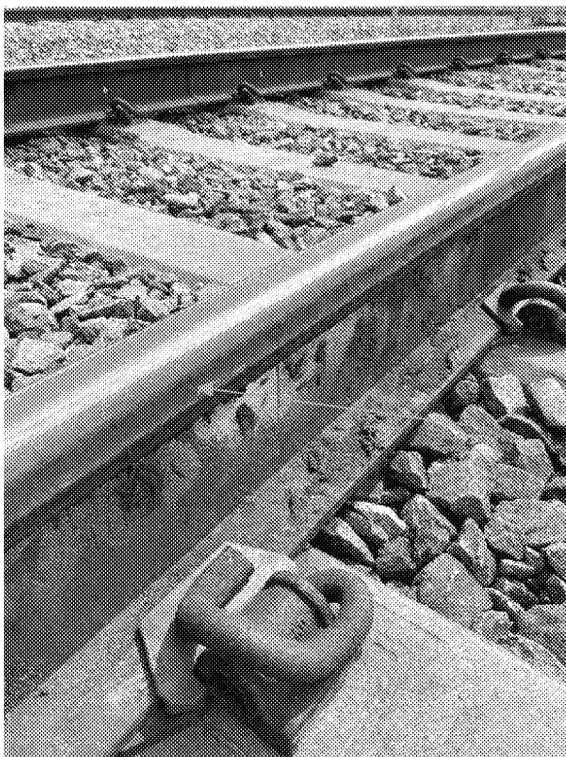
Figure 5.2: Transposed Rail with Excessive Side Wear Now Moved to the Outside Edge

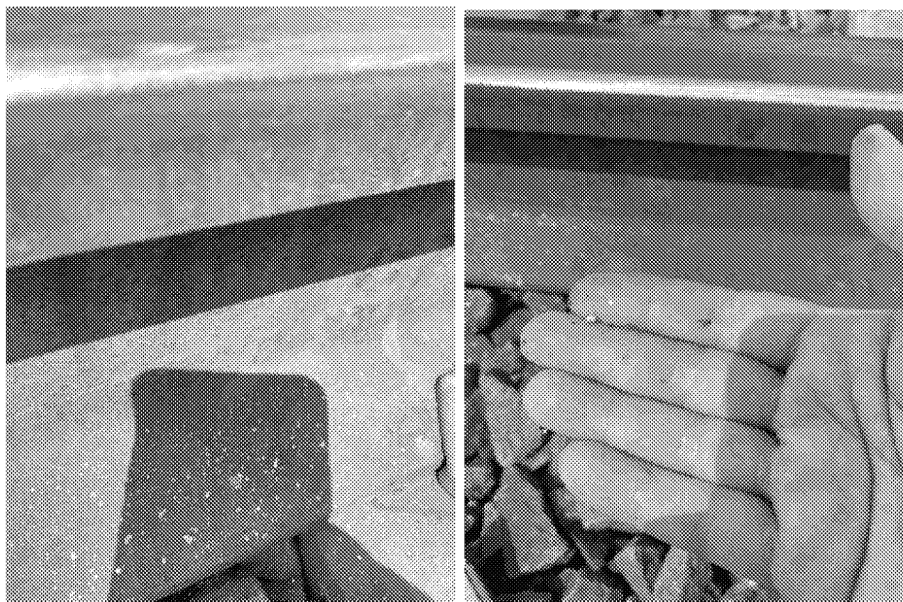
Figure 5.3 & 5.4: Metal Shavings at Curve 19

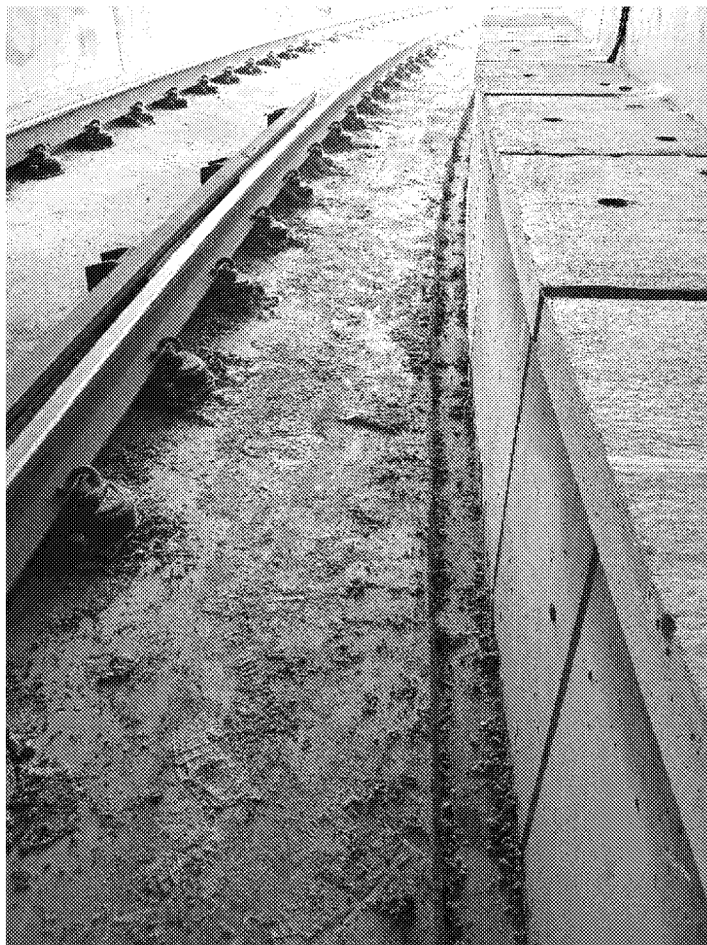
Figure 5.9: Sand in East Connector Portal Tunnel

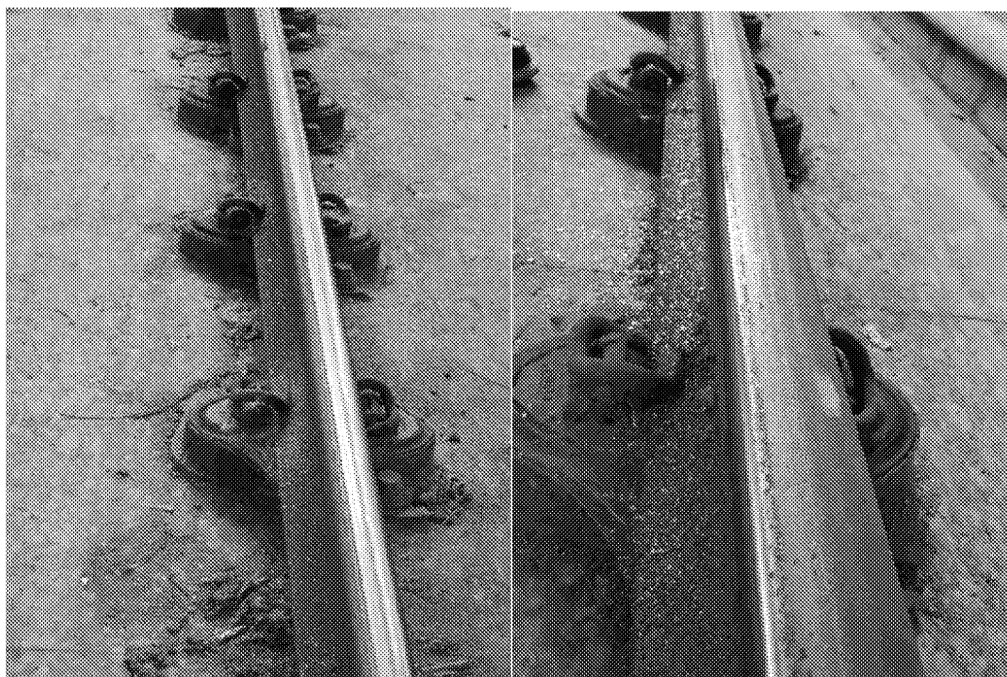
Figure 5.10: Metal Shaving at East Connector Portal Tunnel
