Rideau Transit Group 805 Belfast Road Ottawa, ON K1G 0Z4

25 April 2020

Subject: RTG Revised Plan

Ottawa LRT Project – Project Agreement, dated February 12, 2013 ("Project Agreement")¹, between the City of Ottawa (the "City") and Rideau Transit Group Partnership ("RTG")

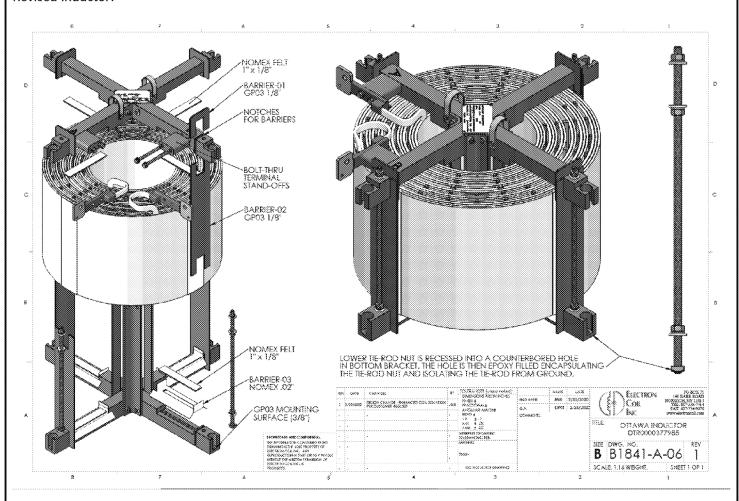
Revised Inductor:

Line Inductor Failure Analysis Report Doc # DED0000 Rev A shall be issued to the City as will Failure analysis report LINE INDUCTOR DTR0000377985 Doc # AYD0000561716

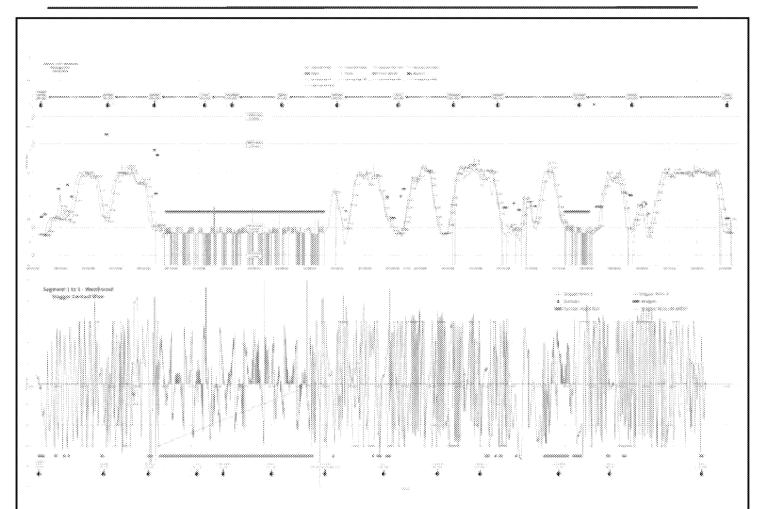
Several surveys of the OCS infrastructure have been conducted, initially by a third party systems engineer firm and more recently as part of the HV Arcing Task Force, as a participant in the Taskforce, Alstom utilized their OCS Tracer and Health Hub data system to survey and record the current OCS installation for height and stagger compliance. In addition, Subject Matter Specialists that form part of the Taskforce also conducted a preliminary line recording (pro-cam) of the OCS and Vehicle Interface and reported similar findings.

The recent surveys concluded that there are locations pertaining to the OCS alignment that will benefit from adjustment to allow for more "stagger", specifically in the rigid rail sections.

Several recommendations from the submitted surveys to the Taskforce include;

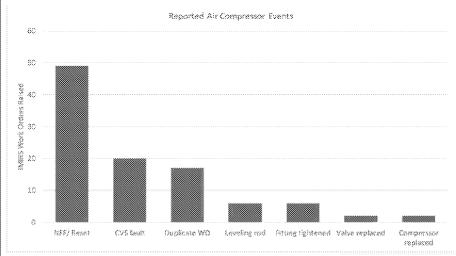
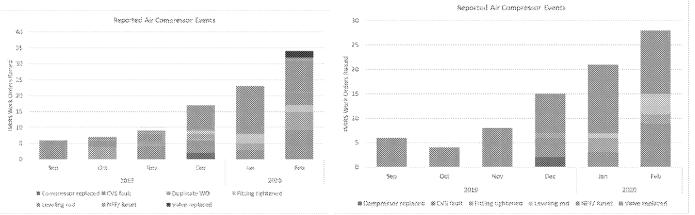
The impression is influenced by the fact that numerous Air Supply IOS are raised (125 events since Revenue Service) due to parking on a super elevated curved track, duplicates, Auxiliary Power Supply events (air supply is a consequence) and some air piping leak.

Alstom are also tackling technical topics leading to "Air Supply IOS" such as levelling rod adjustment and fittings. PARETO for "Air Supply" is part of the reliability analysis the vehicle supplier is doing.
