**Chapter 4 The Physical Causes of the Contamination**

## Chapter 4 The Physical Causes of the Contamination

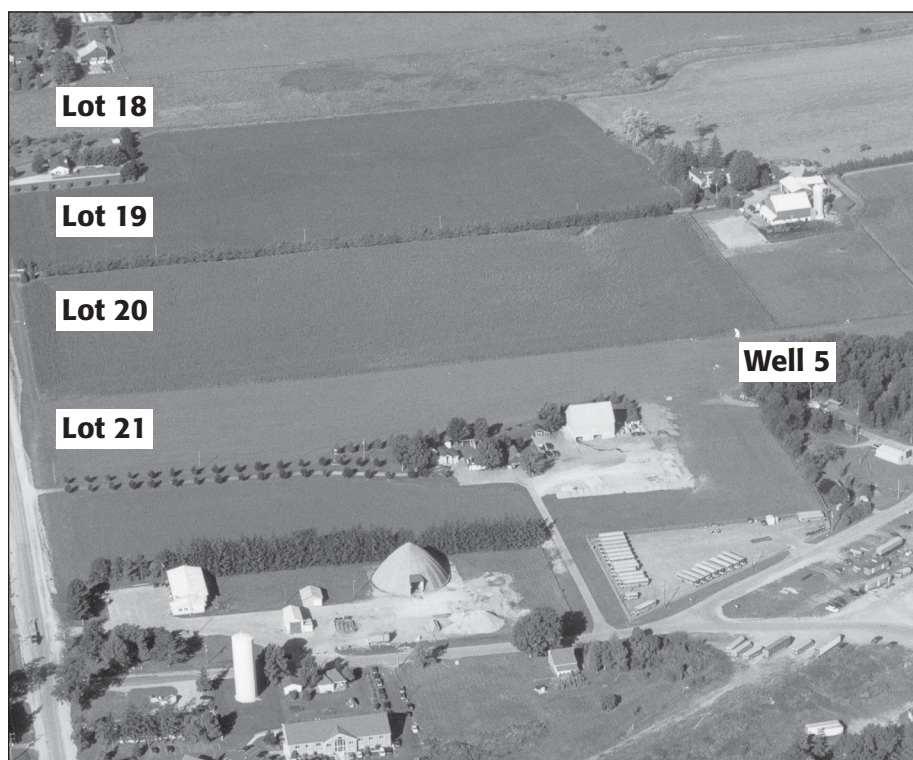
**Figure 1 Aerial View of Biesenthal Farm, September 9, 2000**

The farmhouse can be seen in Figure 1. The barn is to the east of the farmhouse. A small paddock surrounds the barn on two sides. There is a fence around the paddock area where the manure storage pad was located, and another fence around the yard. The fence post holes around the paddock were dug by backhoe, to a depth of about 1.25 m. The fence post holes were approximately 2.4 m apart. The overburden was likely 2.5 m to 4 m deep, so the fence post holes penetrated a significant portion of the overburden.

Dr. Biesenthal farmed a total of 133 acres (54 ha). As can be seen in Figure 1, Lot 18 borders the west bank of Silver Creek. In 2000, it was the main area used for grazing. Lot 19 borders the east bank of Silver Creek and was used for grain crops and cut forage. These two lots drain toward Silver Creek. Lot 20 was used for grain crop production and contains the livestock barn and yard. There is also a small paddock used for calving and grazing for a brood mare; Lot 20 also provided some cut forage. Lot 21 was used for cut forage. The land and buildings on Lot 21 are the Gutscher property, formerly the Pletsch property. Dr. Biesenthal took forage from Lot 21 but did not own the land. Most of the natural drainage from Lots 20 and 21 is to the east, presumably feeding the spring and wetland close to Well 5. The soil is loam. The depth to bedrock on Lots 20 and 21 ranges from 1.5 m to 7 m.

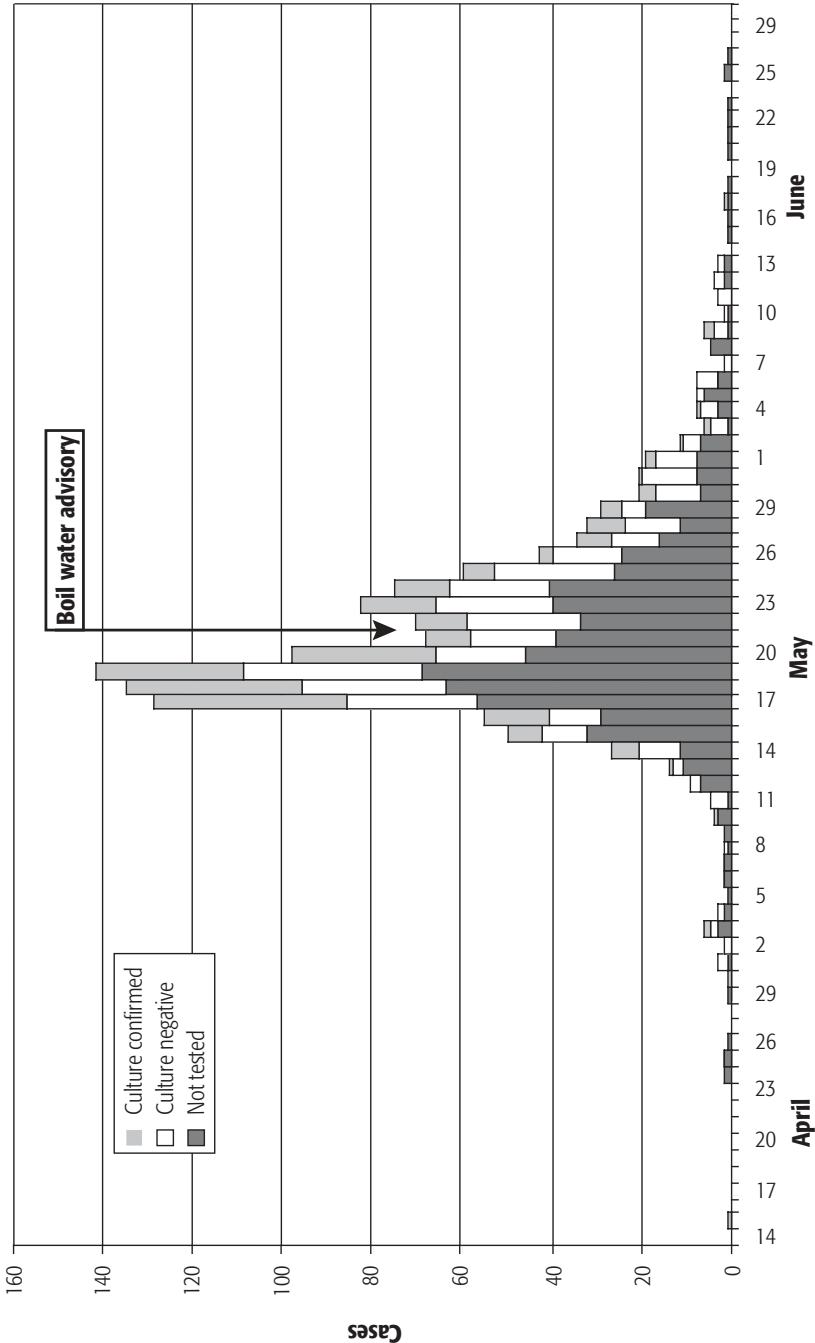
**Figure 2** Epidemic Curve, Walkerton, 2000  
Number of cases (n=1335) Date of onset missing for 11 reported cases

The health unit's epidemic curve indicates a small number of people who reported an onset date of illness before May 14 and whose stool cultures tested positive for *E. coli* O157:H7. However, the stool cultures were not taken and confirmed until late May. Accordingly, in Dr. Ellis's view, it is not certain that these people were experiencing illness due to *E. coli* O157:H7 infection before May 14. One must therefore be careful in attaching a great deal of weight to

these reports. This becomes important in trying to determine the time that the contamination first entered the system.
