<b>ALSTOM</b> · mobility by nature ·	<b>LRV 1119 Derailment Investigation Report (LeCreusot Technical Team)</b>	Document Reference: <b>DED0002013535</b> Version A	Application date: <b>2022-05-10</b>
<b>Written by:</b>	N. Sembeyev / Transmission Design Engineer C. Benais / Transmission Expert P. Boichot / WCE Master Expert RSC JP. Lefebvre / Design Engineer FEM D. Song / Bogie Project Engineering Manager		
<b>Verified by:</b>	L. VALETTE / Bogie Design Manager	Ensures that the technical/ process accuracy has been checked.	
<b>Approved by:</b>	F. BRUN / Bogie Engineering Warranty Manager	Orders, by his signature, the implementation of the document.

The purpose of this report is to document the investigation related to the axial clearance generation in the axle hub cartridge bearing assembly that was identified in the preliminary report on the TS19 derailment. This report presents the global context of the root-cause analysis, preliminary investigations, further analysis to be carried out and recommendations based on current analysis.

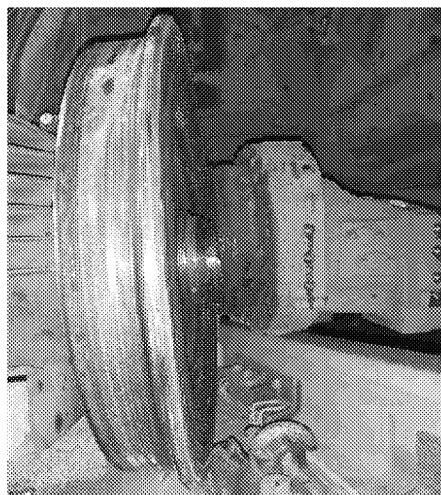
**Figure 2 – LRV 19 Axle 2 failure**

On site examination of the failed axle assembly shows that significant heat and abrasion of the mechanical parts led to failure. See Figure 2 below.

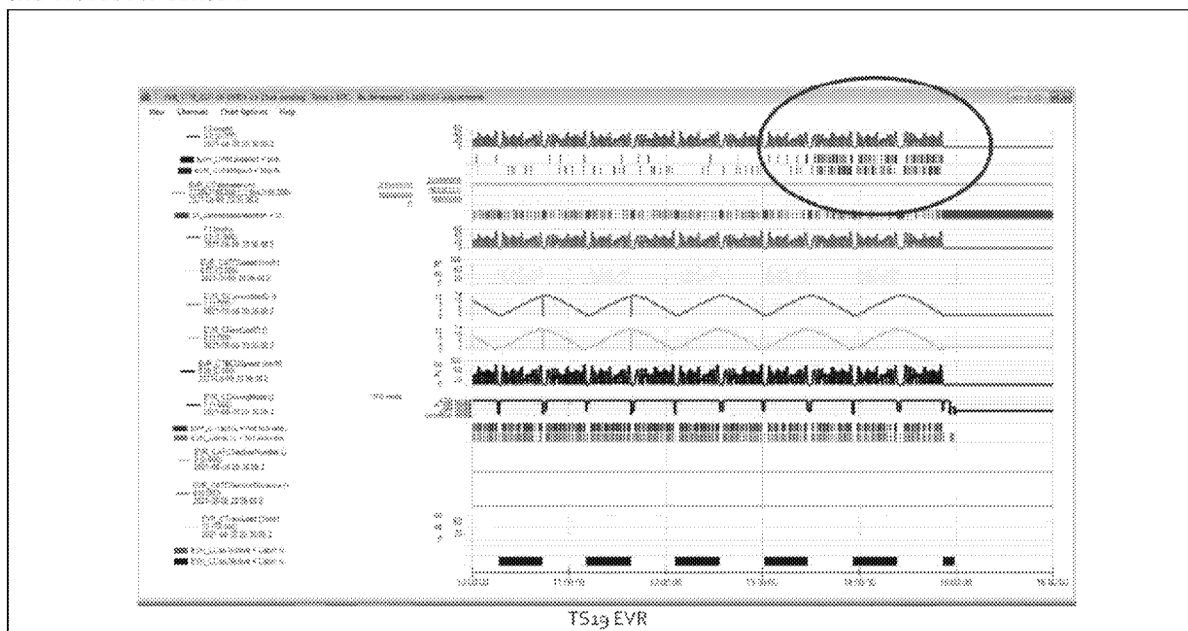
**Figure 3 – Evidence of slip/slide activity in build up to catastrophic failure**

Analysis of the LRV data leading up to the failure shows that axle 2 had been showing significant slip/slide events in the preceding 90 minutes (see Figure 3 below). This is indicative of a loss of integrity of the splined axle connection between the two wheels as the failure of the cartridge and bearing mechanism progressed to a critical point. This data was taken from the operational period immediately preceding the LRV being stabled at Tunney's Pasture at 3pm on 8th August. At this point, it is thought that the failed drive cooled, seized, and upon subsequent departure from Tunney's Pasture at 8pm failed as it transited the crossover switch.

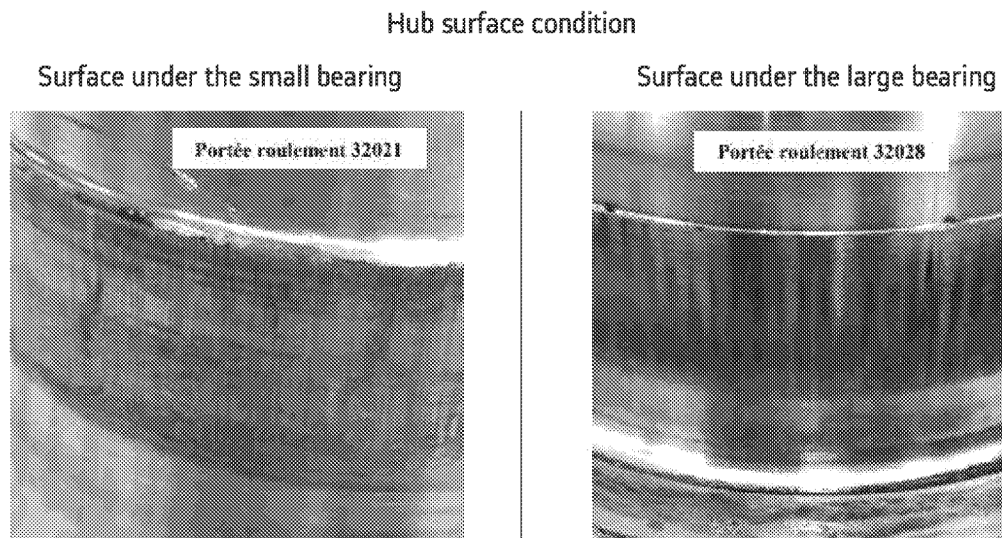
**Figure 6 – Fretting corrosion under the small bearing**

During the technical evaluation of the parts, the fretting phenomenon was observed on the surface of the hub (part #7, Figure 6) under the small bearing (part #12) while no fretting was present under the large bearing (part #6).

When the fretting under the small bearing becomes excessive, it leads to a contact wear that can generate a loss of fit under the bearing, as well as axial clearance on the bearing seat. This consequently, or in parallel, will lead to another fretting phenomenon within the stack that finally generates the observed bearing clearance.

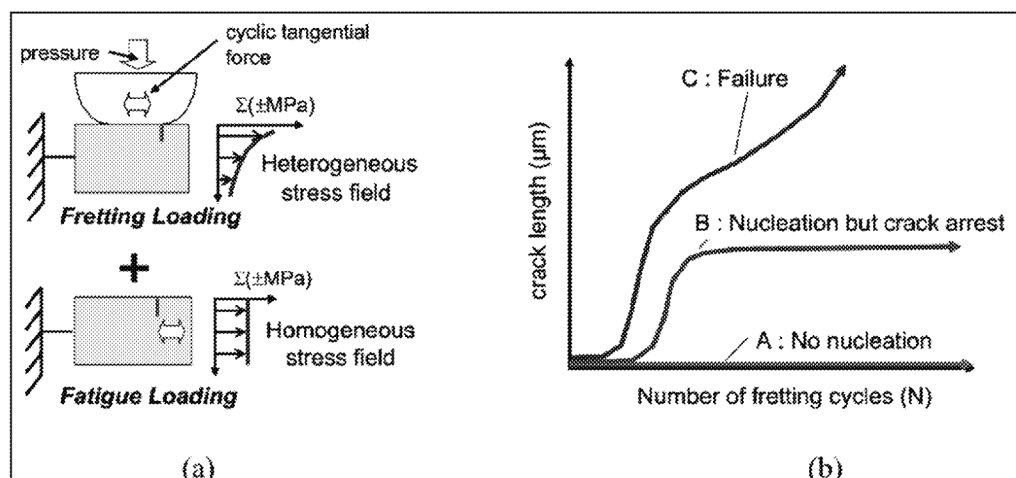
**Figure 8 - Fretting phenomenon**

- Dark area which is acceptable and without risk for the parts (Minor fretting)
- Red powder (Fretting corrosion) which is more severe and can cause wear and failure
- Crack nucleation which generates surface degradation and wear
- Crack propagation which are critical and cause failure.

What we observe after the technical evaluation of the parts is the situation "B" (Figure 8,b). The consequence is a significant wear with a modification of the contacts, the load distribution, etc.

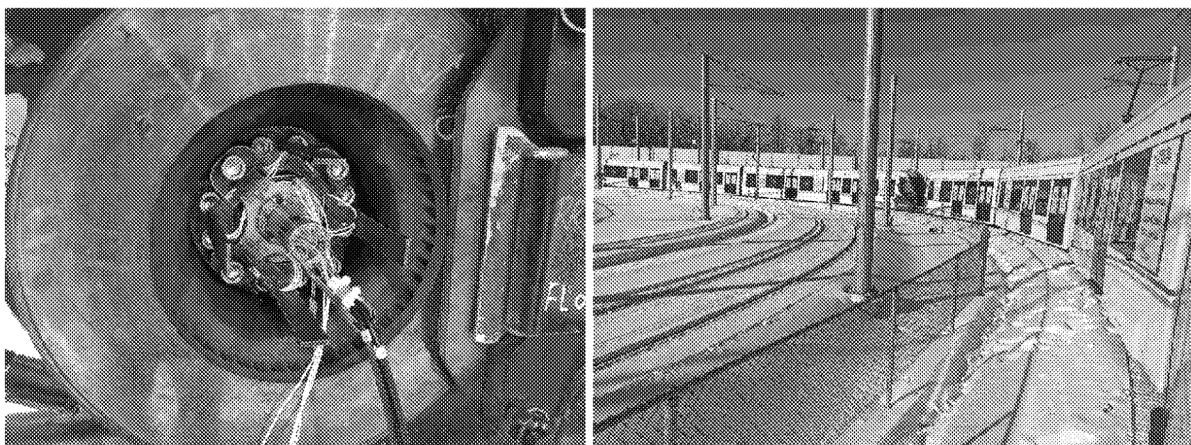
**Figure 9 : Illustration of the test instrumentation (left) and conditions (right)**

In total, 150 channels were instrumented and recorded during the test (stress, speed, accelerations, displacement...). The test campaign was totally performed on 2 weeks (preparation, test runs, uninstallation) with no stops and night and/or days shifts.

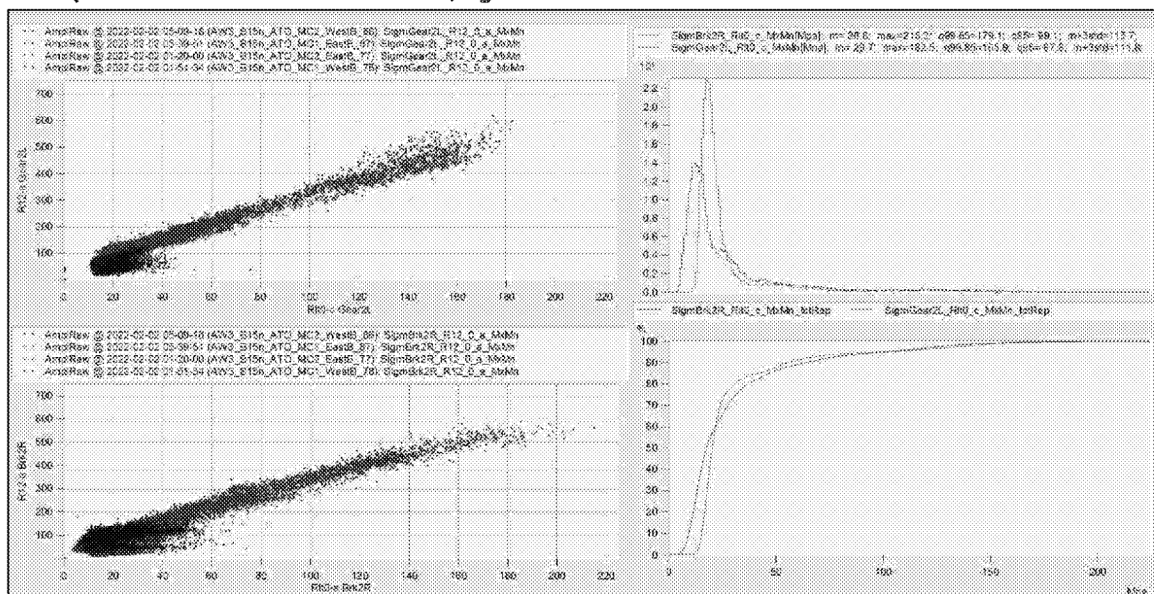
**Figure 13 - Max-min analysis per wheel turn from on track data**

The tangential stress record identified as "RltO:c" is directly correlated to "R12:a" input, and also sensitive to Y & Q efforts and vibration excitations, Figure 13.

The correlation between "R12:a" and "RltO:c" is shown by Max-Min analysis per wheel turn, at Figure 13. The graphics showed a 0.3 ratio between "RltO:c Mx-Mn" and "R12:a Mx-mn".

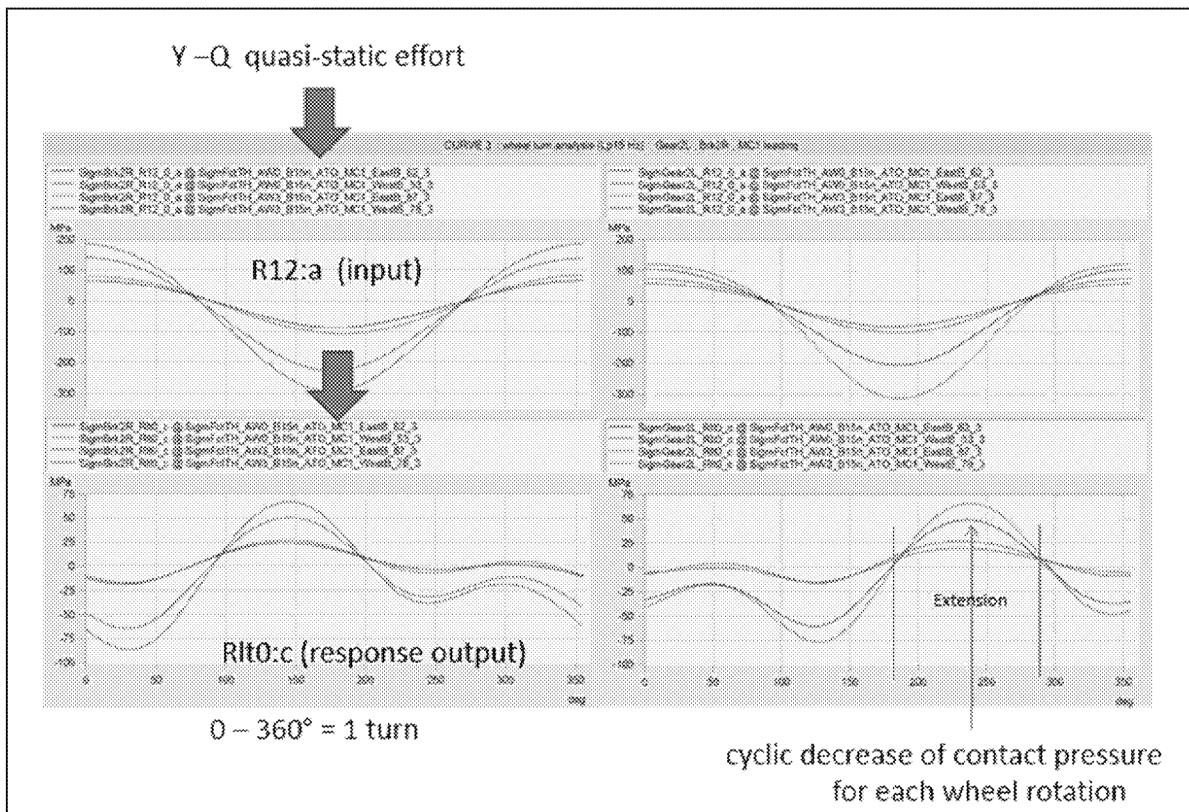
**Figure 14 – Cyclic stress level evolution from on track data**

The evolution of "Rlt0:c" stress during wheel rotation confirms a cyclic reduction of the contact pressure under the small bearing, that can lead to fretting phenomenon and waving movement of the bearing. This was already a specific behavior detected in the raw finite element analysis performed prior to the test.

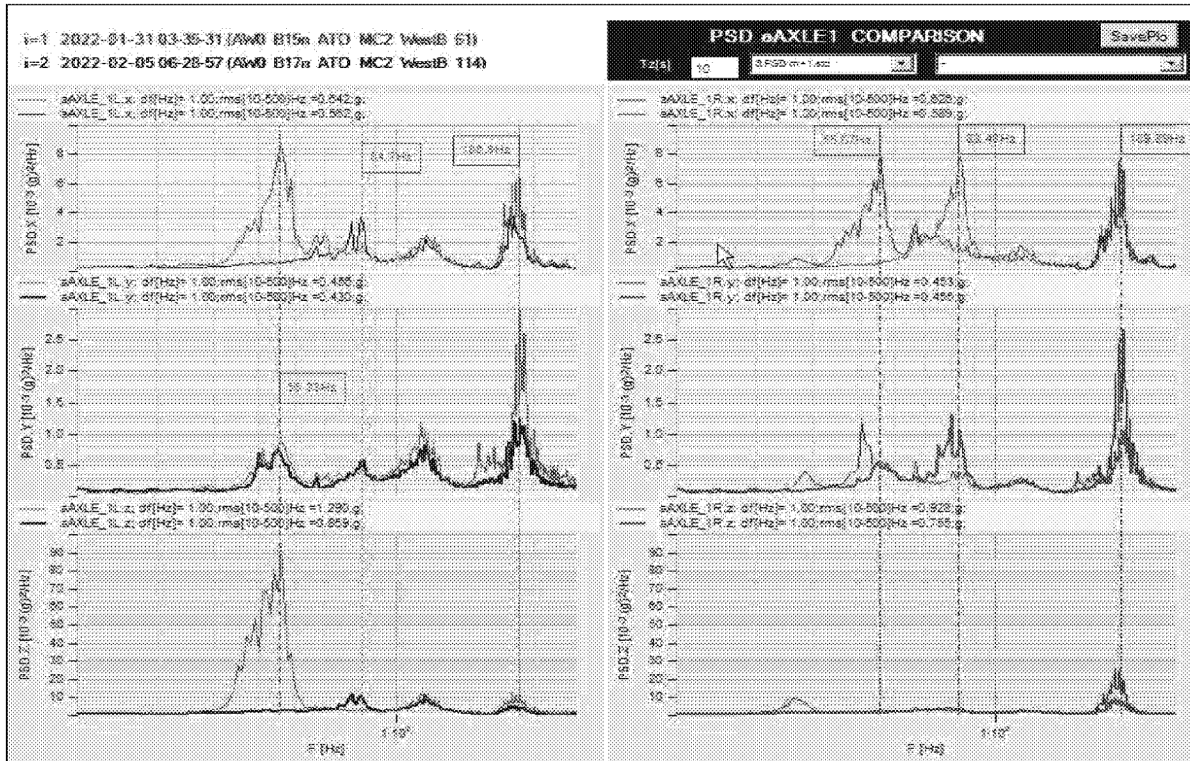
**Figure 17 - Comparison between B15 and B17 measurement**

PSD comparison (Figure 17) of leading axle boxes acceleration showed that enlarged track clearance with B17 profile, compared to B15 profile, leads to less coupling in X-Z direction with Y solicitation in curve on disk brake side (55 Hz).

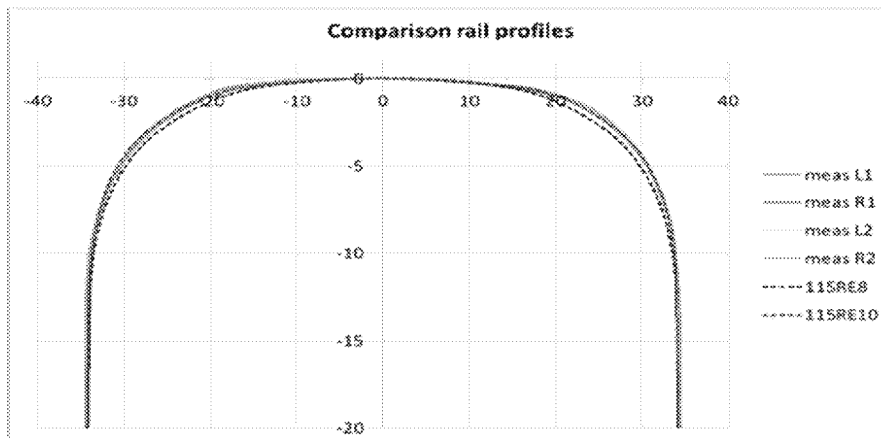
- As part of the investigation into the yard derailment of TS16, the question of the rail profile being a contributor to the derailment was raised. At that time, using the Calipri™ tool to measure a new section of rail, it was found that the rail cross section did not match the specified 115RE 8 inch crown rail. The profile comparison is shown below

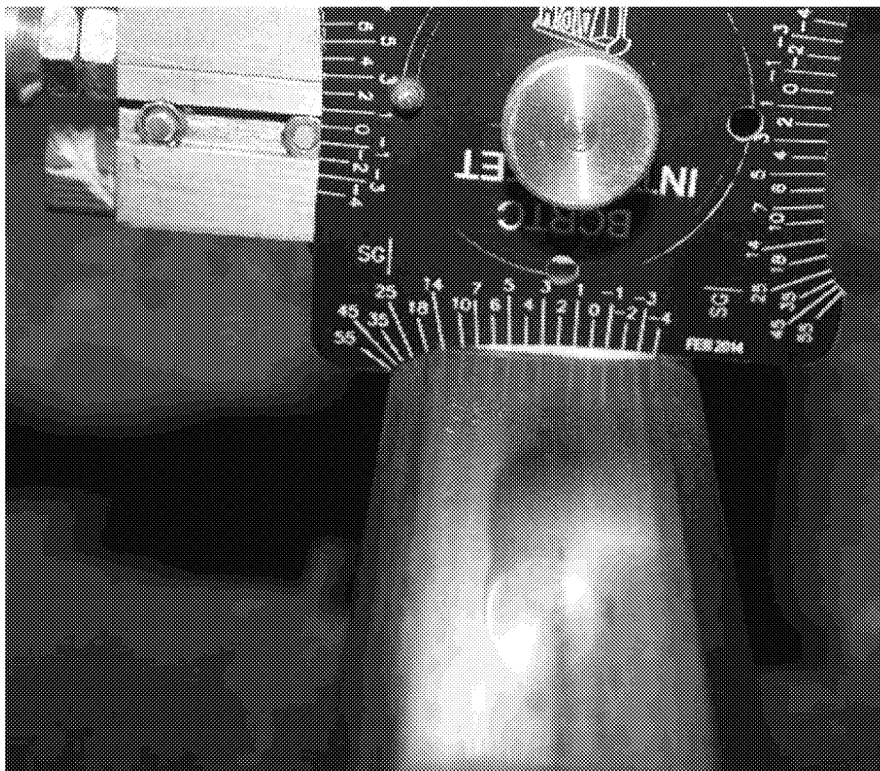
- In addition, as part of the re-machining process for the rails, an initial survey was conducted by the subcontractor, The profile is shown below

The reported conclusion was that this profile could not have occurred naturally, but the subcontractor did not have sufficient history of the track to explain the condition. It is known that prior to the start of service there was a surface grinding operation to remove surface corrugation, prior to the start of revenue service.

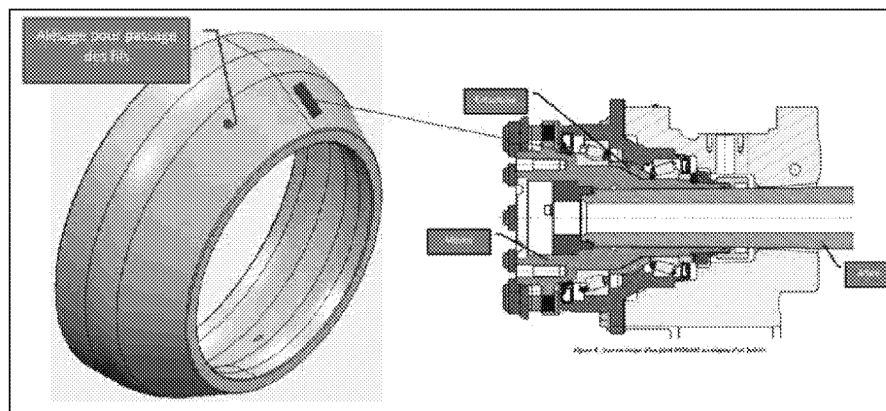
**Figure 19 - Instrumented bearing spacer**

The bearing spacer was instrumented with strain gauges, Figure 19. On track data, the log did not show sensibility to forces in curve but showed brutal loss of signal from spacer after 70km test run. This would suggest part movement in the assembly. The phenomenon needs to be confirmed by the teardown on the test parts.

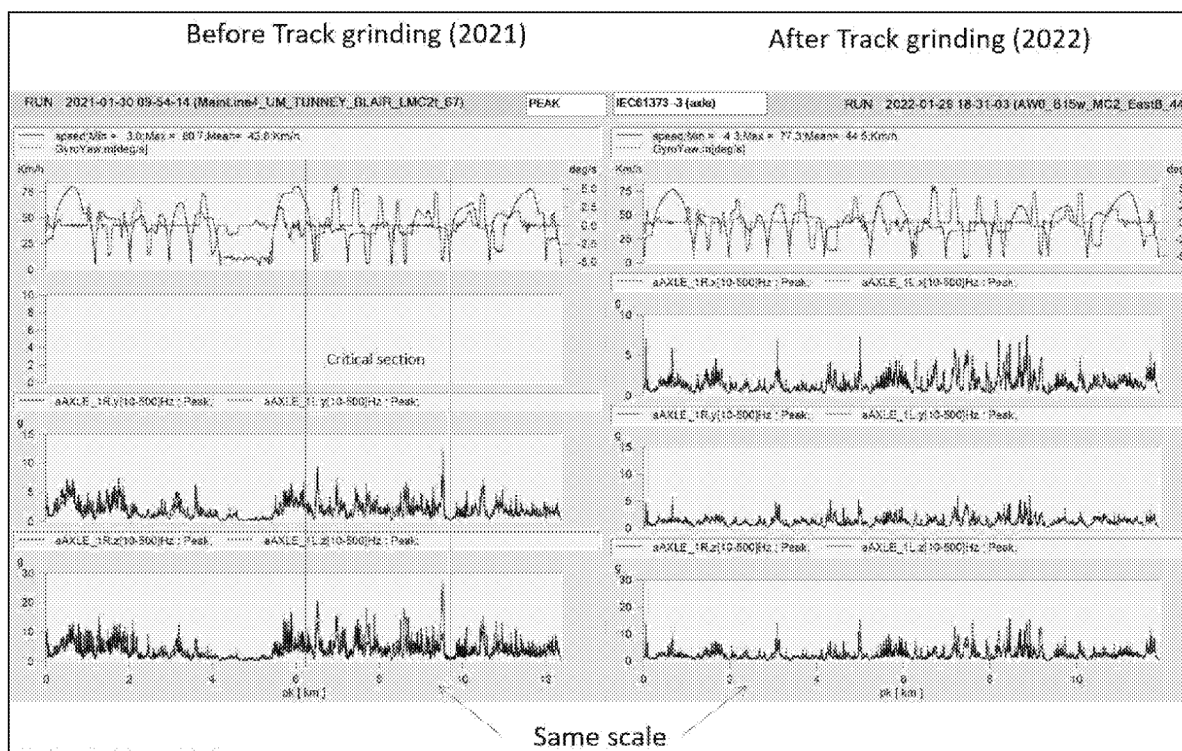
**Figure 20 - Comparison of 2021 VS 2022 Peak acceleration level on axle box**

Measurements taken after track grinding show peak axle box accelerations (calculated on 10m window, within [10-500] Hz) were reduced by a factor 2 in curves: in vertical **and also in lateral direction** compared to the same measurements before grinding.

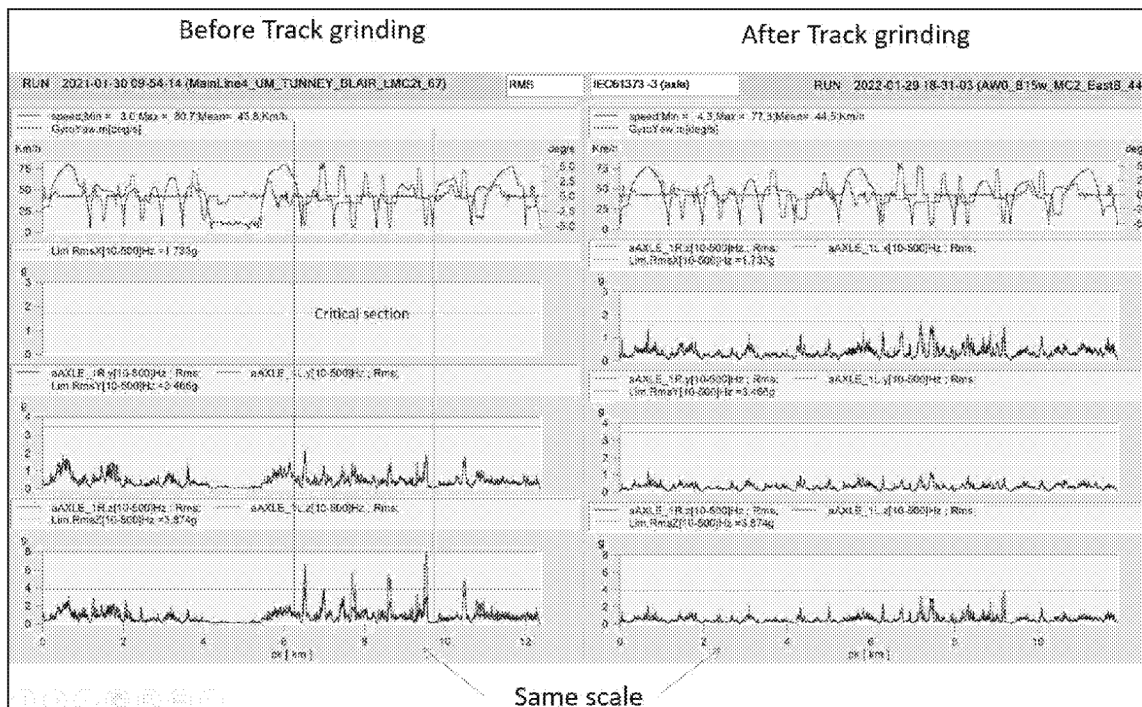
**Figure 21 - Comparison 2021 VS 2022 RMS acceleration level on axle box**

The RMS axle box accelerations (calculated on 10m window, [10-500] Hz), clearly demonstrated an excessive level in curve section, and coupling with lateral excitation in 2021, Figure 21.

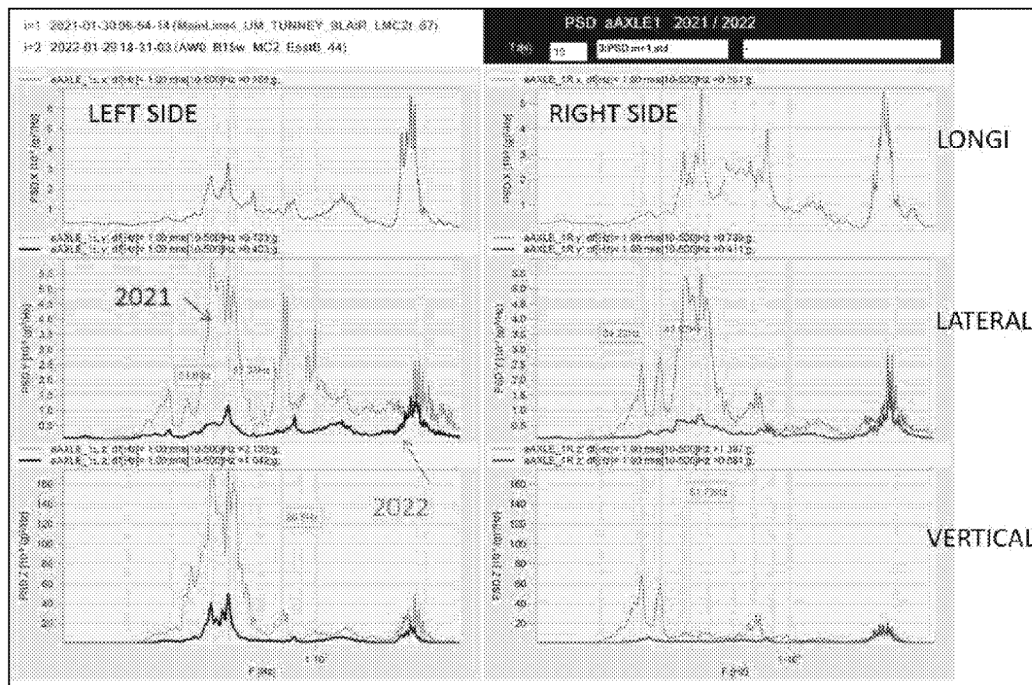
**Figure 22 - Comparison 2021 VS 2022 PSD analysis**

The PSD (Power Spectral Density) axle box accelerations analysis, cumulating a “10 seconds” window along the track and retaining spectrum envelop as a “Mean+1 standard deviation”, points out vertical excitation on 2021 related to top of rail corrugation **but also increased lateral excitation which is sensitive for the bearing of the CBA as demonstrated previously, Figure 22.**

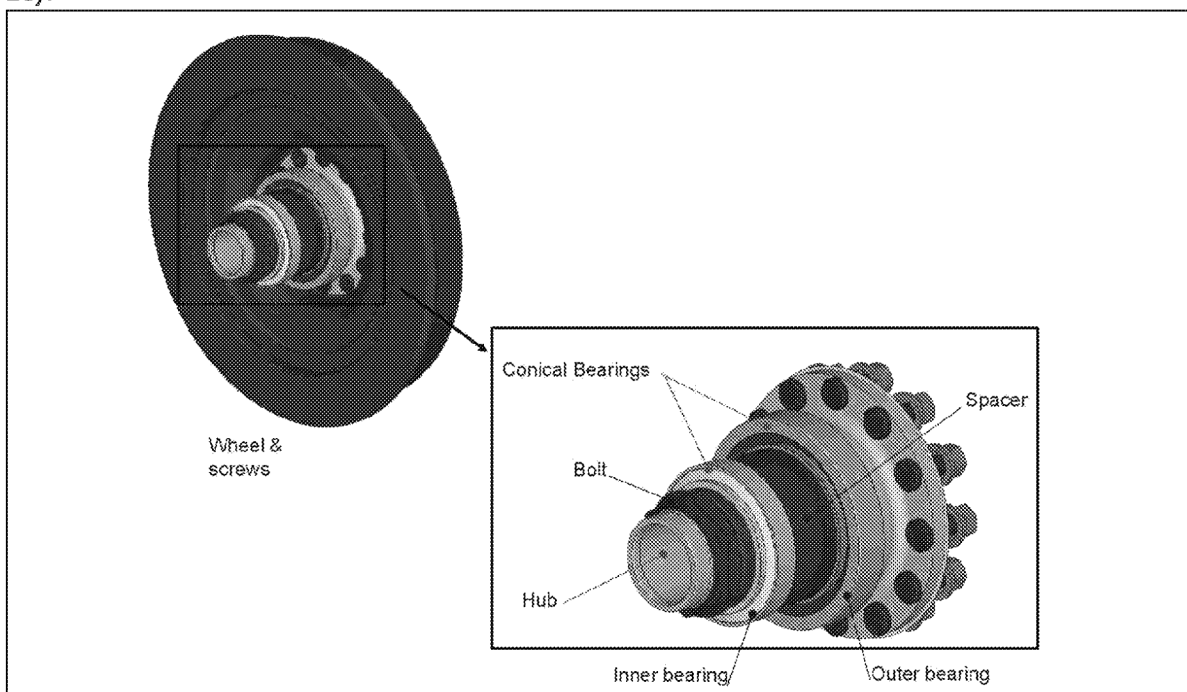
**Figure 24 - Global overview of the FE model**

The following picture (Figure 24) presents two visualizations of the complete model, in the isometric point of view and along a cut section. A detailed view of the mesh is also presented in the cut section (Figure 25).

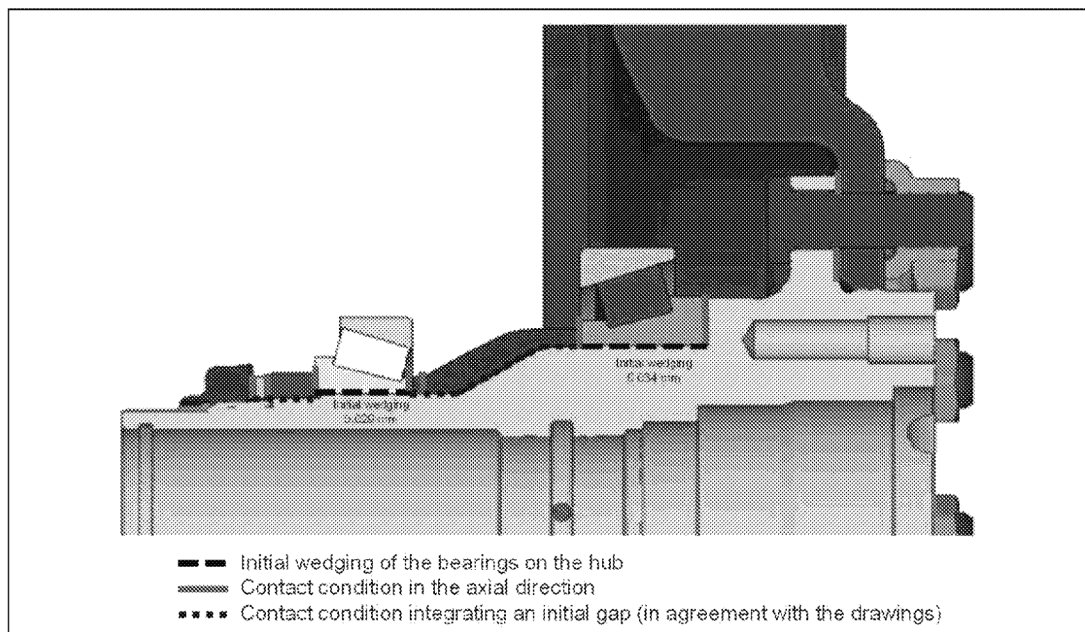
**Figure 26 - Contact conditions applied to the interfaces**

In order to be as representative as possible, all the interfaces between the different components are modelled though contact conditions with friction coefficient, including the initial gaps or wedgings (according to the drawings). The Figure 26 below details the contact conditions.

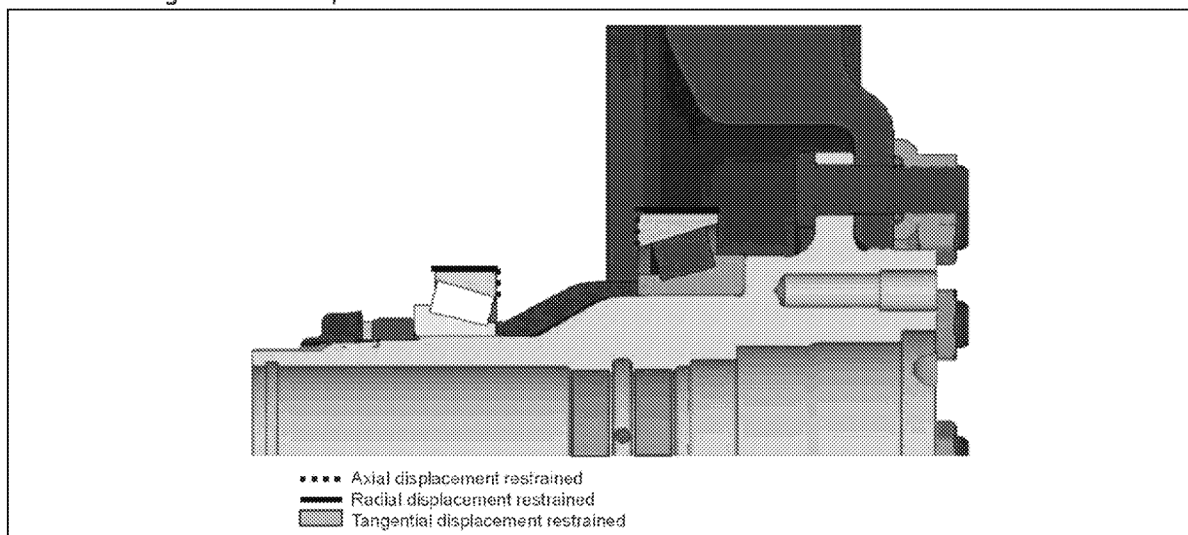
**Figure 27 – Overview of the boundary conditions**

The restraining surfaces are presented below:

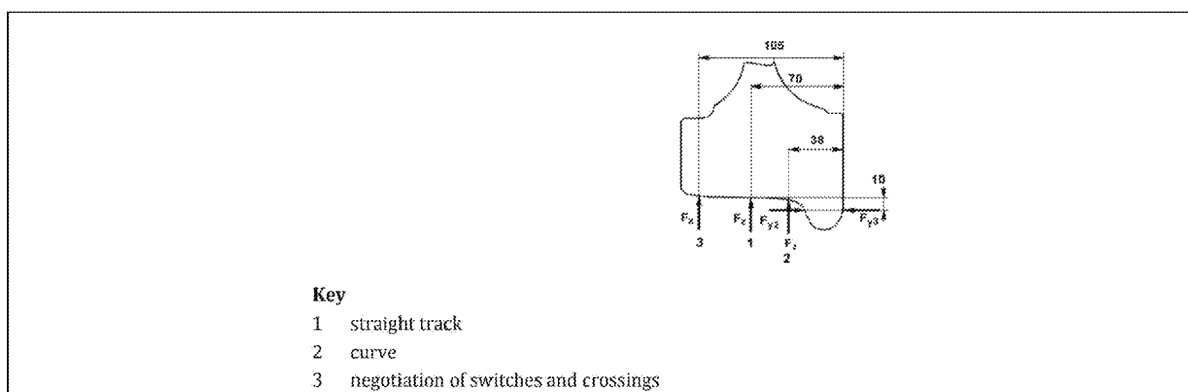
**Figure 28 – Wheel/track load introduction points – Extract from EN 13979-1**

- Transversal and vertical loads (respectively Y and Q) are applied at the wheel/rail contact point, as presented in the below figure. The combination of Y and Q loads are representative of the circulation of a vehicle on the track, either in a curve ( $Q_{curve}$  &  $Y_{curve}$ ), or in a switch ( $Q_{switch}$  &  $Y_{switch}$ ). The position of the points where the curve and switch loadings are applied is defined according to the recommendations of the EN13979-1[P2] (see Figure 28).
- The influence of the inertia of the gearbox is also investigated (loads  $I_y$  and  $I_z$  are applied at the center of gravity of the gearbox) (see Figure 29)

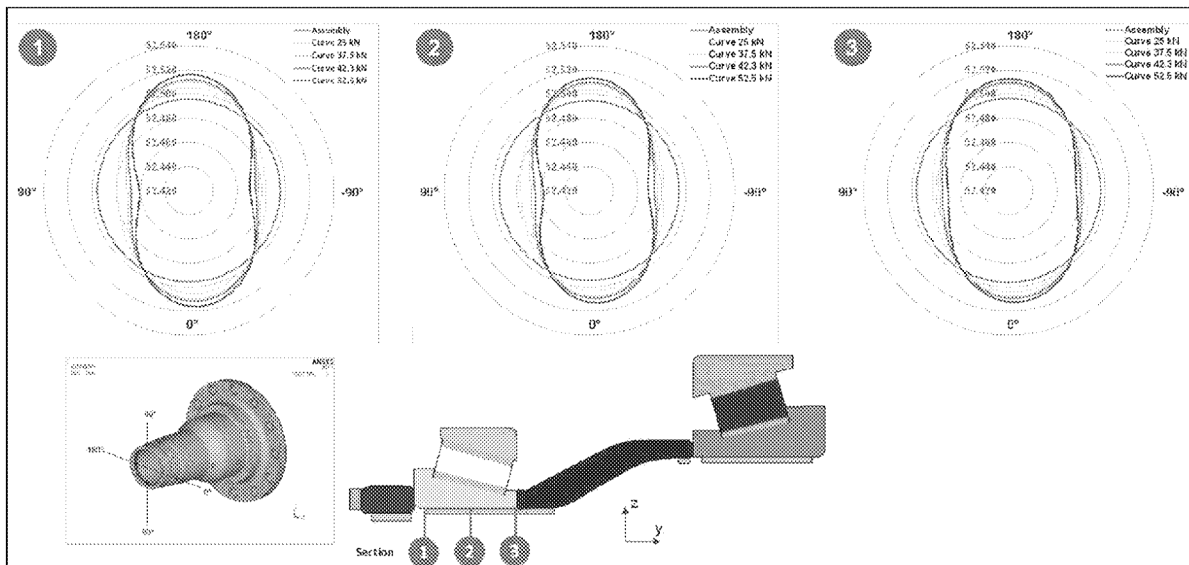
**Figure 33 – Curve load case – Visualisation of the deformed shape under the small bearing**

In addition to the analysis of the contact details (status, pressure), it is also interesting to get an overview of the deformed shape of different sections of the hub (under the inner ring of the small bearing). In order to facilitate the comparisons and the analysis of the deformed sections, the center of the deformed shape is shifted back to zero. The figure below (Figure 33) shows that the hub becomes oval when the curve load (mainly Y effort) is applied.

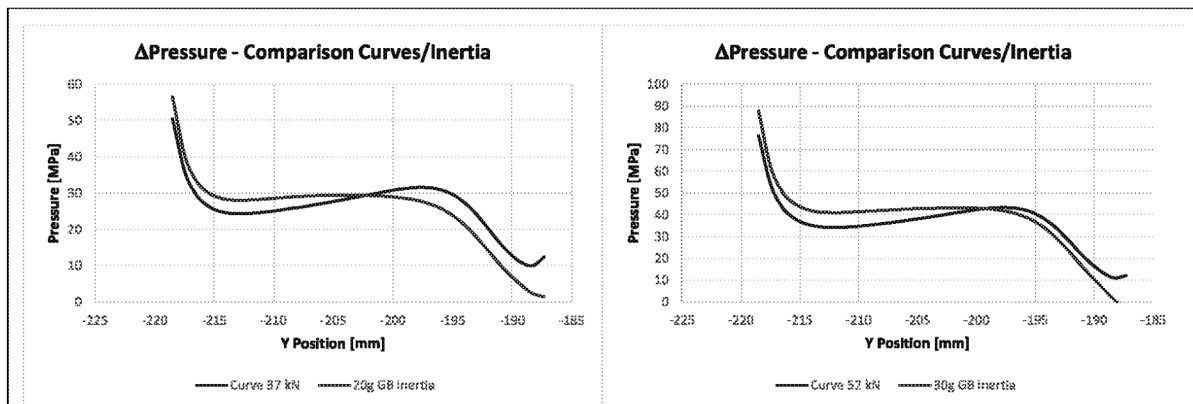
**Figure 36 – Comparison of the variation of contact pressure for Curves and Gearbox Inertia**

The increase of contact pressure is consistent across both load cases (see Figure 36).

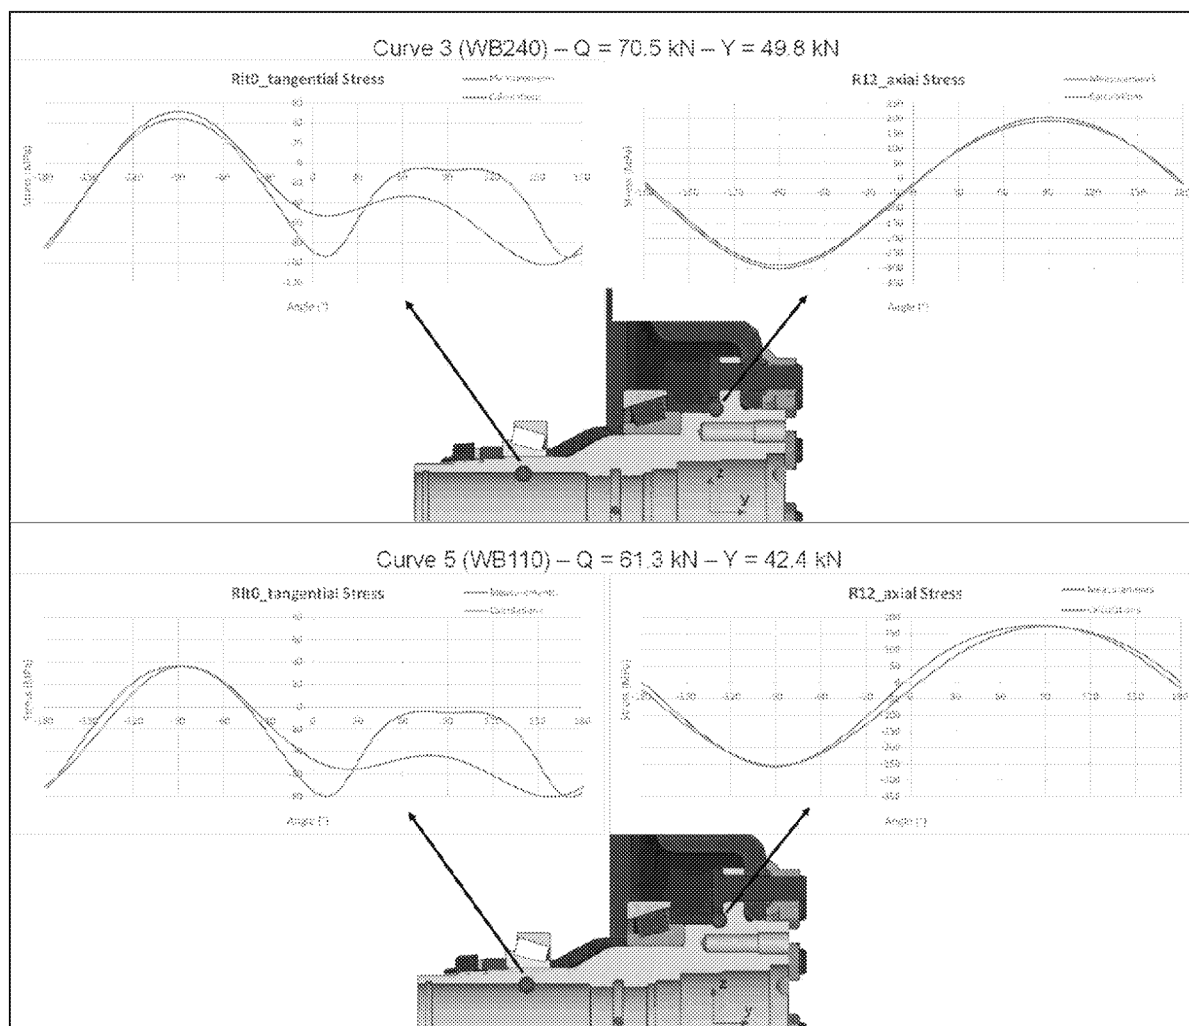
**Figure 39 – Measurements / Calculations – Stresses for R12 & Rit0 locations for Curves 3 & 5**

As explained in paragraph 3.1.3, vertical and transversal loads computed by Multi-Bodies Simulations are applied in the FE model for computing the stresses in both "R12" and "Rit0" locations. The graphs that are presented below (Figure 39) depict the evolution of the stresses for these two locations over one single wheel turn.

Given these first results, the FEM model is judged representative of what is measured on real hubs for quasi-static conditions.
