CITADIS SPIRIT
Type Test Report

TS10 - Climate Comfort

TS24 - Climatic Conditions

This document reports on Alstom Transportation, Inc. climate comfort and climatic conditions testing of the Citadis Spirit 404 Light Rail Vehicle (LRV).

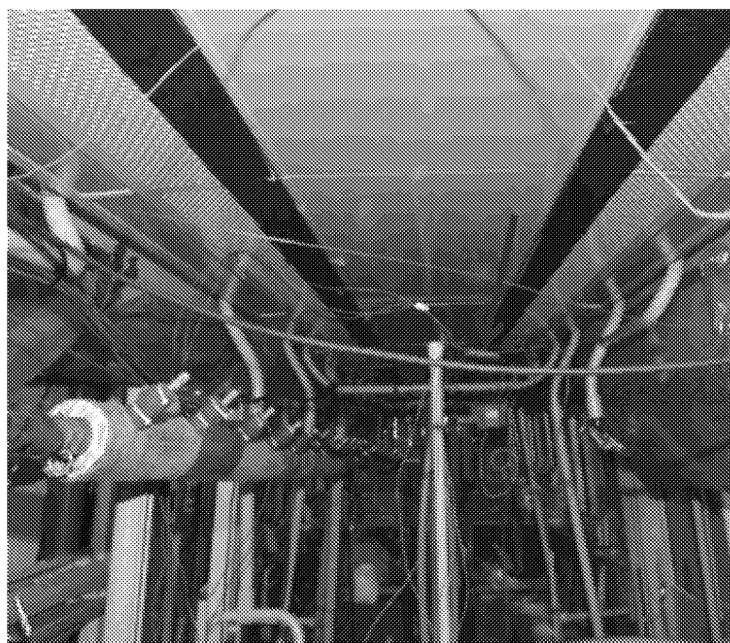
It should also be noted that the thermocouples have an appreciable mass, as indicated below in the photo by the red arrow. This explains the slow response time.

Figure 3 Photo of thermocouple setup

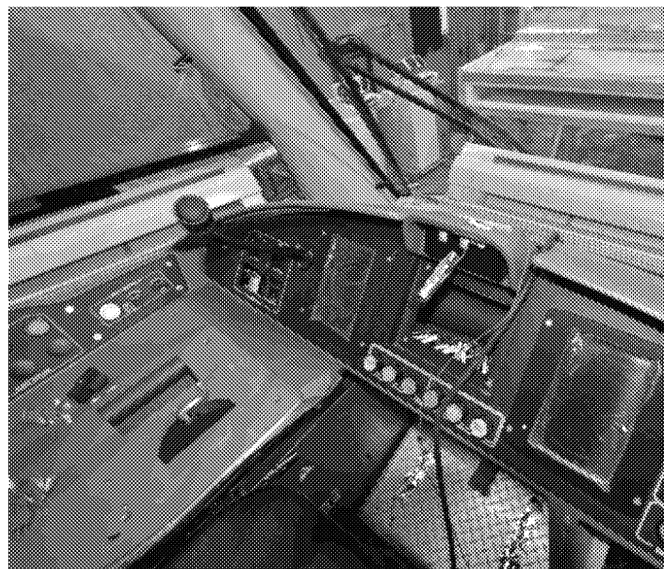
Figure 2 - Cabin Thermocouples and Loads Simulation

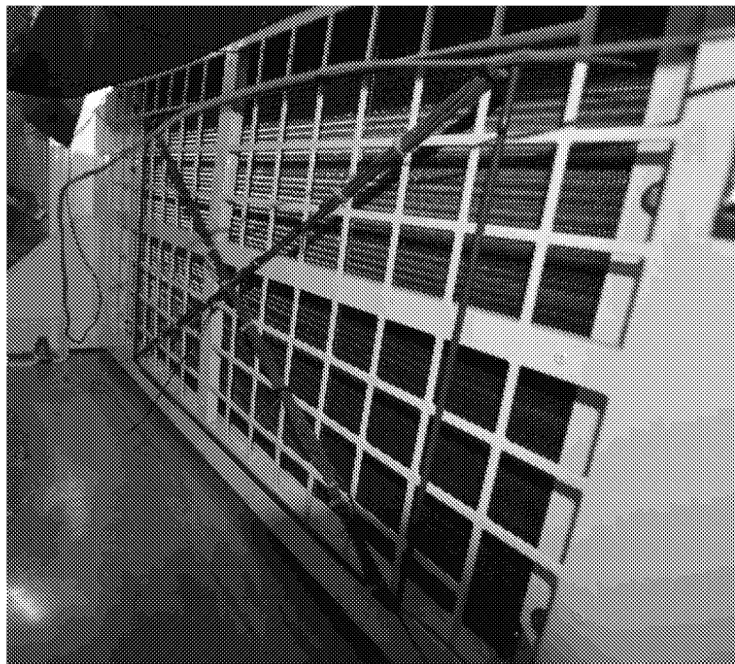
Figure 6 - Thermocouple Grid, HVAC Condenser Inlet

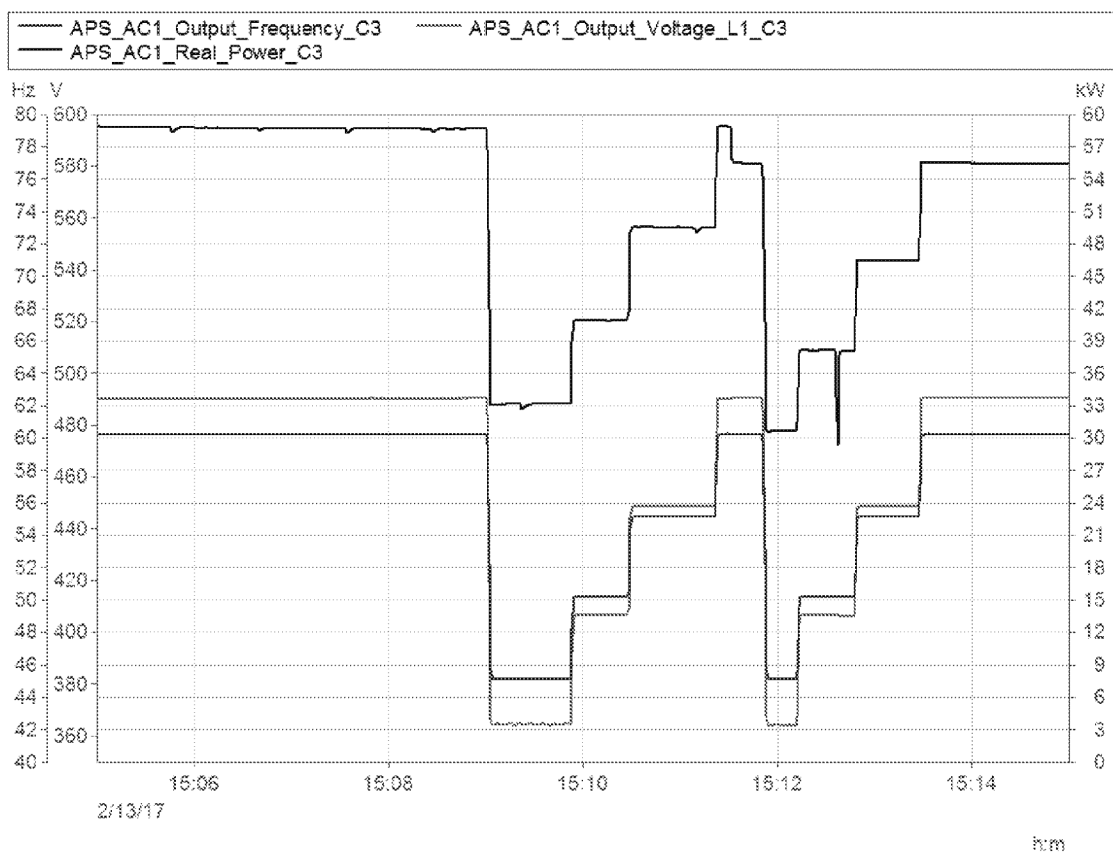
To demonstrate HVAC functionality, during each test the HVAC was cycled through its eight modes (four each in partial and full mode). The step changes in frequency, voltage and power as shown in Figure 12 show the full mode activations followed by partial mode activations at 45/50/55/60Hz.

Figure 12 - Test 4, HVAC Functionality @ 45/50/55/60Hz Full and Partial Modes

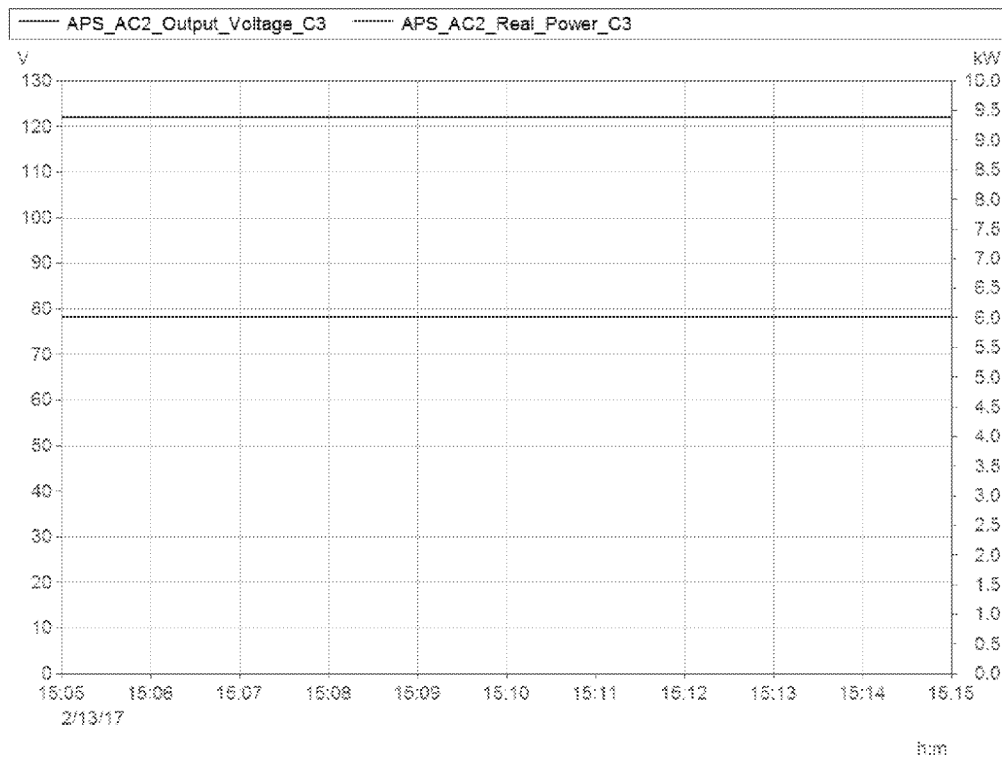
To demonstrate Heated Floor functionality during Tests 7 to 9, it is observed that 6.0kW of power was drawn on the 120V circuit as shown in Figure 13

Figure 13 - Test 4, Heated Floor Functionality

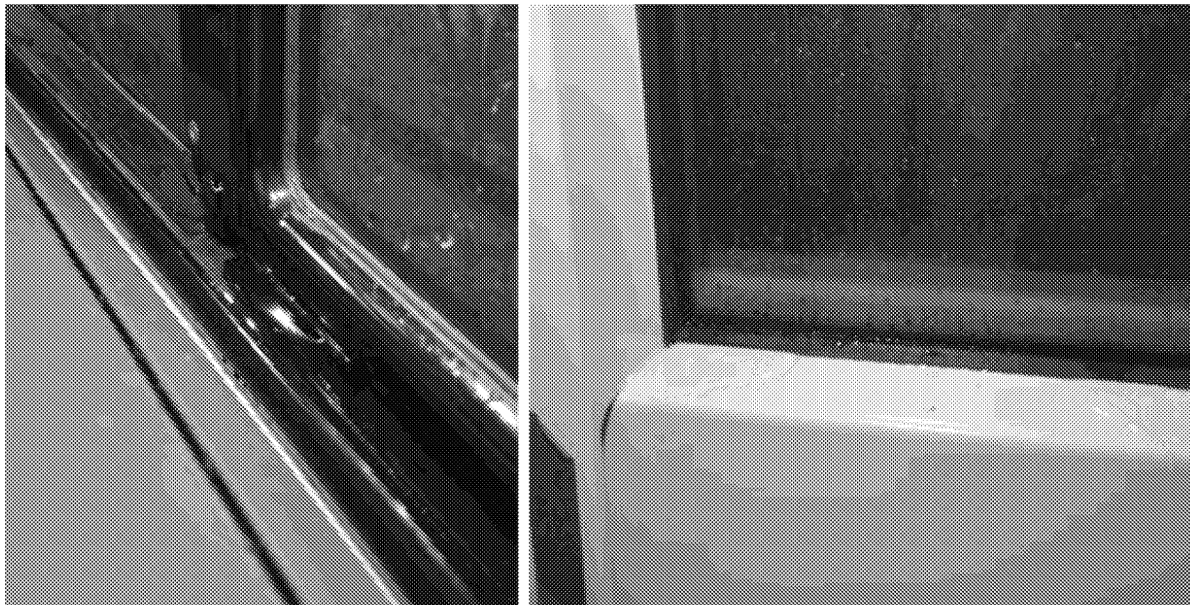
With respect to moisture ingress as shown in Figure 16 and Figure 17, water drops or pooling were observed throughout both the LMC2 and LCC at window and door seals, as well as the gangway promontory bar and the cab sliding doors. Water tightness checks on the external of the cars including the various rooftop electrical and mechanical boxes revealed no water ingress.

Figure 16 - Water Ingress at Cab Sliding Doors and LMC2 Window

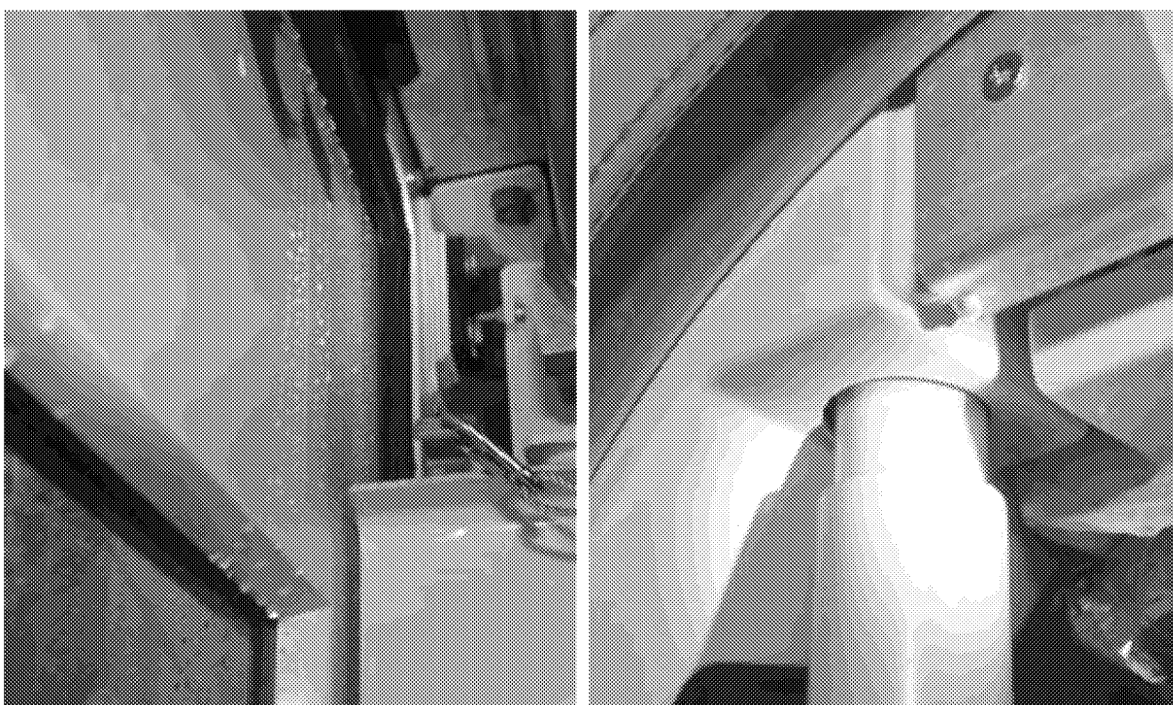
Figure 17 - Water Ingress at LCC Door and Gangway Promontory Bar

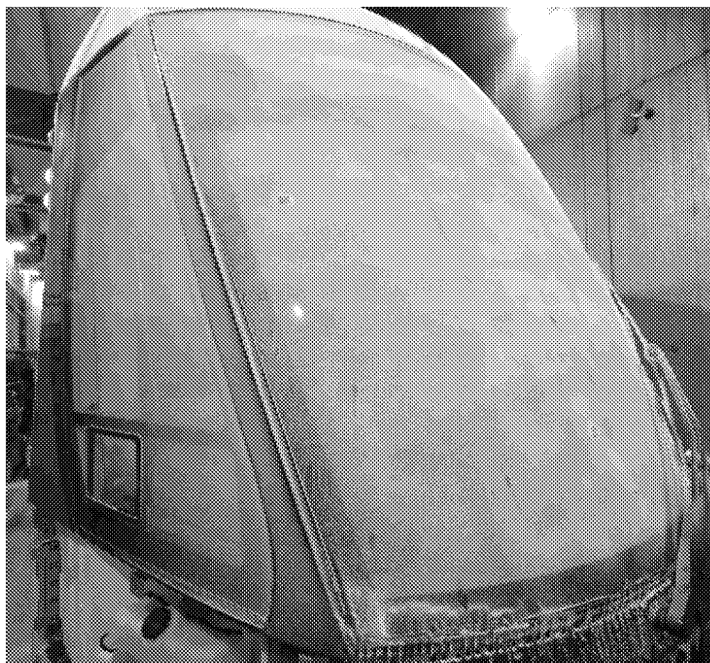
Simultaneously, the external surface of the windshield was frosted using a handheld sprayer as per SAE J381 to spray 0.05mL of water per square centimeter and form an even coating of ice over the entire glass surface as shown in Figure 20.

Figure 20 - Nominal Defrost Test, Windshield Frosted

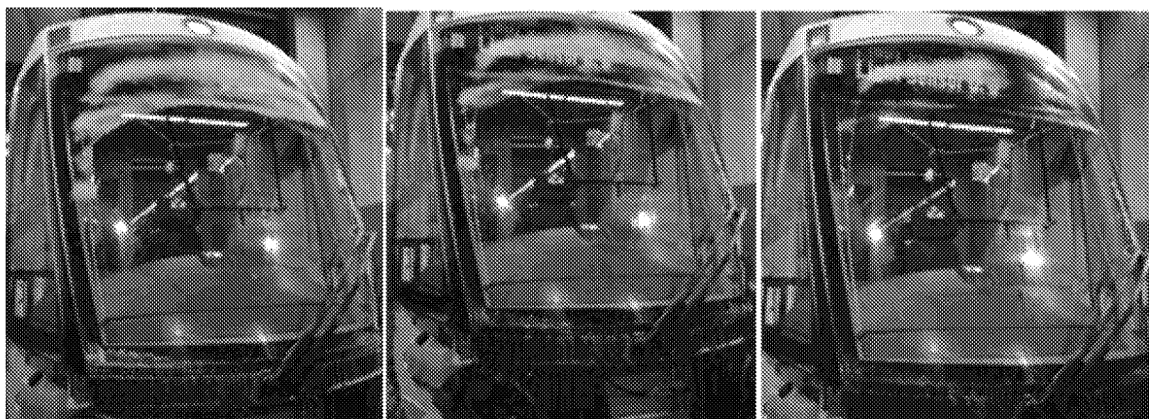
At 10:55, within 40 minutes of completing the windshield frosting, the defrost commenced with the defroster set in nominal mode. The evolution of the defrost is shown in the Figures below, with pictures spaced five minutes apart starting at 25 minutes when visible signs of defrost were evident until the defrost was deemed complete after approximately 68 minutes at 12:03. After approximately 50 minutes a first wipe attempt was made.

Figure 21 - Defrost Nominal Mode, 25/30/35 Minutes

Figure 22 - Defrost Nominal Mode, 40/45/50 Minutes

Figure 23 - Defrost Nominal Mode, 55/60/68 Minutes

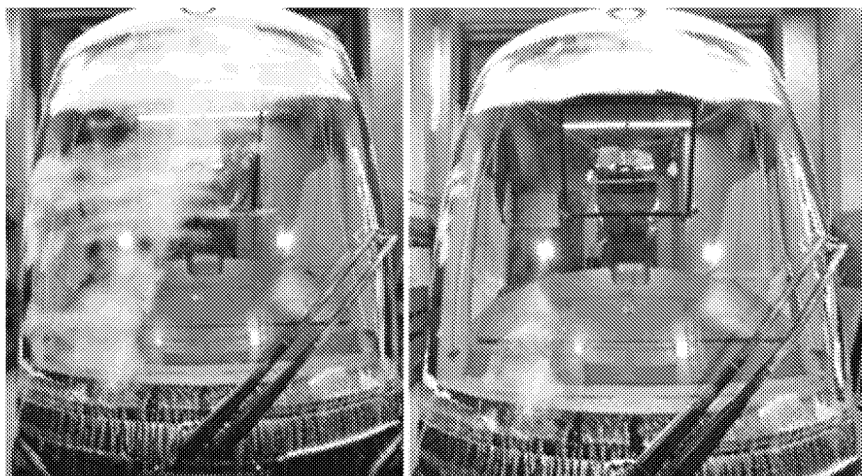
The evolution of the defrost is shown in the Figures below, with pictures starting at 60 minutes and spaced 30 minutes apart until the defrost was deemed complete after approximately 162 minutes at 19:32. After approximately 131 minutes a first wipe attempt was made.

Figure 26 - Defrost Degraded Mode, 60/90/120 Minutes

Figure 27 - Defrost Degraded Mode, 150/180 Minutes

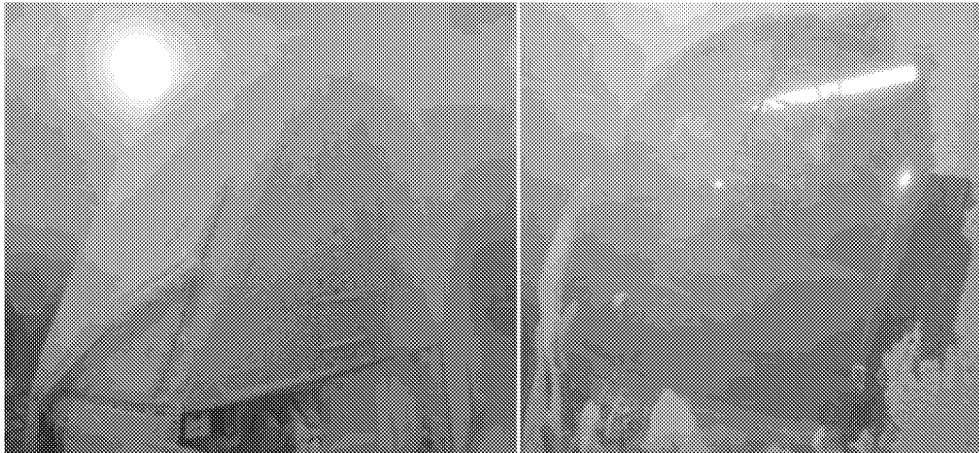
Figure 31 - Windshield Snow Accumulation and Wipe

Subsequently the snow was terminated and the train energized and visually inspected to assess functionality and water tightness. The windshield wipers were activated with approximately 7cm of snow accumulation as shown in Figure 31 for three minutes.

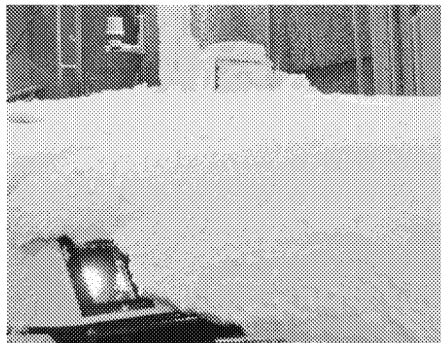
With the Horn packed as shown at the top in Figure 32, it was operated and audible.

Figure 32 - Horn Packed with Snow

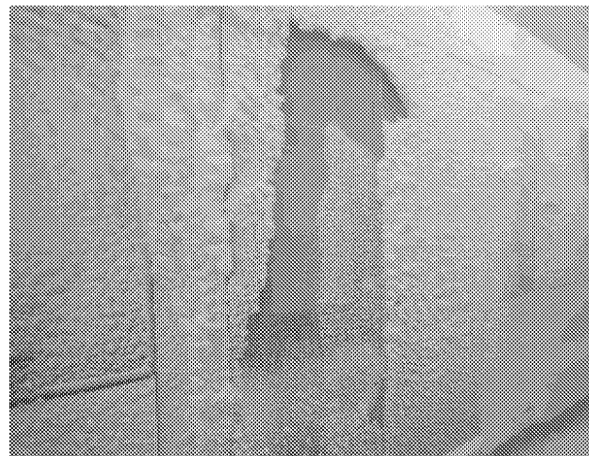
Accumulation of snow on the LMC2 door is shown in Figure 33, subsequent water tightness checks indicated no moisture ingress to the car interior.

Figure 33 - LMC2 Door Snow Accumulation

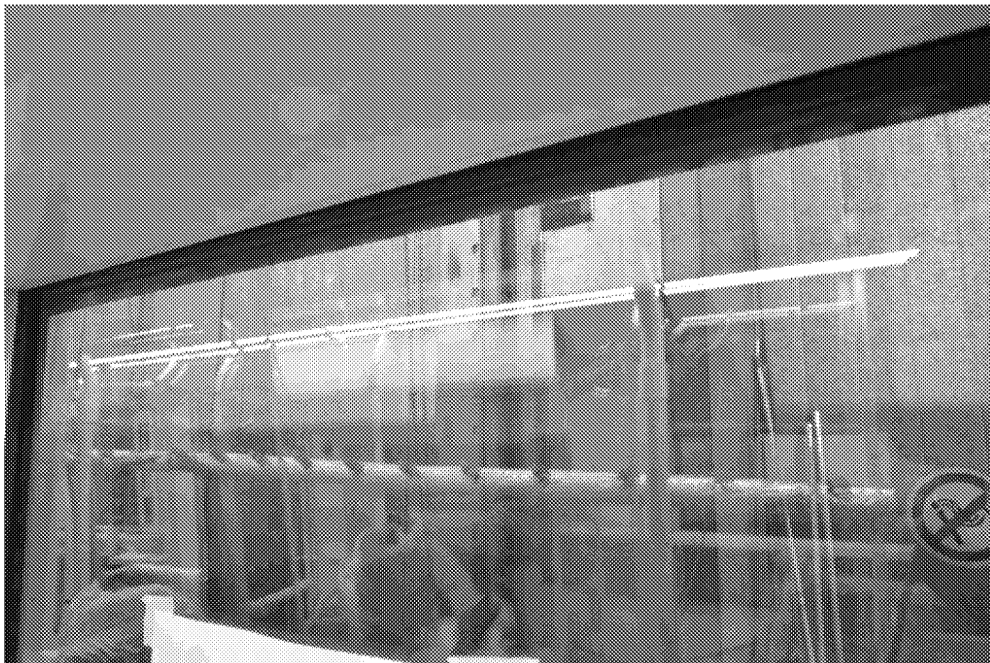
Figure 46 - LMC2 Interior Window

An inspection of the Cabin, LMC2 and LCC rails cars indicated no presence of condensation on any of the interior windows, as shown in Figure 46 as an example.

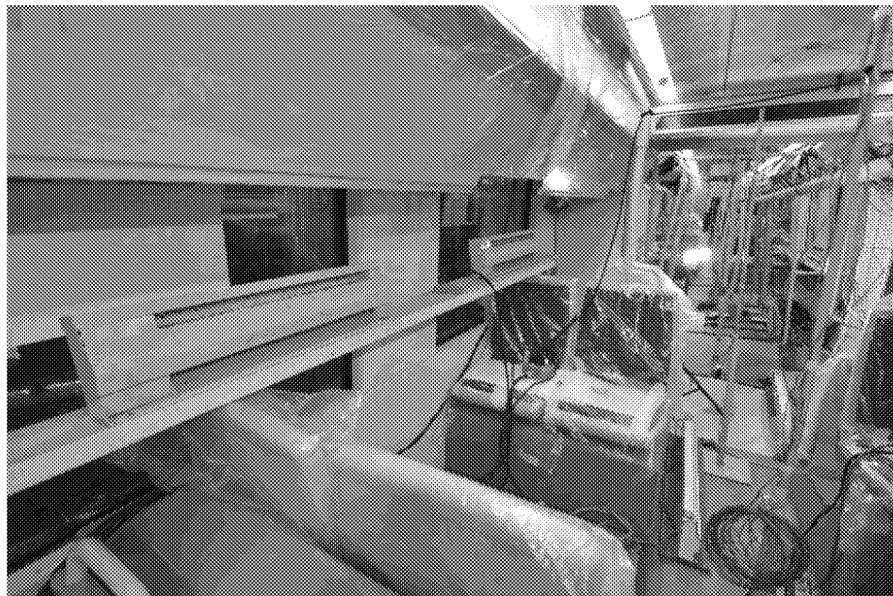
Figure 122 - Resistive Heaters Equally Spaced Throughout LMC2/LCC

Externally powered resistive heaters were installed in the LCC and LMC2 cars (with a combined area of 249.49 m²) as per Figure 122. All fresh air and exhaust air openings were sealed and four fans installed to promote uniform thermal gradients within the rail cars.

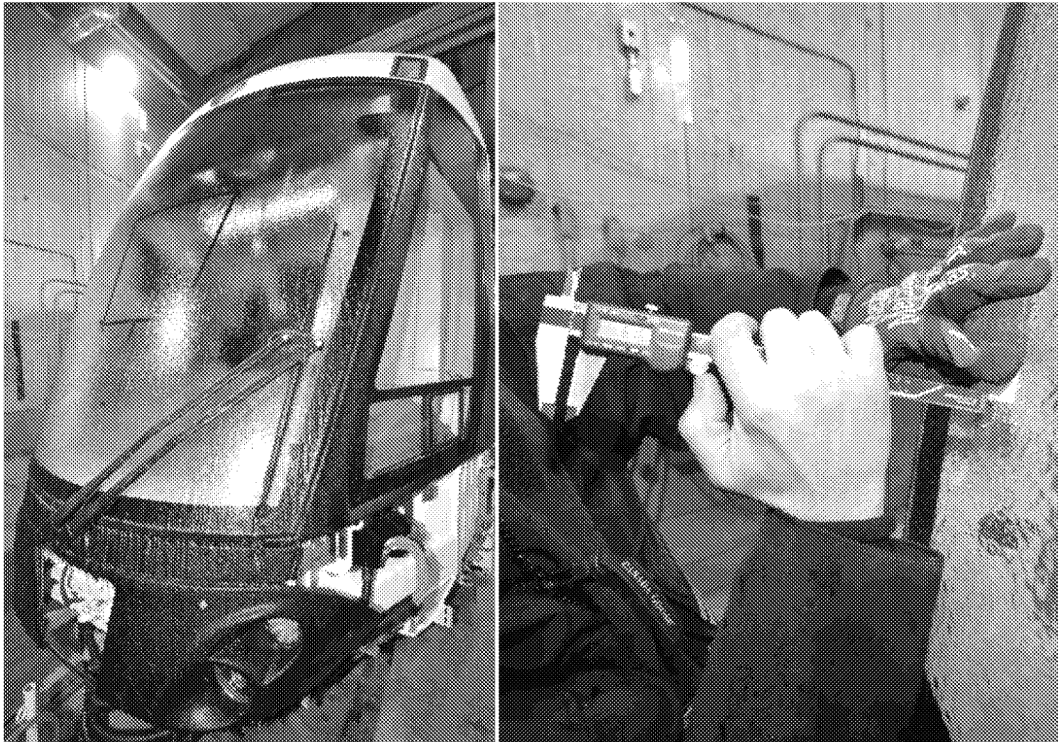
Figure 137 - Ice Accumulation of ~3mm as Measured

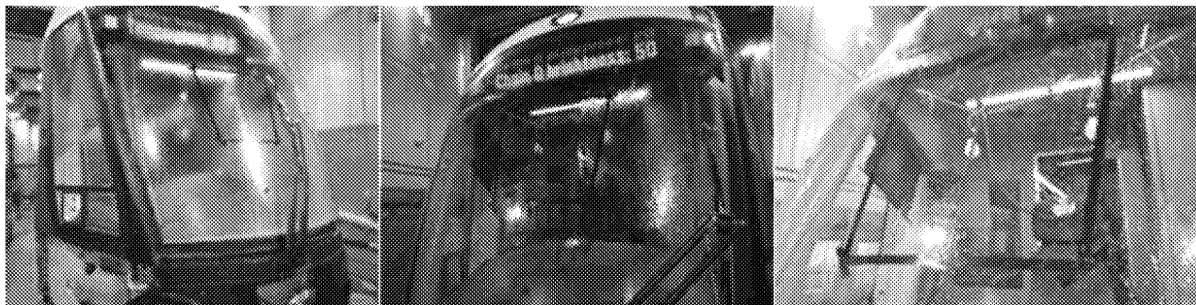
Figure 138 - Wipe at 13:53 / 14:17 After 32 wipes / 14:28

When 45 minutes had elapsed at 13:53, the windshield wiper was activated for two wipes to demonstrate it was not stuck to the windscreen, again at 13:56 for a single wipe, and at 14:10 for two wipes totalling five wipes.

Subsequently at 14:14 the wipers were activated for ten wipes and at 14:28 for 17 wipes. The series of figures below show the evolution of the wiping and defrost.

Assessing the wiper defects with respect to Figure 135, a note of 0 (zero) is assigned based on the fact that the blade was missing portions of the visibility area due to either a frozen blade or ice persisting on the windshield after the 32 wipes.
