- 1. Spline wear problem overview
- 2. V5 fleet status
- 3. T20 axle solution
- 4. Ottawa retrofit planification

Spline wear problem overview

Spline wear problem overview Safety Analysis

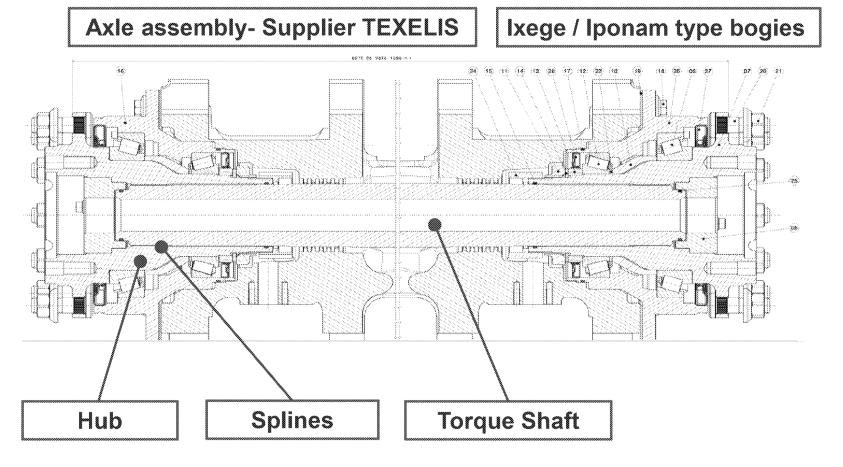
Wear of the splines leading to excessive play between the hubs and the torque shaft and ultimately failure of the splines and loss of drive between the two wheels.

2 axle assemblies/ bogie

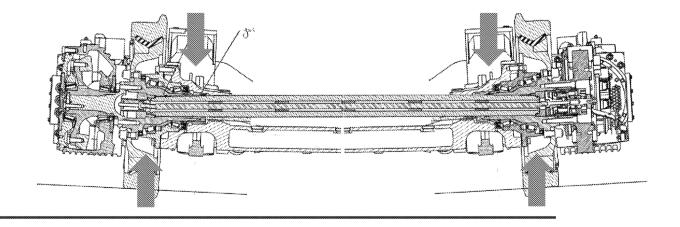
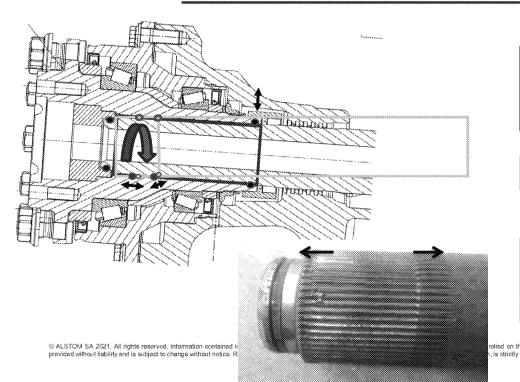
Spline wear problem overview Root cause explanation

Assembly → play in spline connection

Vertical load → axle beam bending

At 0 torque → Straight shaft + △ angle max

Torsional torque + Shaft rigidity

Partial realignment between shaft and hub

Δ angle

+ in-uniforme stress distribution in soline

Contact pressure + Sliding

Power dissipation in spline
Wear
rease migration to extremities (gumning ex

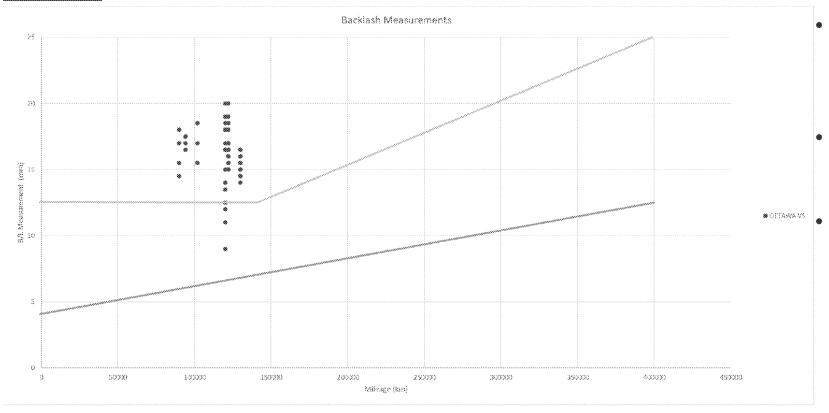
Ottawa V5 fleet status V5 spline wear follow-up

- Data gathered from 7
 LRV with high mileage
 so far
- B/L measurement at reflecting spline wear
- 25mm as replacing criteria (within 40kkm)
 - Alert zone
 - Comfort zone

Alerting V5 fleet performance

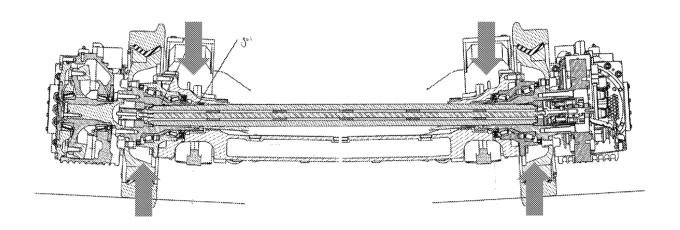
- Texelis T20 axle implemented on Toronto project
- 1 change in machining process in order to re-align hub / shaft spline connection

- Rotating angle calculation based on weighted average of IPONAM bogie axle loads and considering geometrical constraints for assembly operation. Rotating angle defined as **1.85mrd** (0.106°)
- Identical Back-to-Back measurement by adjusting mounting shims

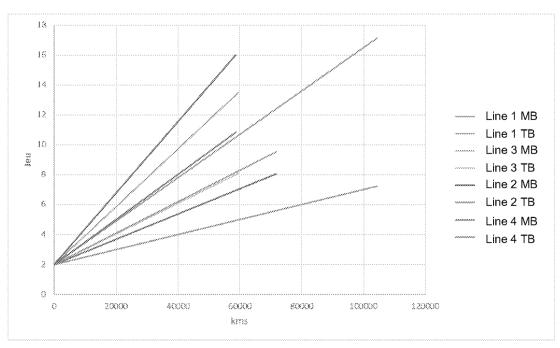
T20 axle solution Simulation Results

- Simpack simulation model
- Good correlation simulation results VS fleet evolution.

Wear	P Diss	
track	mm/km	kW*hr/100kkm	
Line 1 TB	5.02E-05	9.7	
Line 2 MB	8.43E-05	12.8	
Line 3 TB	1.02E-04	16.6	
Line 2 TB	1.05E-04	11.8	
Line 1 MB	1.45E-04	12.7	
Line 4 TB	1.50E-04	17.4	
Line 3 MB	1.93E-04	20.5	
Line 4 MB	2.38E-04	19.7

kW*hr / 100kkms	Gain car.
T20 Mean value	1.9	ref
V5 Mean value AW0	9.6	5.2
V5 Mean value AW3	13.8	7.5
