## OTTAWA LIGHT RAIL TRANSIT

### Track Assurance Report 1 – Tunney's Pasture to Tunnel Portal West

<b>Document Ref:</b> OLR-22-0-0000-REP-0001		<b>Document Title:</b> Track Assurance Report 1 – Tunney's Pasture to Tunnel portal west

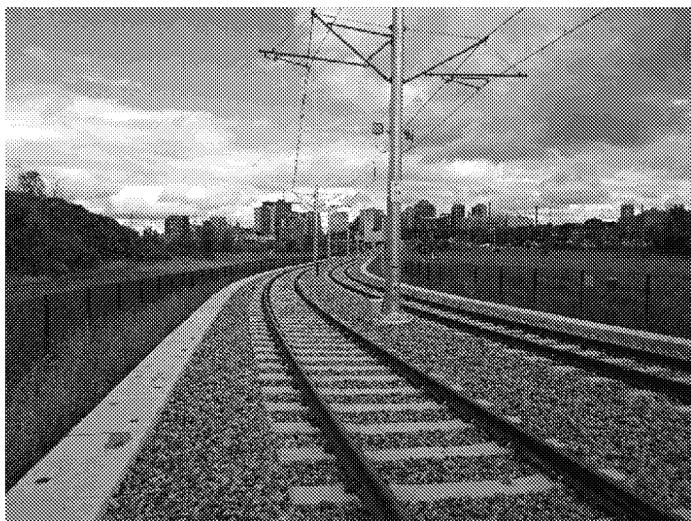
The track centres are in tolerance to design [Ref.06 to Ref.15]. Sample checking during the inspection has not identified any concerns.

Photo no.1 (left): West bound track, looking facing traffic, from Bay View towards Pimisi

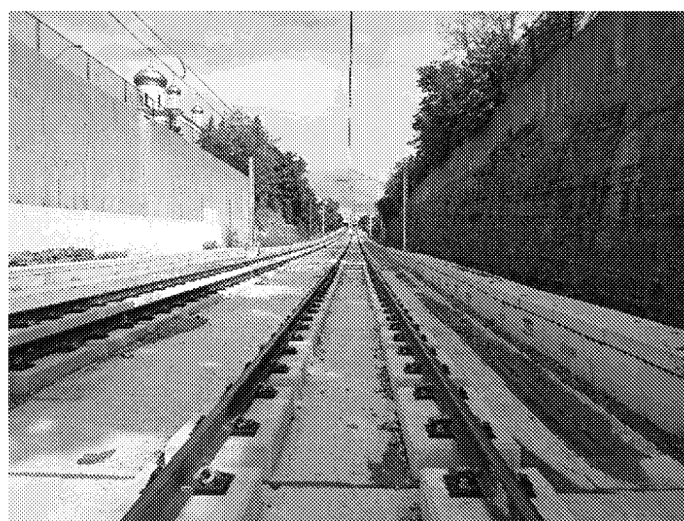
Photo no. 2 (right): East bound track, looking with traffic, at the end of the plinth system (98km 752m) towards Bay View.

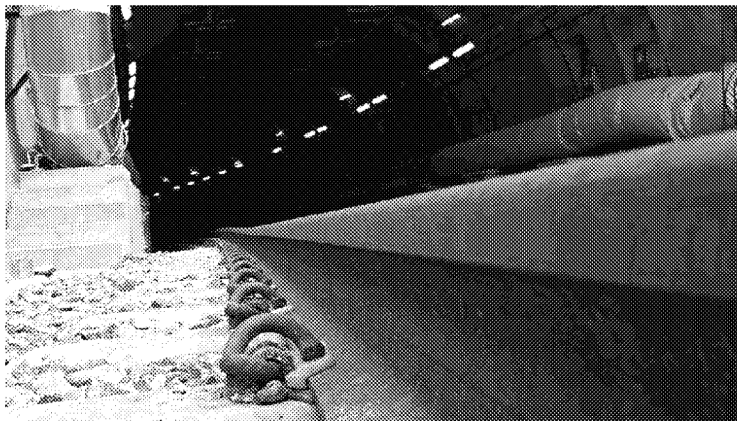
The alignment across ballast to slab and slab to ballast transitions are robust, except for the westbound exit from the main tunnel. This exhibits loss of design on both rails of approximately 5mm, as seen in photos 3 and 4 below:

Photo no. 3 (top): westbound low rail looking towards the tunnel mouth at 100km 408m

The assessor recommends that remedial action is taken to reinstate the design prior to the opening to passenger operations. All other ballast/slab transitions are robust, and do not present any ride quality concerns.

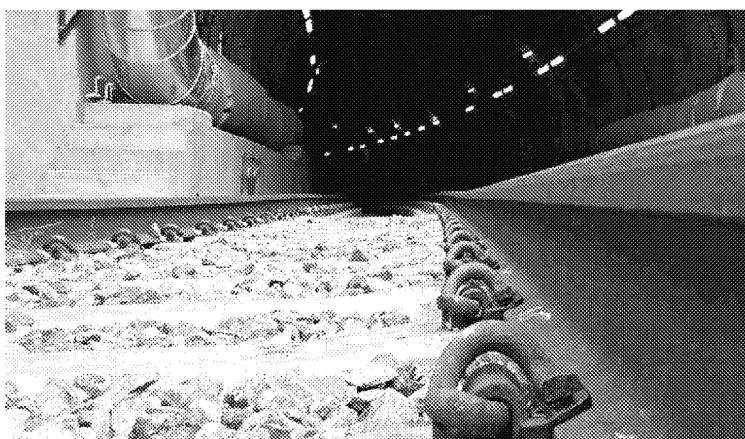
Photo no. 4 (bottom): westbound high rail looking towards the tunnel mouth at 100km 408m

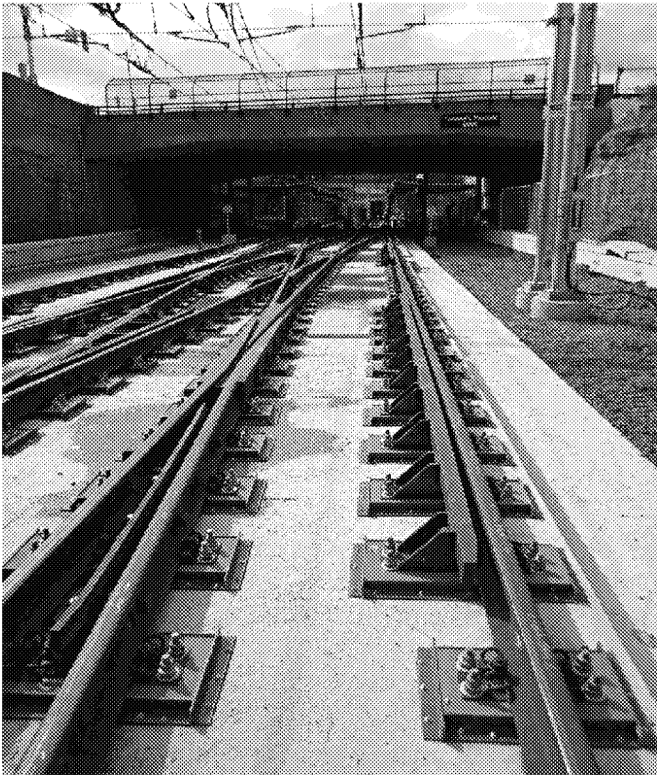
All check rails, restraint blocks and drive mechanisms are installed.

Photo no. 5: West bound towards Tunney's Pasture station, taken from centre of 304 points towards 301 points.

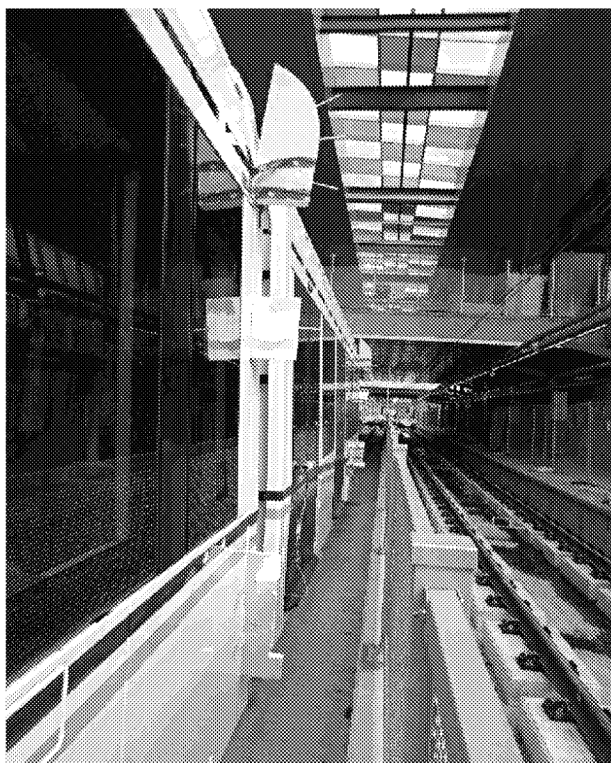
During the site inspection, the assessor undertook random sampling of structural, passing and platform clearances. In addition, a modified tram was observed in Tunney's Pasture, that has been fitted with temporary polystyrene blocks to mimic the dynamic clearance. This approach to validate actual clearance is supported.

Photo no.6 (left): Citadis Tram with polystyrene blocks to mimic minimum clearances

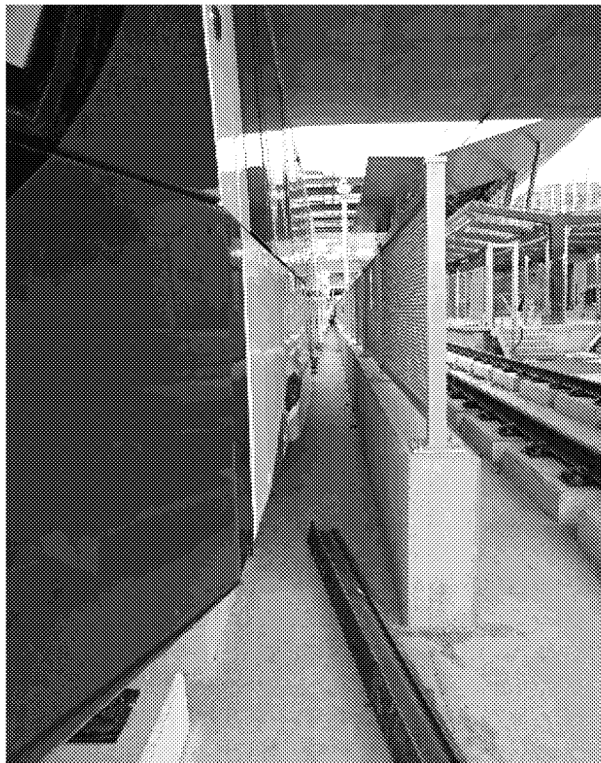
Photo no. 7 (right): typical clearance to obstacles installed in the track centre area.

The assessor recommends that datum plates are established on all structures and OCS masts to capture the design clearance values, to aid future monitoring on clearance values.

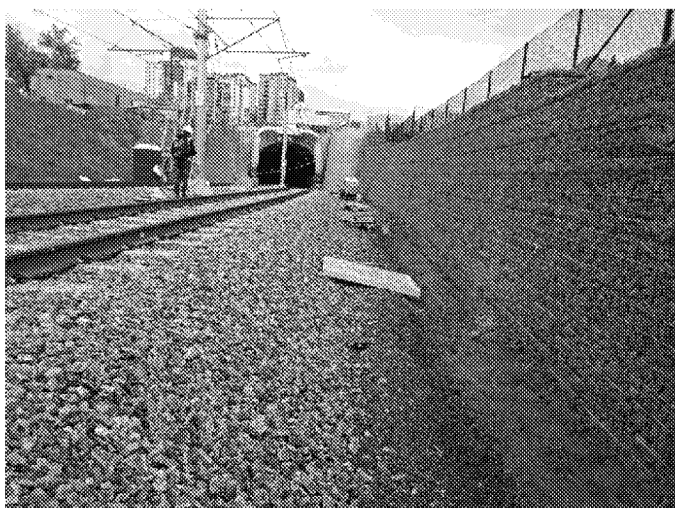
Localised loss of ballast shoulder on the east bound line between Pimisi station and the tunnel portal. This is primarily due the area being used by other OLRT contractors to store materials and plant, which has caused the migration of the ballast away from the sleeper (tie) ends. (see photo no. 8);

Photo no. 8 (left): loss of ballast shoulder approaching main tunnel from Pimisi station. Note the storing of materials and plant at this location.

The assessor recommends that the ballast shoulder deficiency is corrected prior to the start of passenger operations and the contaminated ballast removed within 3 months of the start of passenger operations.

5.6.2	Ballast shoulder profile not compliant	Prior to opening to passenger operations	Either manually reprofile or add extra ballast with Hi-rail.
5.6.2	Ballast contaminated on east bound line 100km 410m	Within 3 months of opening to passenger operation	Manually dig out contaminated material and replace with new ballast

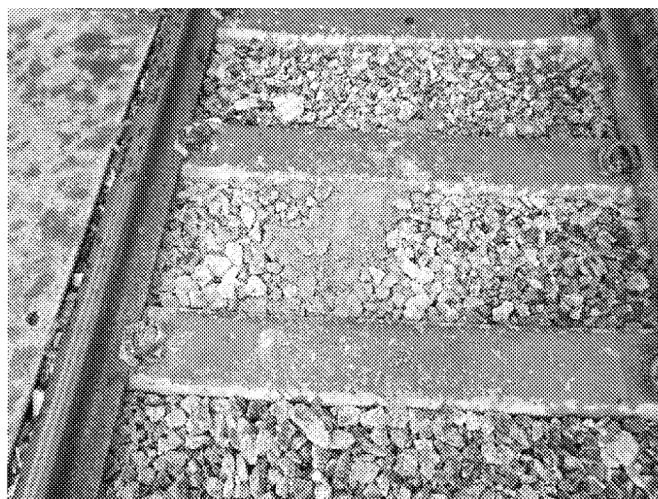
Localised contamination of the ballast due to spillage or debris from other OLRT contractors (see photo no. 9).

Photo no. 9 (right): localised contaminated ballast on east-bound line, approaching the tunnel portal, at 100km 410m. This appears to be associated with the activities that have required the plant and materials to be stored nearby (in photo 8).

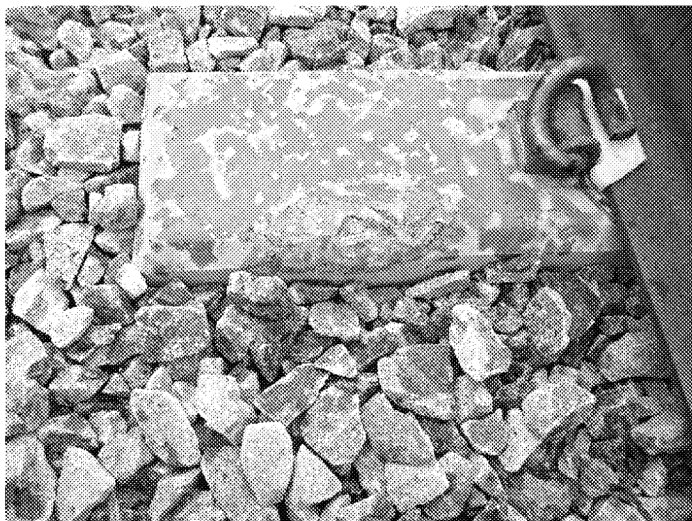
In general, the site inspection can validate that the design sleeper spacing has been achieved during the installation process. There is evidence of isolated damage to the sleepers, either through installation mis-handling or through tamper damage. There is evidence that repairs of such damage are being carried out.

Photo no. 10: Evidence of local repair to damage to sleepers

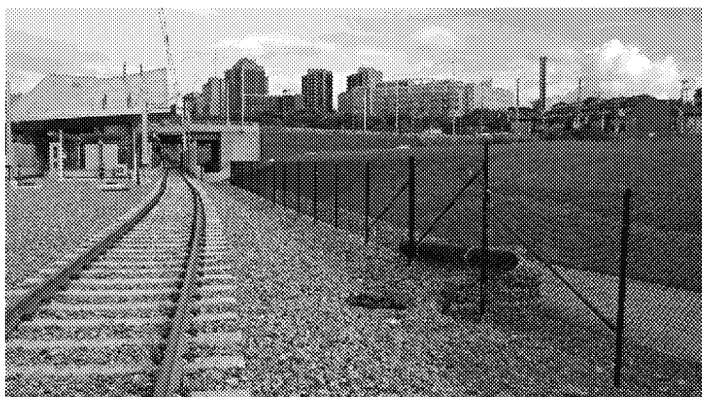
There are some locations where the adequacy of the fencing is not sufficient and provides an easy climb trespass opportunity to the guideway.

Photo no. 11: Evidence of inadequate fencing protection leaving an easy climb trespass opportunity.

Photo taken east bound facing Pimisi Station at 100km 050m.

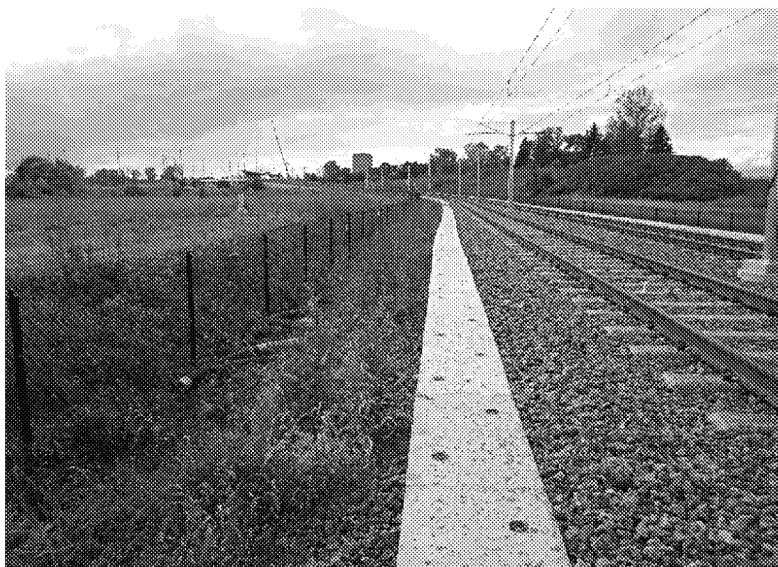
There is a section of cable trough route installed between Pimisi station and Bay View station that presents a walking at heights issue. The trough units are 600mm deep and on the fence line side of the route there is no support. Any track workers walking along the route could fall over 800mm into the cess. The assessor recommends that either a handrail is installed or that the cess is built up behind the trough to reduce the fall dimension, subject to ensuring that any improvements do not increase the risk of trespass. This evaluation of fall risk should be carried out on all cable trough route on the guideway.

Photo no. 12: lack of support/embankment behind cable trough presents a fall risk.

Photo taken of the east bound cess at 99km 900m, taken facing Bay View. This applies to the west bound cess as well at this location.

5.6.2.2	Working at Height "fall risk" from line-side cable troughing	Prior to opening to passenger operations	Undertake hazard evaluation of all cable troughing for fall risk and carry out mitigations.

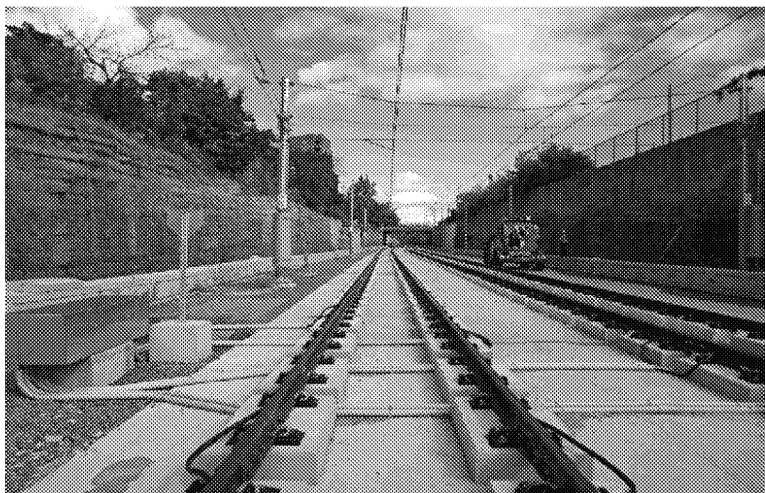
Photo no. 12: West bound approach to Tunney's Pasture station, taken from 304 points looking toward Bay View.

Site inspection checks has generally found the plinths to be in robust condition and the fixing of the base-plates in good order with adequate concrete cover to the retaining bolts to avoid break-out under normal operational loads.

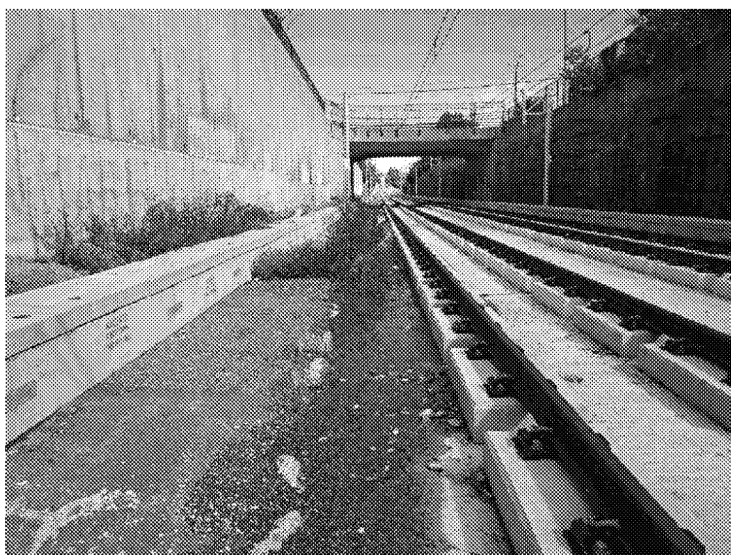
Although this approach will aid winter management of snow and water, the core support slab and associated areas must be kept clear of debris and vegetation.

Photo no. 13: Excessive vegetation growth along side the track at 98km 550m, west bound side.

The assessor recommends that such areas are cleared before the opening to passenger operations.

5.6.3	Debris and vegetation in slab area	Prior to opening to passenger operations	Manually clean slab area of debris and vegetation
5.8	Loose or missing Vossloh fasteners in special trackwork	Within 3 months of opening to passenger operation	Manually install missing fasteners and torque all fasteners to correct value

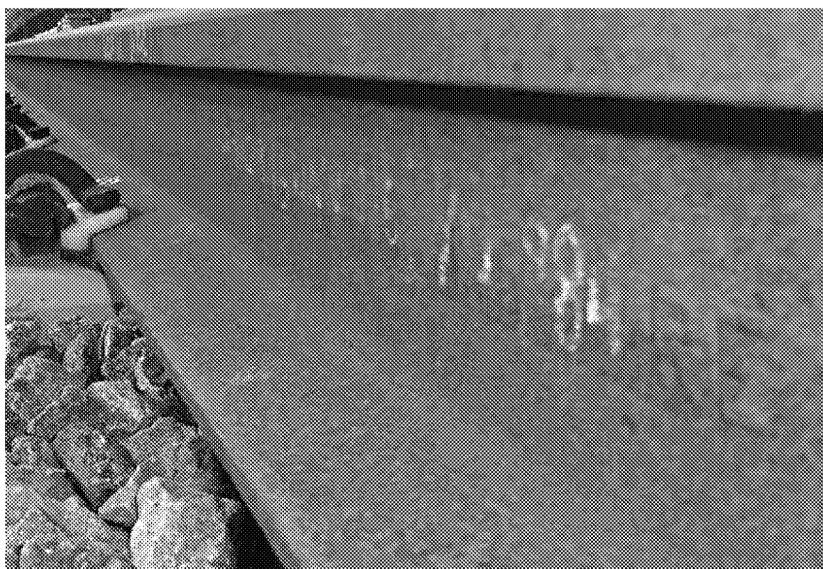
The project has, by requirement of the PA, installed 115lb RE rail that complies to the technical details of AREMA manual. The design contractor has then specified that all rails are a minimum of 310 Brinell hardness [Ref.01]. This is a medium strength rail hardness that can reduce rail wear and prolong asset life if it is well maintain and is the minimum strength requirement mandated in the AREMA manual.

Photo no. 14: Evidence of rail branding marks for 115 RE rails

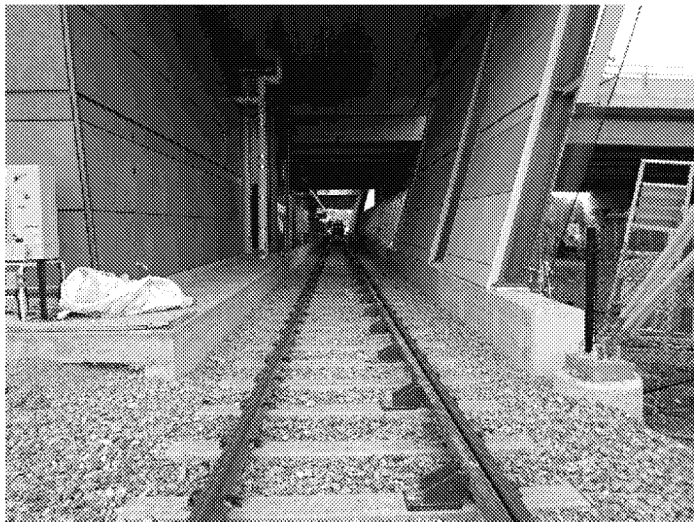
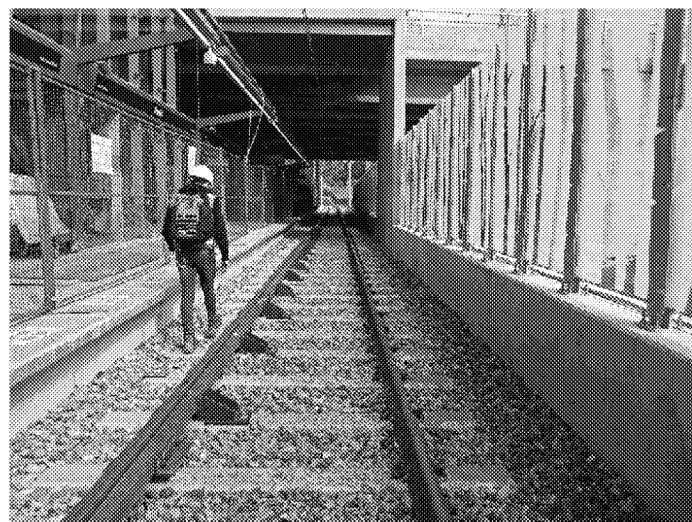
However, as part of good derailment risk management, restraining rails have been provided in Pimisi station on both lines.

Photo 15 (left): Restraining rails in Pimisi west bound platform. Photo 16 (right): Restraining rails in Pimisi east bound platform.

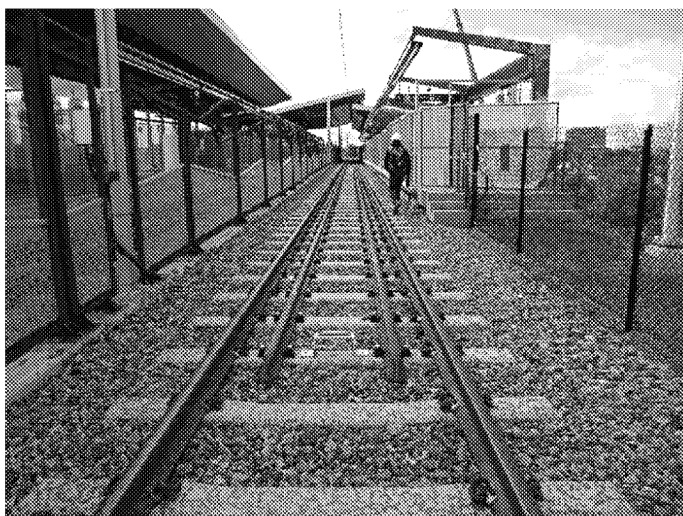
Additionally, there is a long section of “Jordan Rail” (guard rails) track between Bay View and Tunney's Pasture.

Photo no. 17 (left): start of Jordan rail protection west bound into Bay View station.

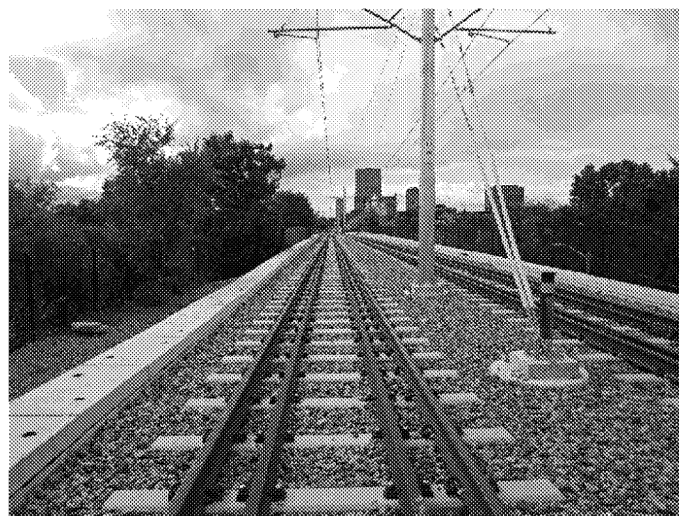
Photo no. 18 (right): view of Jordan rails on both lines, taken 99km 350m looking towards Tunney's pasture.

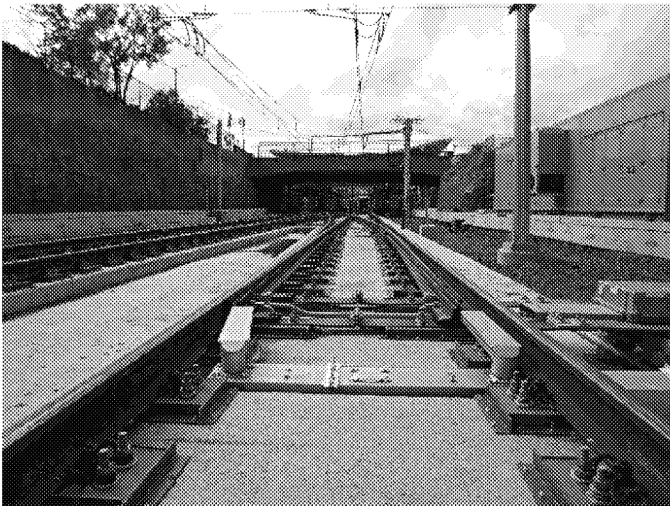
Therefore, the core requirement to provide switch clearing devices has been met.

Photo no.19: switch heaters at 304pts  
(silver unit in 4ft pointing towards the  
switches)

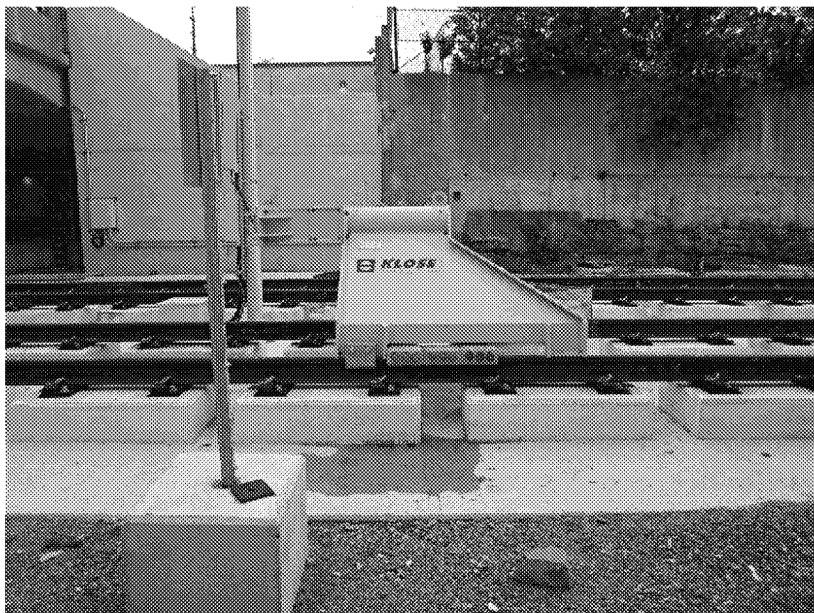
Photo no.20: Installed buffer stop at Tunney's Pasture, with compliant friction resistance devices.

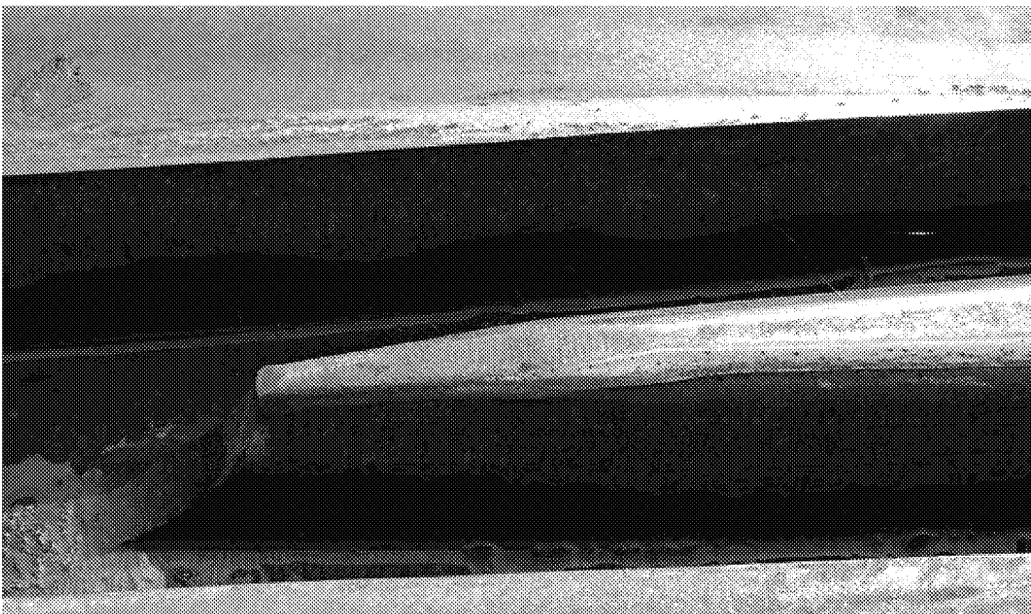
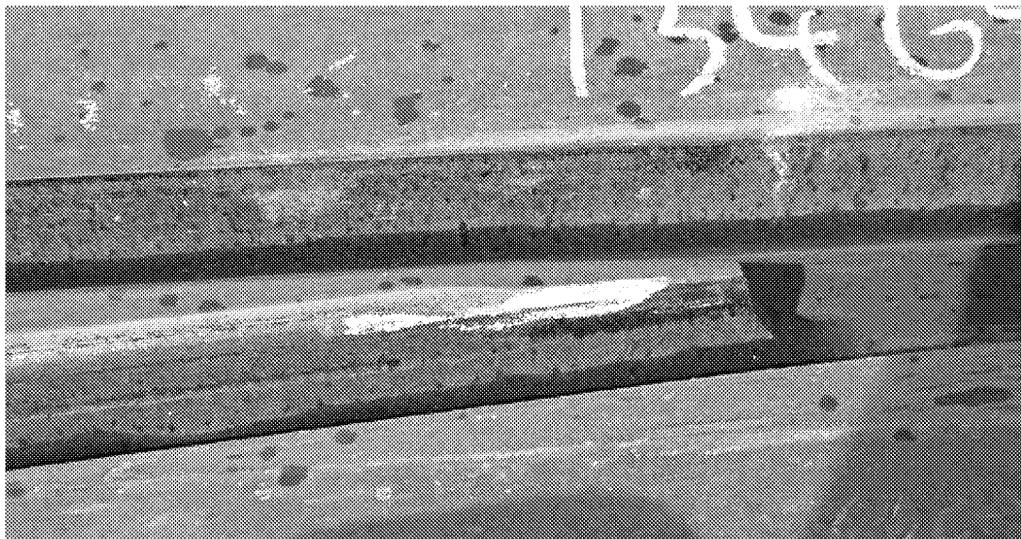
Switch blades have started to demonstrate initial lipping at approx. 3.5m to 4.5m from the switch toe. This is normal behaviour, but the lipping must be ground off before significant defects and cracks start to form within the metal. As the grinding and profiling of switches is a specialist skill, the assessor recommends that all remedial works are undertaken by the OLRT track Maintainer within the first 3 month of passenger operation (on a risk-based priority approach).

The crossing units (frogs) have started to demonstrate initial lipping and deformation under Hi-Rail vehicle and tram movements. This is normal behaviour, but the lipping must be ground off and any deformation rebuilt before significant defects and cracks start to form within the metal. As the grinding and profiling of switches is a specialist skill, the assessor recommends that all remedial works are undertaken by the OLRT track Maintainer within the first 2 month of passenger operation (on a risk-based priority approach).

Photos no. 21 (top) and 22 (bottom) are taken of 304pts and 303pts respectively.

5.8	Start of lipping wear of switch blades	Within 3 months of opening to passenger operation	Task to be undertaken by skilled operator of OLRT Maintainer team

5.8	Start of lipping wear on frog crossings	Within 2 months of opening to passenger operation	Task to be undertaken by skilled operator of OLRT Maintainer team
