CONFEDERATION LINE PROJECT: TUNNEY'S PASTURE TO BLAIR STATION

3. DESIGN AND CONSTRUCTION STATUS

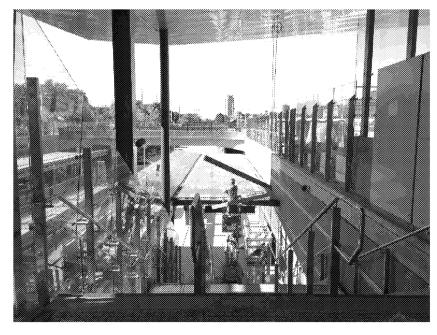
Tunney's Pasture Station

- Glazing installation nearing completion.
- CBTC testing ongoing for Zone 1.
- Entrance lantern assembly underway

- Fare gate installation ongoing.
- Final lighting installations underway.

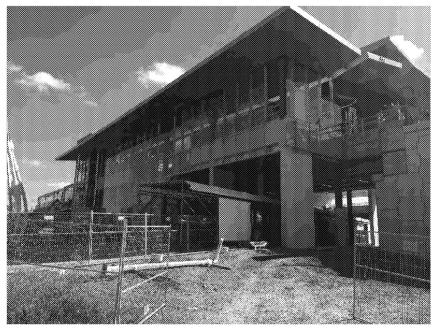
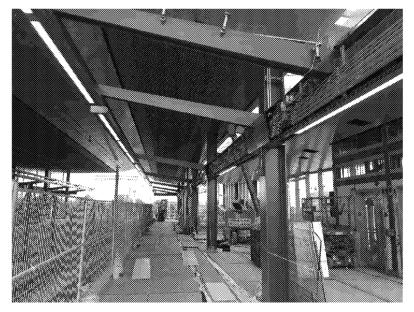
Bayview Station

- Wood ceiling installation underway.
- Final lighting installations underway
- System peripheral installations ongoing.

- W5 glazing installation ongoing.
- Fare gate installation ongoing.
- Entrance lantern assembly underway.
- South landscaping from O-Train Line 2 ongoing.

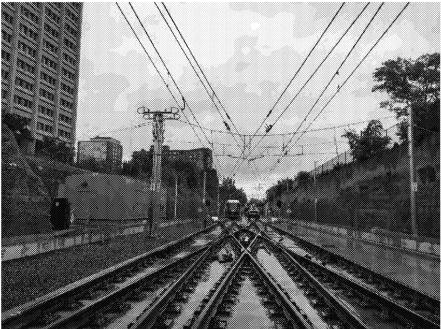
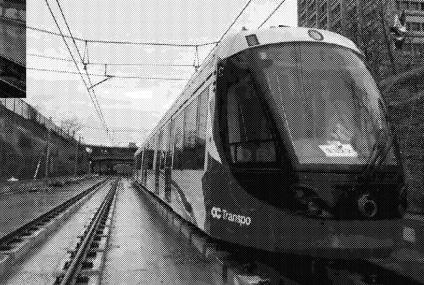
Segment 1 Guideway East of Tunney's Station

- Diamond crossover east of Tunney's station.

Guideway approaching Tunney station.

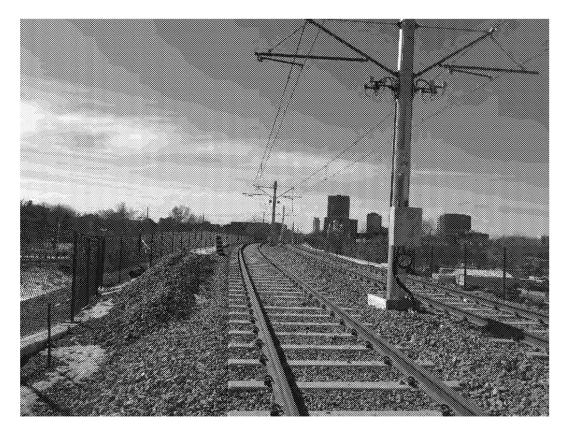
Segment 1 Guideway West of Bayview Station

- Trackwork east of Bayview Road Bridge.

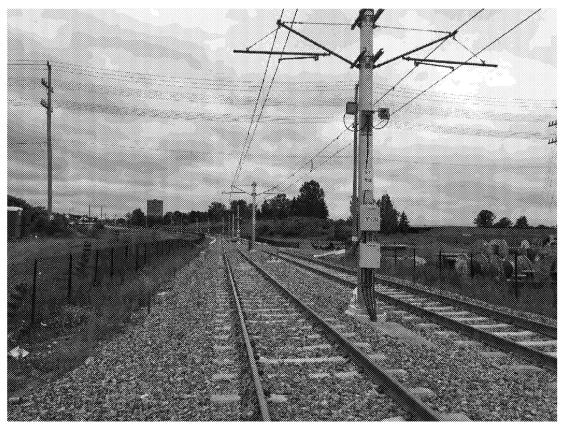
Segment 1 Guideway West of Pimisi Station

- Trackwork between Bayview & Pimisi Station

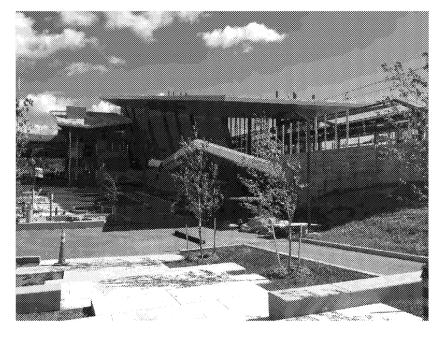
Pimisi Station

- Wood ceiling installation ongoing.
- Glazing installation ongoing.
- Landscaping in progress.
- Entrance lantern assembly and faregate installation underway
- Lighting and wayfinding installation in progress.

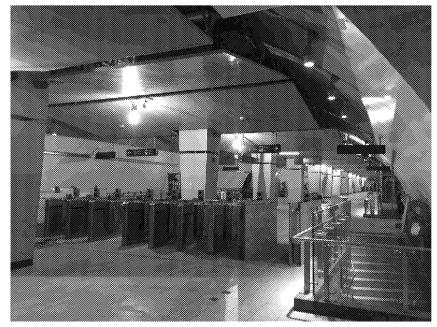
Lyon Station

- Utility cabinet installation ongoing.
- Porcelain tile installation at platform level complete.
- Wayfinding installation underway.

- Architectural finishing ongoing.
- Acoustic panel installation in progress for concourse ceilings.
- Escalator enclosing with SST panels underway.

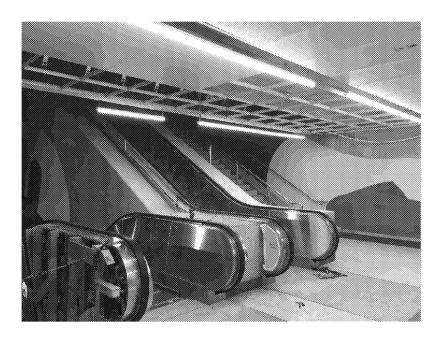
Lyon Station West Entrance

- Wood ceiling panel installation ongoing at grade Level.
- Ceiling acoustic panel installation underway.

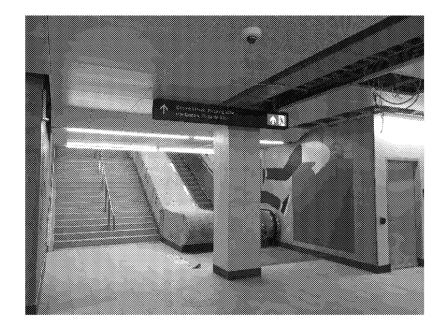
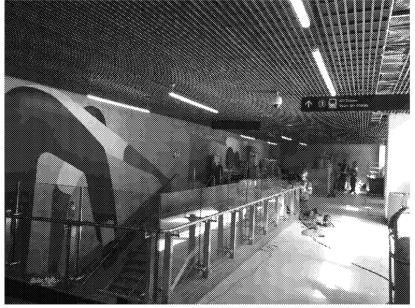
Lyon Station East Entrance (Place de Ville)

Wood ceiling panel installation ongoing at grade Level. Ceiling acoustic panels installation underway.

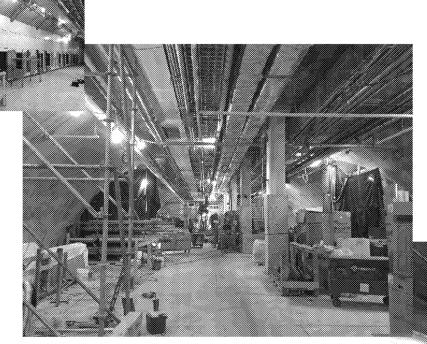
Parliament Station

- Systems installations ongoing in COMMs room.
- MCCs, fans, dampers and silencers installed for TVS system.
- TVM housing complete at concourse level.

- CCTV and PA devices installation ongoing.
- Acoustic panel installation for ceiling underway.

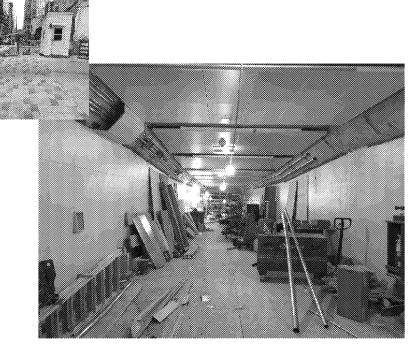
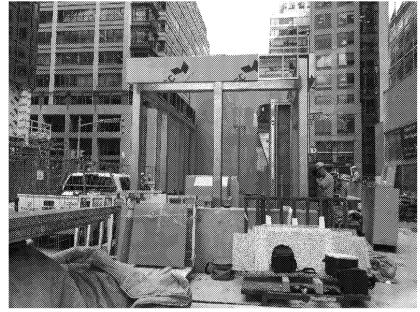
Parliament Station West - Mid Entrance

Mid entrance elevator cabs assembly in progress in shafts.

- Porcelain tile finishing in entrance corridor.
- Acoustic panel installation complete in the corridor.
- Interlock paver stone installation ongoing at street level.

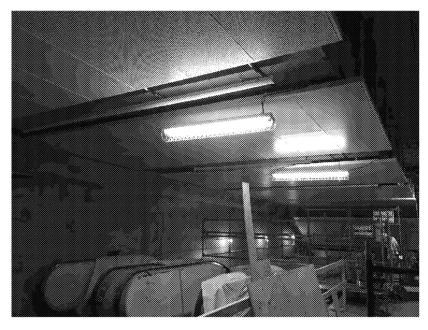
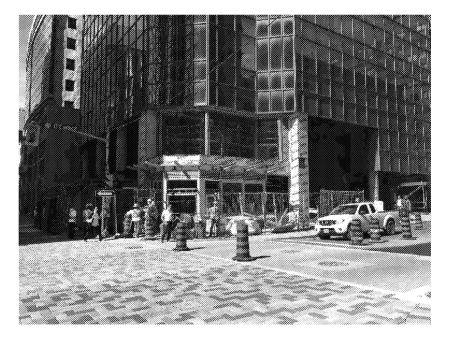
Parliament Station East Entrance (Morguard)

- Porcelain tile installation in progress.
- Façade glazing installation ongoing.

- Acoustic ceiling panel installation underway.
- Door frame Installations in Progress at landing entrance.

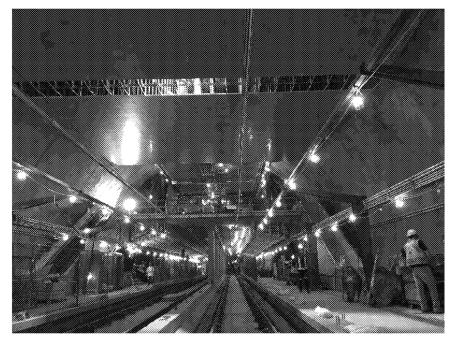
Rideau Station

- Ceiling installation at platform and concourse level nearing completion.
- Elevator installations ongoing in shafts.
- Faregates topping slab poured.
- Wire pulling through ceiling conduits at platform level ongoing.

- Conduit installations in progress for traction power, station power and COMMs.
- Porcelain tile installation at concourse, platform and staircases ongoing.

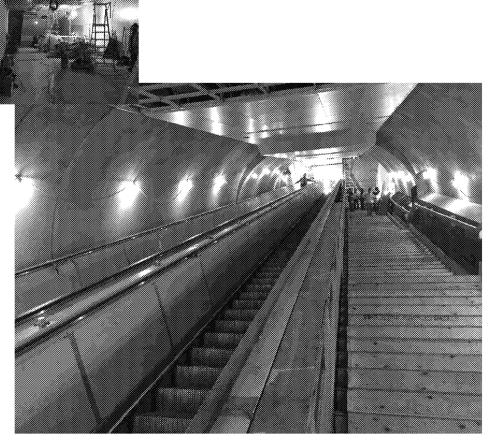
Rideau Station West Entrance

- Acoustic panel ceiling installation underway.
- Porcelain tile installations in progress on walls at retail concourse.
- Escalator commissioning ongoing.

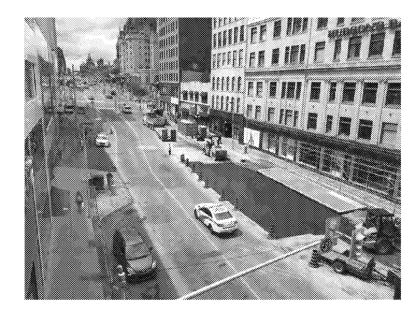
Rideau Station West TVS

Electrical fans installation ongoing. West TVS shaft paving and reinstatement complete.

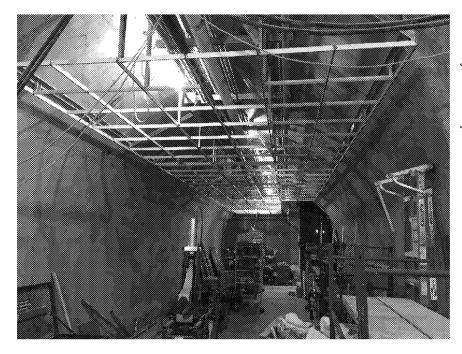
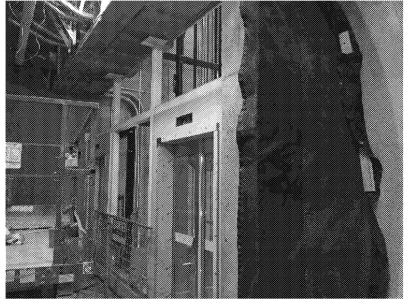
Rideau Station Mid Entrance

Elevators assembly in progress.

- Ceiling framing installation ongoing.
- Floor porcelain tile installations complete of mid entrance adit.

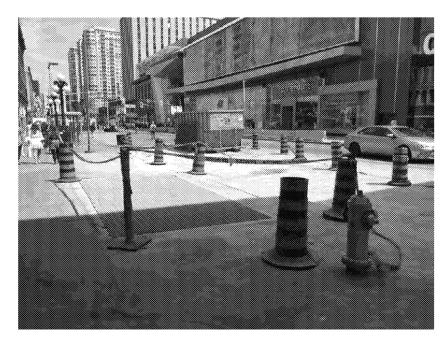
Rideau Station HVAC Shaft

Ventilation connections of the air handling unit is complete in HVAC room. HVAC shaft paving and reinstatement complete at street level.

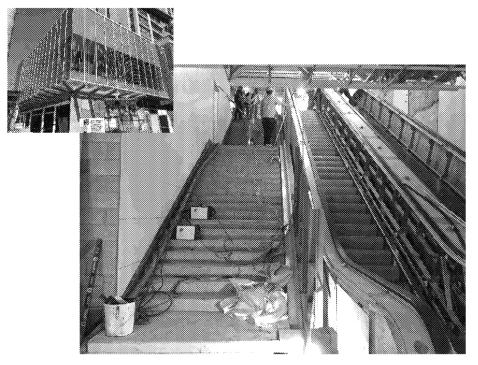
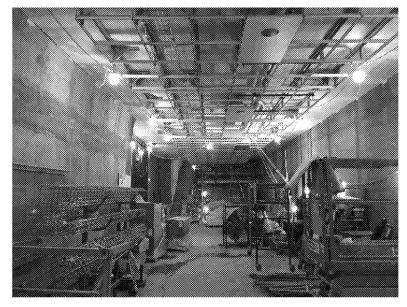
Rideau Station East Entrance (Bank of NS)

- Ceiling framing complete in the concourse connection.
- Wire pulling in progress throughout ceiling.

- Porcelain tile and ceiling installation in progress on walls of public areas.
- Escalator commissioning underway.

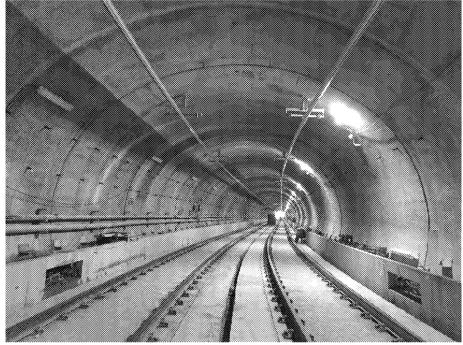
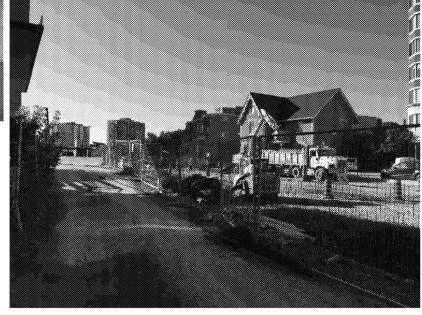
East Portal to Ottawa U Station

Backfilling complete atop cut-andcover section of tunnel at East Portal.

- Trackwork, OCS, WRU, GIDS and tunnel lighting complete for this section of tunnel.
- Jet fan installations imminent in fan niches.

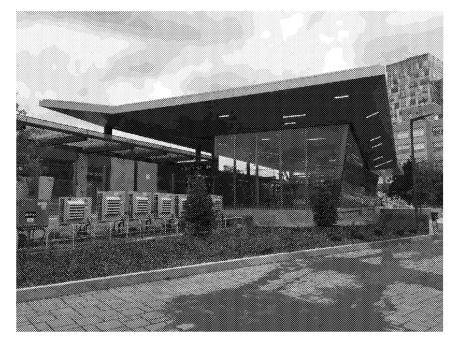
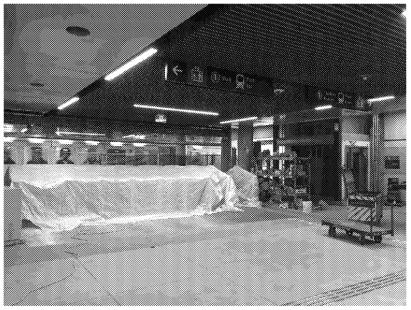
Ottawa U Station

- Wood ceiling installation underway.
- Utility cabinet and faregate installation ongoing.

- Entrance lantern assembly underway.
- Landscaping ongoing.
- Final lighting installation underway.

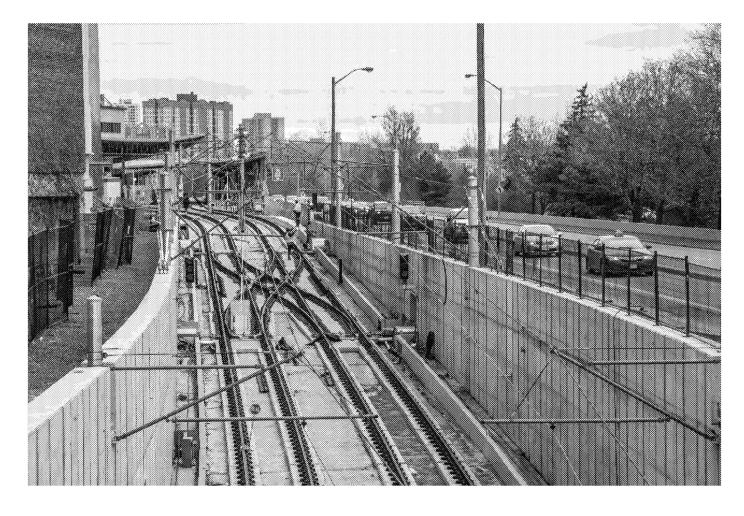
Lees Station

- Glazing installation ongoing.
- Lantern assembly underway.
- Landscaping and paver stone and artwork installations in progress for MUP.

- Signage and lighting installation ongoing.
- Elevator entrance façade installation underway.
- Wood ceilings complete.
- Station Comms SIT testing ongoing.

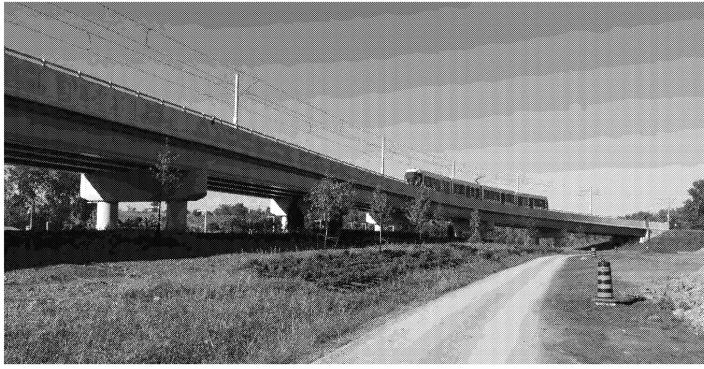
Segment 3 Guideway – East of Lees Station

Elevated guideway east of Rideau River Bridge

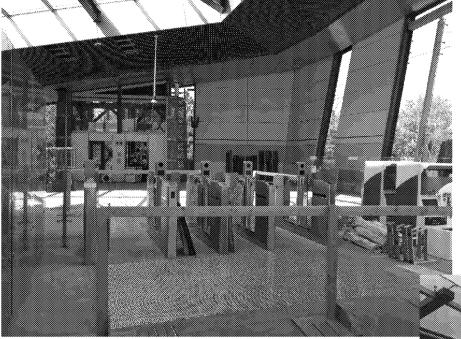
Tremblay Station

- Fare gate installation complete.
- Station Comms SIT testing ongoing.
- Landscaping ongoing.

- Lantern assembly underway.
- Signage, wayfinding and lighting installations in progress.

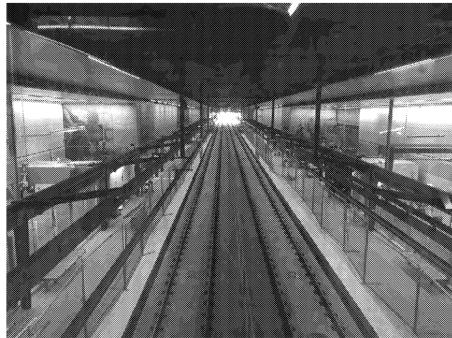
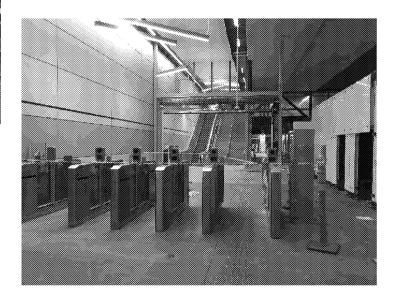
St. Laurent Station

- Fare gates installed.
- Entrance lantern assembly ongoing.
- Signage and wayfinding in progress.

- Station Comms SIT testing ongoing.
- TVS SIT testing underway.
- Glazing installation nearing completion.

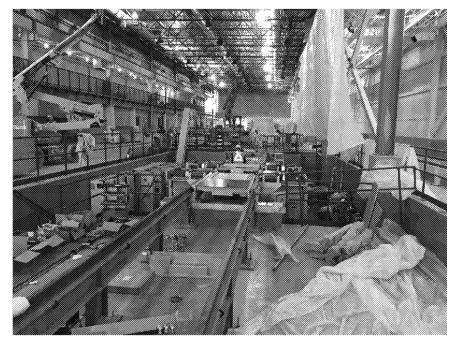
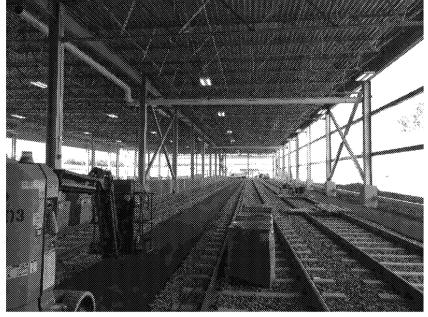
MSF Expansion Stage 2

- Façade composite panel installation in the shed.
- Cable pulling for peripherals in the shed in progress.

- New MSF installation of double wheel lathe ongoing.
- M&E works underway.
- Roof and building envelope complete.
- Painting ongoing.

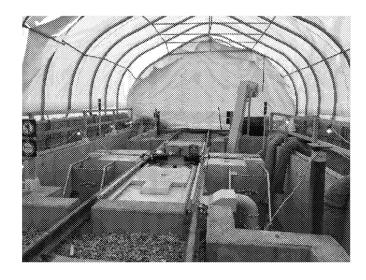
MSF Expansion Stage 2

- Temporary wheel truing pit complete. Machine installed.
- Final commissioning of single wheel lathe in October.

- Composite panel installation at walkway and staircases complete.
- Ceiling installation complete in the walkway (OHWS).
- Asphalt paving complete for access road along Bypass Track # 11

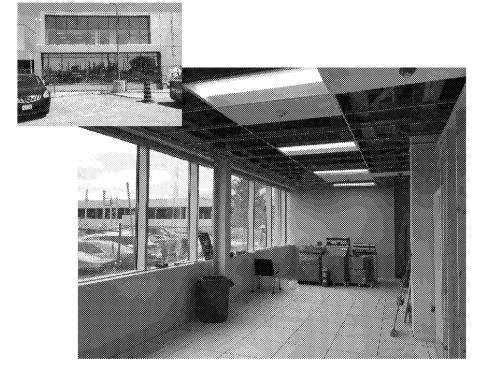
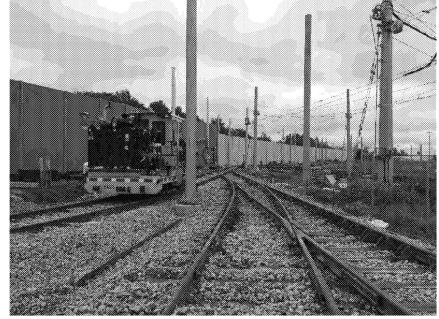
MSF Expansion Stage 2

Ballast profiling and tamping ongoing for trackworks to new MSF building.

- 3m extension YCC/BCC raised flooring installation complete.
- Ceiling framing, fire alarm system and smoke detectors complete.
