Document: Confederation Line Wheel Flats report

Project: Confederation Line Performance Oversight

Client: Rideau Transit Group

Document Ref: JBAUSA/RTM/023-04-04

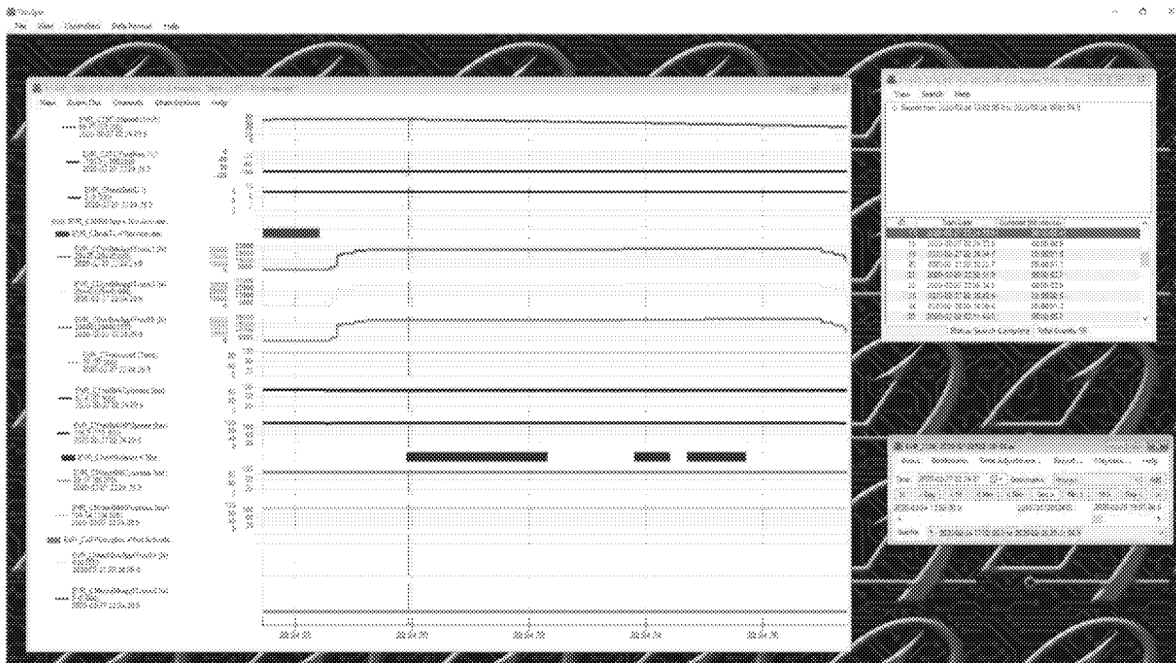
Figure 11 - Method for searching for and displaying wheel slide incidences

JBA were provided with the 'TrackSyte' tool from Bach-Simpson which allows the EVR downloads to be analyzed and exported to Microsoft Excel for graphing and other analysis. The tool allows the data to be searched for wheel slide occurrences. Figure 11 shows a typical example, showing the speed at the time of the wheel slide around 70km/h. A dynamic brake effort of around 30KN is present at each of the motor cars, and no friction brake is demanded. The weight of the train is 97 tons (~100 tons). The adhesion required on each truck, assuming roughly 1/5 of the weight of the train is on the motor truck is 30 divided by (20 x gravity (9.81m/s/s)) which is roughly 0.15 ratio of horizontal force at the truck to vertical force caused by gravity. It is reasonable to assume, as the wheel is sliding at this point, that there is less than 0.15 adhesion available at this place.

Once the sliding is taking place the data for brake force is not valid as the force at the truck is bound to reduce if sliding is taking place. There is no way of knowing what the actual brake force at this point is:

- a) The cars are running in multiple so both EVR's are required to assess the data.
- b) There is no way of knowing which truck or how many trucks are sliding.

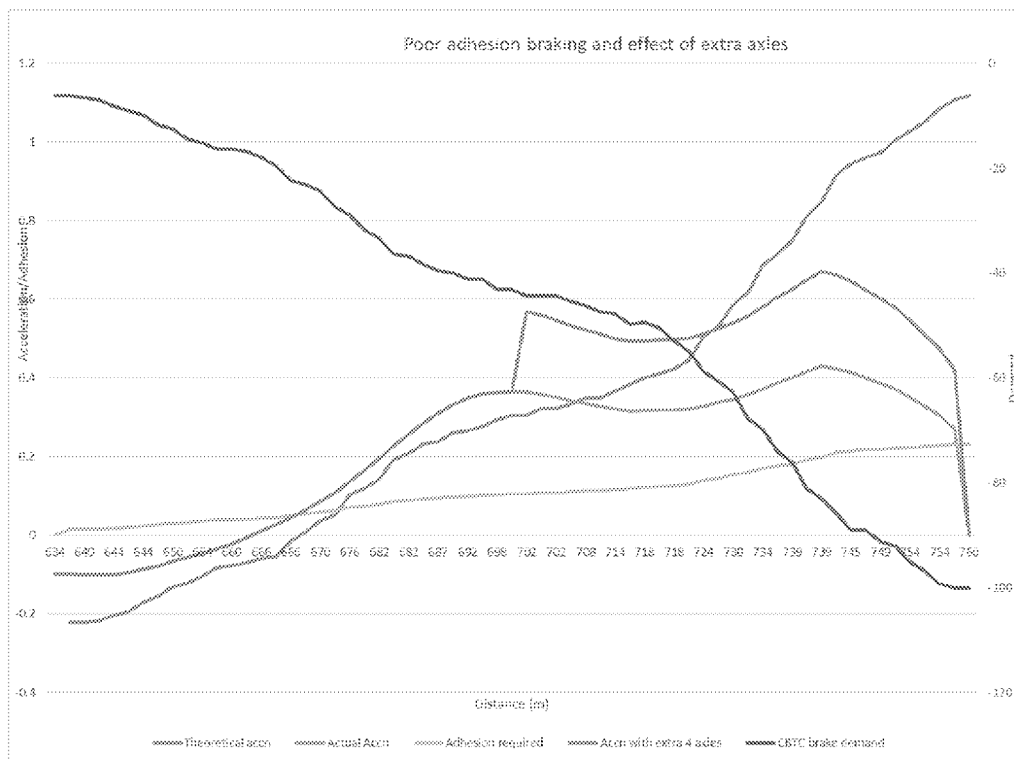
Figure 20 - Effect of additional 4 trailer axles on actual acceleration in low adhesion conditions

The EVR results from the EB from Figure 15 were examined to calculate the additional acceleration that would be available based on the adhesion available at the time of the slide (Figure 20). This was then used to calculate the actual speed profile that would have occurred if the additional axles had been used to stop the train up to the adhesion level available.(Figure 21). There are inaccuracies because the model cannot really assume that all the brake system in both cars is behaving the same.

In this case the car starts to slide when the adhesion reaches 0.11. At that point, the brake effort available from the trailer axles at an adhesion rate of 0.11 is added to the total effort. The resulting effort makes up the loss of effort from the slide to give the demanded acceleration once the orange and light blue lines cross.

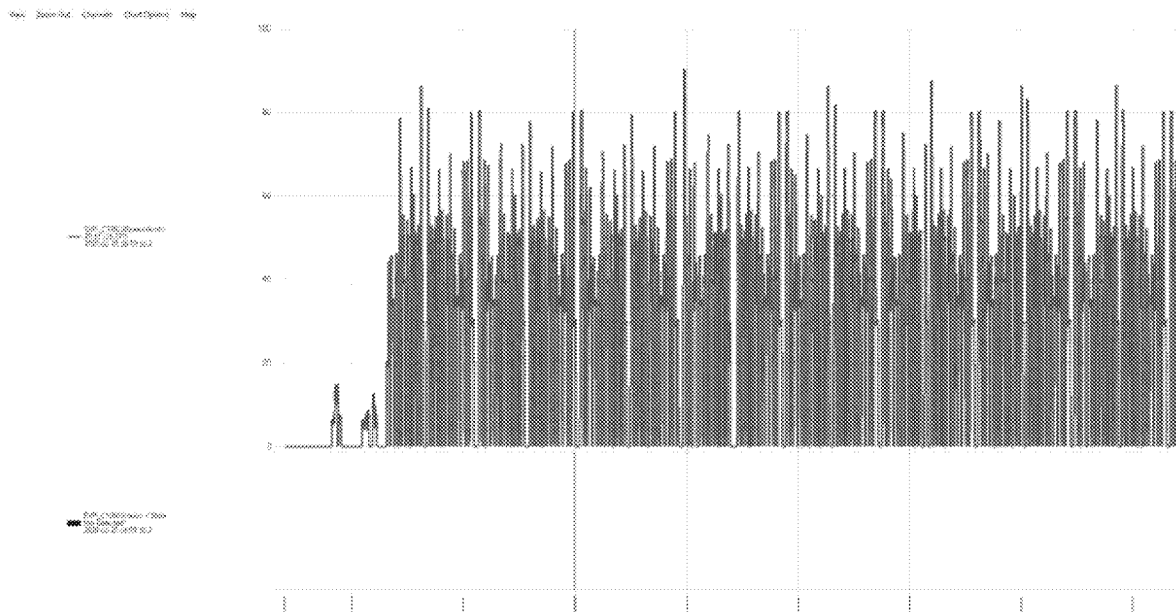
Figure 31 - No wheel slide activity LRV26 on Feb 25, 2020

The following EVR extract from LRV26 on the 25th February over a period of 8 hours shows no wheel slide activity for the first 7 hours of service that day; the red line is the sample time. (note EVR time is around 1 hour ahead of actual time). The X axis shows 1-hour intervals and the green line is the speed of the train, indicating it was in service for that time.

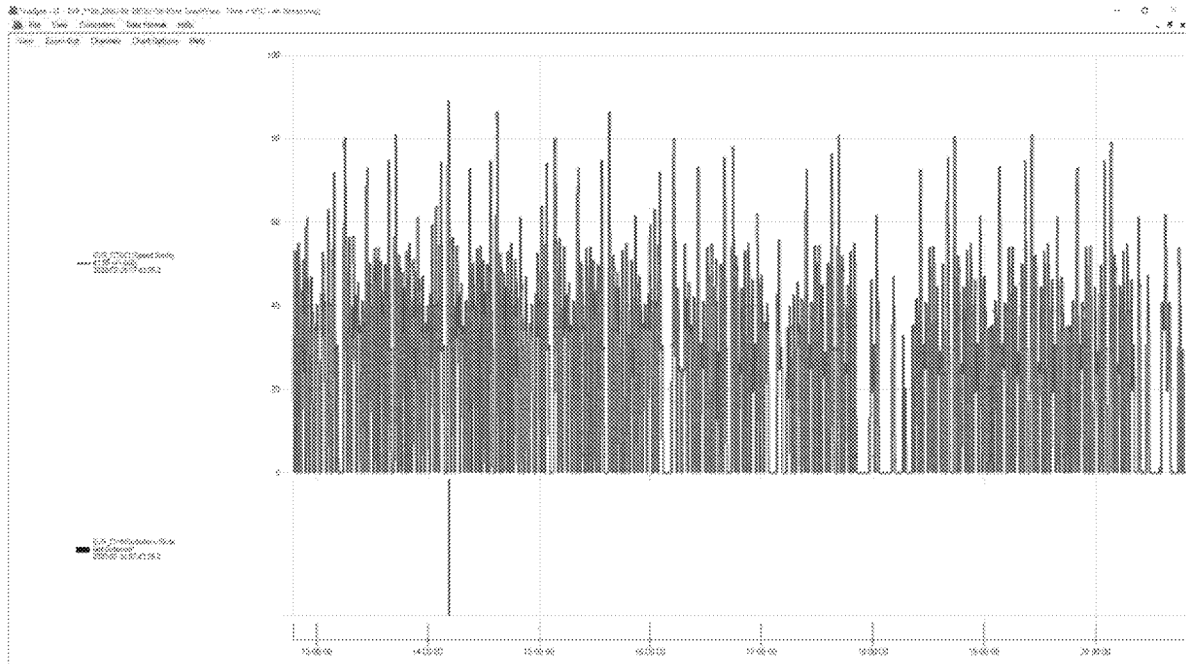
Figure 32 - Limited slide activity LRV26, Feb 26, 2020

The 26th saw a small amount of wheel slide activity although there was snow falling. The blue markers show incidences of wheel slide activity.

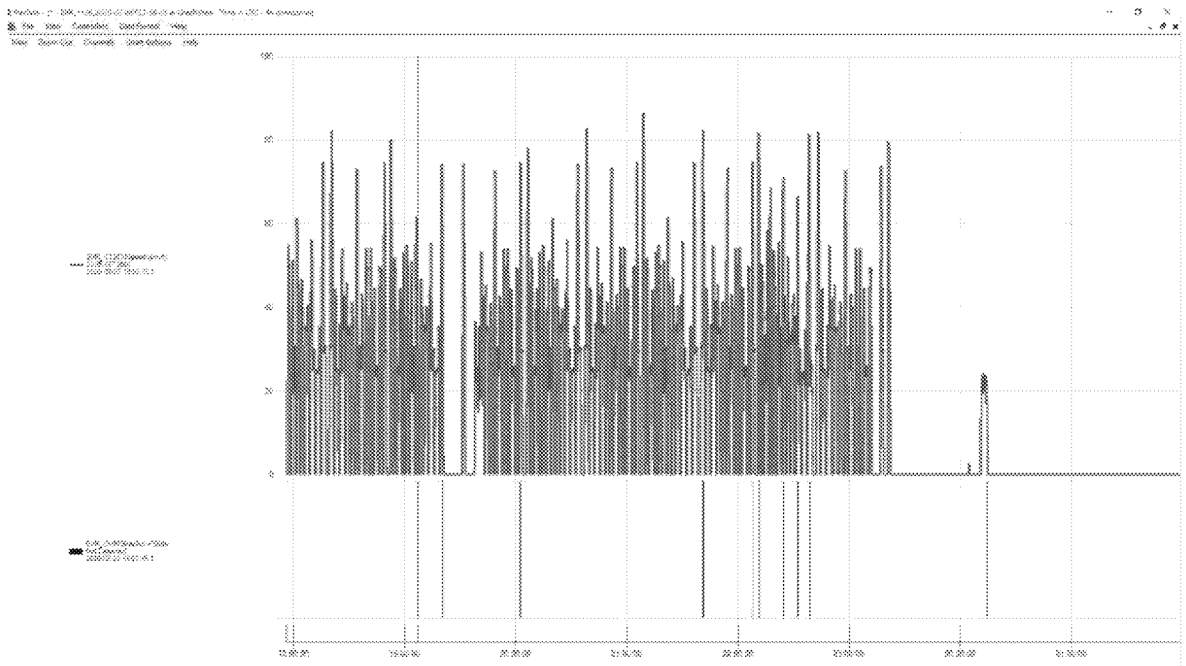
Figure 33 - Significant slide activity LRV26, Feb 27, 2020 PM

The following evening on February 27th, significant wheel slide activity only commenced in the evening, as the temperature started to fall below -5 degrees C.
