Ligne de la  
**Confédération**

## Pre-Grind Inspection Optical Measurements

**Proponent name:** Advanced Rail Management (Canada) Inc.  
**Address:** 26 Harry Collins Avenue, Winnipeg, MB R2M 4N2  
**Phone number:** 321.984.1474  
**Contact:** Gordon Bachinsky, P.Eng.

**Revision 3: March 18, 2021**

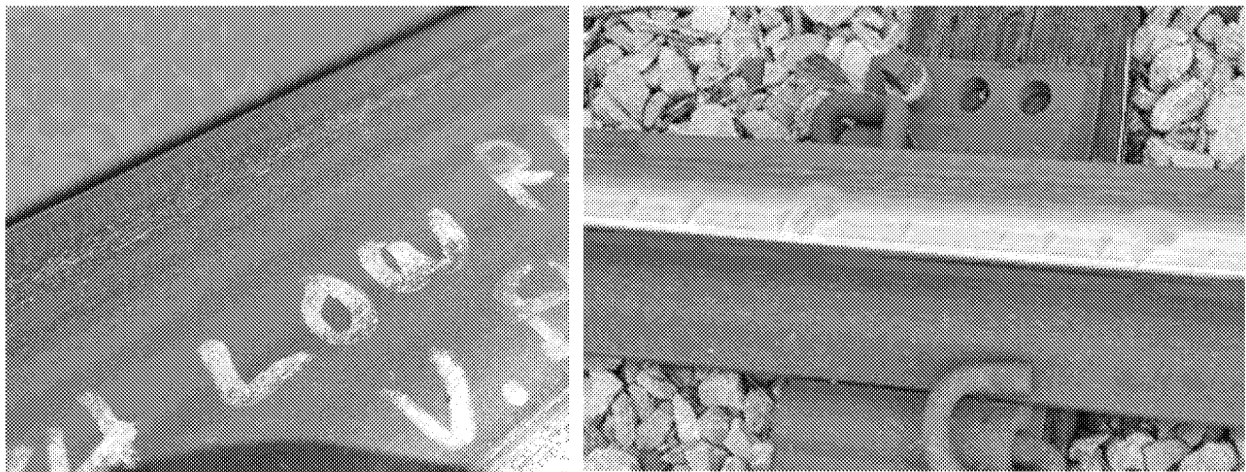
**Rolling Contact Fatigue (RCF)** – uncontrolled RCF can lead to more severe rail defects such as rail fractures, spalls, and squats and severe RCF can impede readings from ultrasonic testing. Light RCF will be removed in profile grinding while moderate/severe RCF will require additional work (see Figure 2 for visual examples). Our rail grinding specialist did not identify any major RCF on the Confederation Line but was shown photographs of some locations with more severe RCF. The RCF shown to the grinding specialist appears to be the result of high gauge corner contact stress caused by the low rail being very flat (close to 14 inch radius) which causes the wheels to increase their angle of attack into the high rail. In our experience, premium head hardened steel without a preventive grind program is prone to the development of RCF due to the light axle loads of transit agencies and low rail wear values along with high stress profiles. In systems like heavy haul where annual tonnage and axle weights are higher these rail surface features are naturally worn out. The high rail RCF could be controlled by re-establishing an 8 inch radius on the low rail and creating asymmetric profiles to support steering.

**Figure 2: Example RCF (not from Confederation Line) of gauge corner cracking (left image) and top of rail surface defects (right image)**

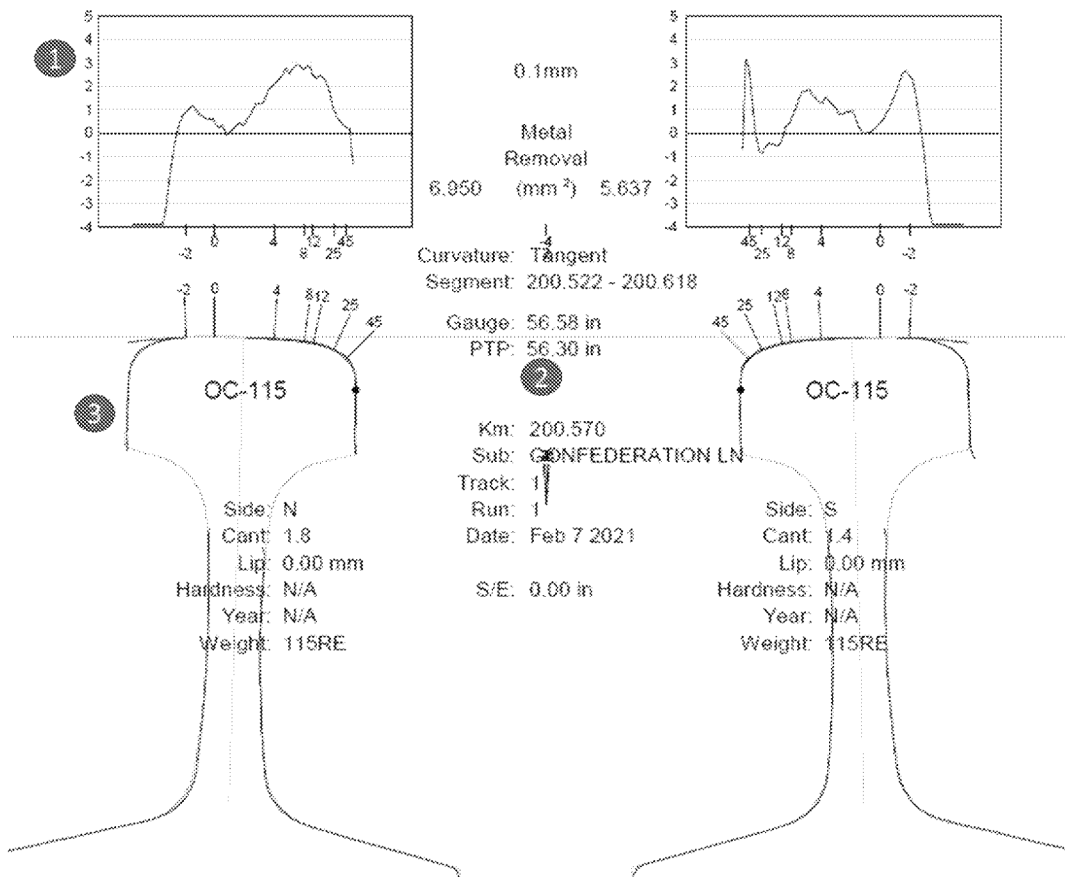
Figure 15: Typical 2-Up Plot

Figure 15 shows a typical 2-up plot of the left and right rail. The plot is broken into three general areas:

1. Metal Removal graphs – show where on the rail head work needs to be done to achieve the target profile (in this case 115RE)
2. Track Characteristics – general information about the location, curvature, and gauge
3. Rail Profiles – plot generated from scan shown the worn rail shape with the target profile overlaid (red line is the target profile)
