Transportation
Safety Board
of Canada

Rail Safety Advisory Letter 617-02/21

Roller bearing failure resulting in derailment of Ottawa Light Rail Transit vehicle

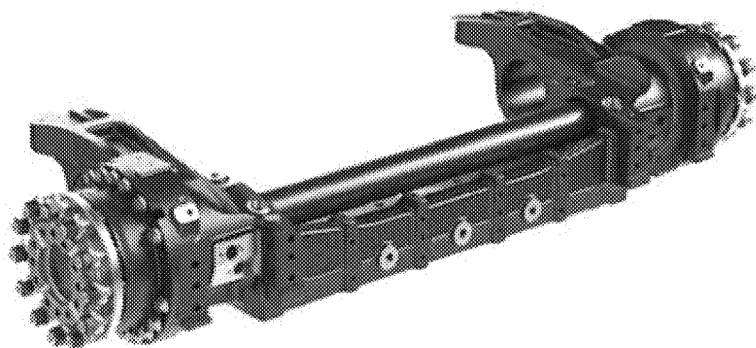
Figure 3. Iponam bogie axle assembly (Source: Alstom)

The cartridge assembly integrates the splined axle with the rotating part of the wheel that allows the wheels to turn. Each cartridge assembly includes 2 tapered roller bearing assemblies, and the whole assembly is held together tightly by a large locking nut (thrust nut), which is torqued at 3000 newton-metres of torque.² A cartridge assembly is installed on each end of a splined axle, secured with bolts.

Alstom's root cause failure analysis suggested that the roller bearing failure was related to the loosening of the large locking nut that holds the cartridge assembly together.
