Transportation
Safety Board
of Canada

617-03/21
TSB file R21H0121

SUBJECT: RAIL SAFETY ADVISORY LETTER 03/21
Work procedures for Ottawa Light Rail Transit vehicle maintenance

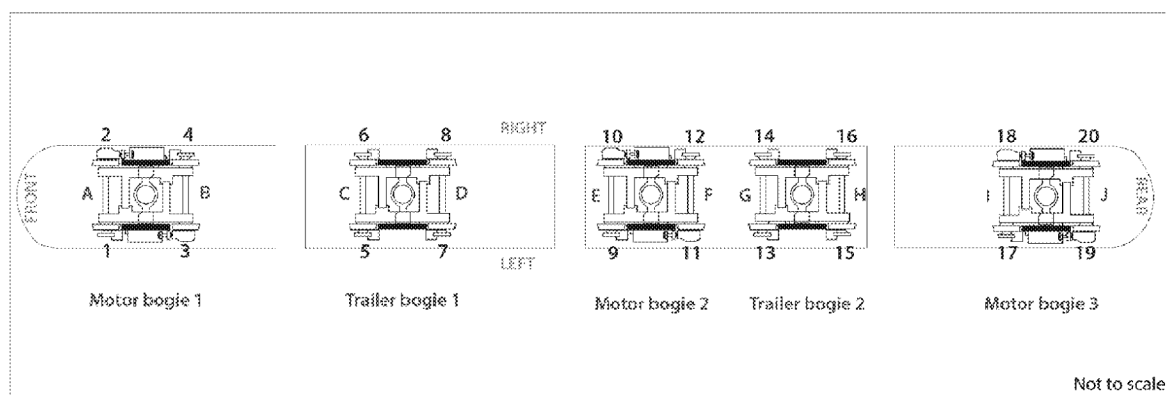
Figure 1. Schematic of an LRV showing bogies. Official Alstom nomenclature identifies the axle locations as A–J but Alstom refers to axle positions 1–10 and wheel positions 1–20 (Source: TSB)

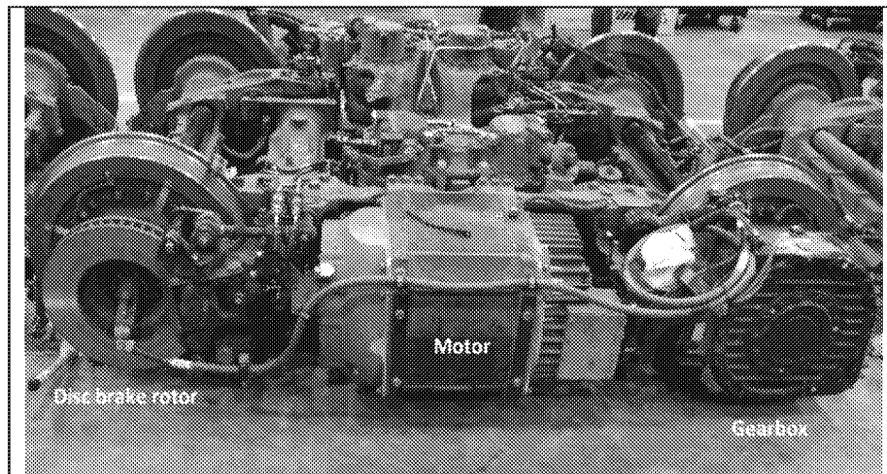
Figure 2. Alstom LRV Iponam motor bogie (Source: TSB)

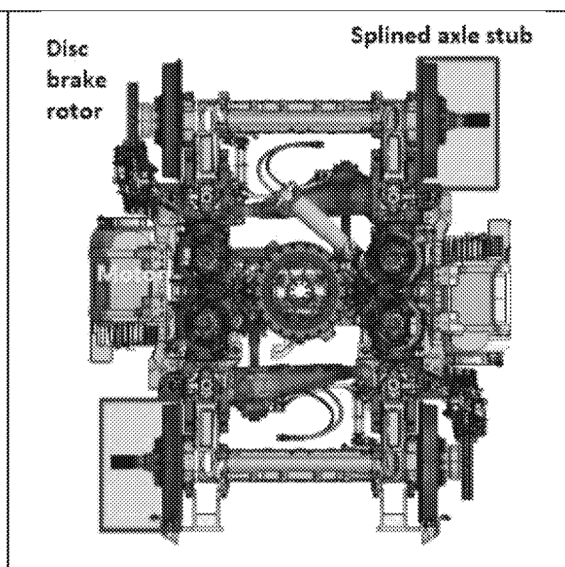
Figure 4. Bogie schematic (Source: Alstom, with TSB annotations)
