Subject: Final Derailment Report of LRV 1116 on March 14th, 2021

LRV 1116 MSF Yard Derailment Investigation Report	Document Reference: OTT-ENG-REP-66 Version B	Application date: 2021-06-28
Written by:	N. Sembeyev / Bogie Warranty Engineer Y. Liu / Project Engineering Manager S. Hernandez / Project Quality Manager C. Khokhar / Engineering Technician		
Verified by:	L. Goudge / Train System Engineer	Ensures that the technical/ process accuracy has been checked.	
Approved by:	R. France / Project Manager	Orders, by his signature, the implementation of the document.

On 14 March 2021, at approximately 13:19, Ottawa Confederation Line LRV 1116 derailed at low speed in the maintenance and storage facility Yard (MSF) during a routine move from the storage area to the handover platform.

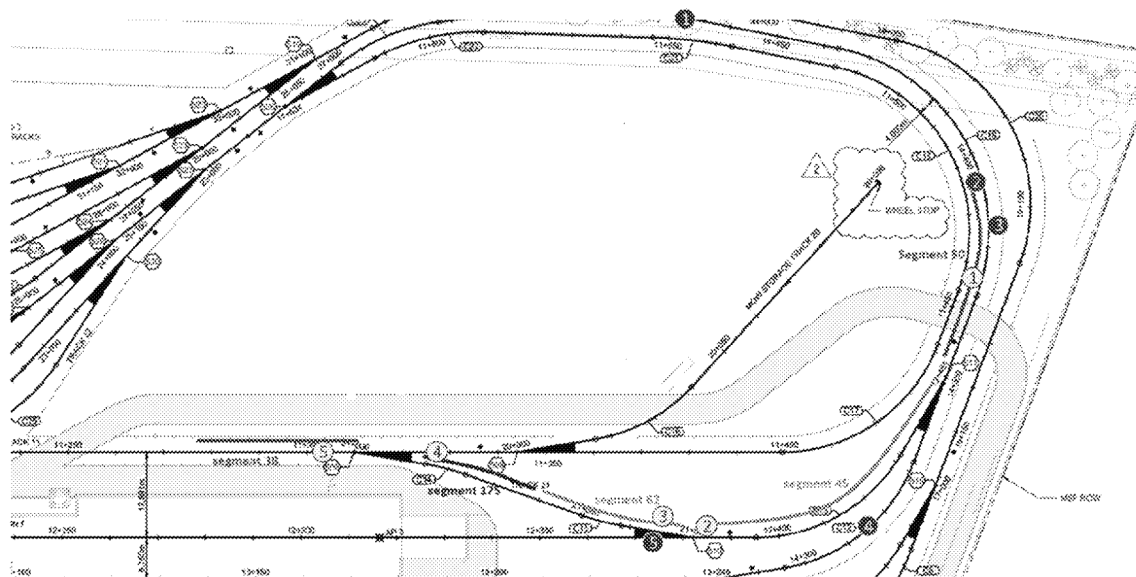
Figure 1 Train location corresponding

On 14 March 2021 at approximately 13:19 EST, LRV 16 was coupled to LRV 17, with LRV17 as the leading car. The consist was performing a move from MSF storage shed to the handover platform. The direction of travel and train orientation is as shown in Figure 1. No passengers were on the LRV at the time. The speed of the train through the movement ranged from 0 to 10 km/h.

As the multiple unit consist moved through curve 19, the IMC and LMC1 bogie on LRV16 derailed. The detailed sequence of events as below.

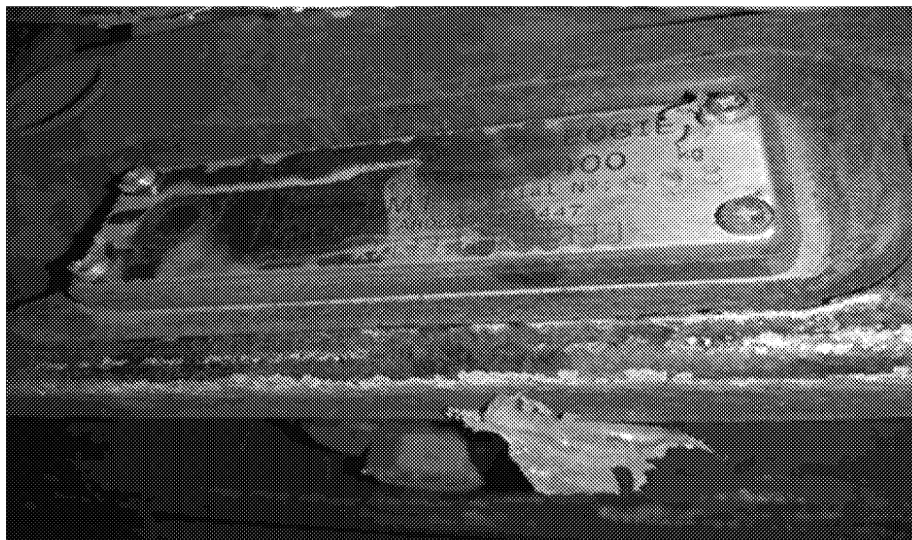
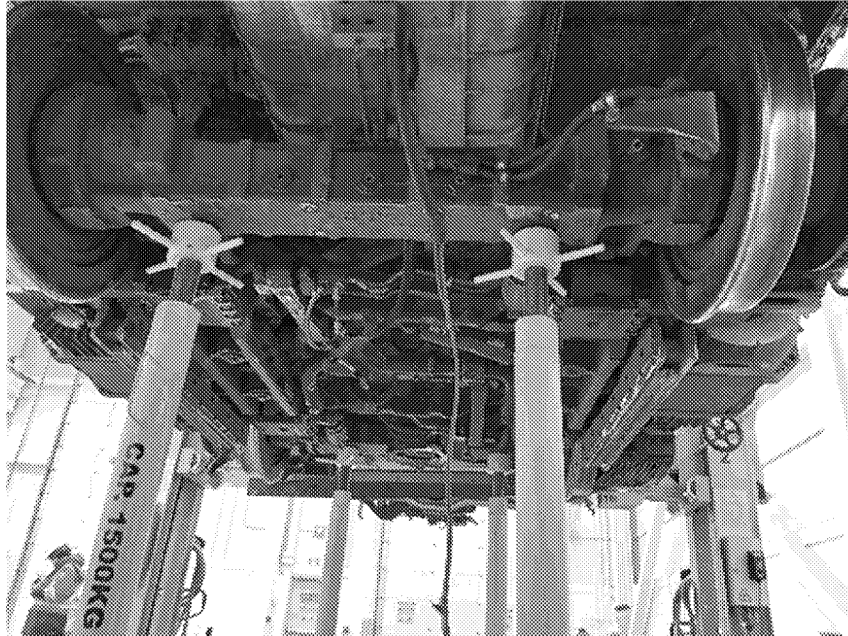
Figure 19. Bogie BM1

- LMC1 BM1 bogie overview

- LMC1 BM1 impact on anti-roll bar

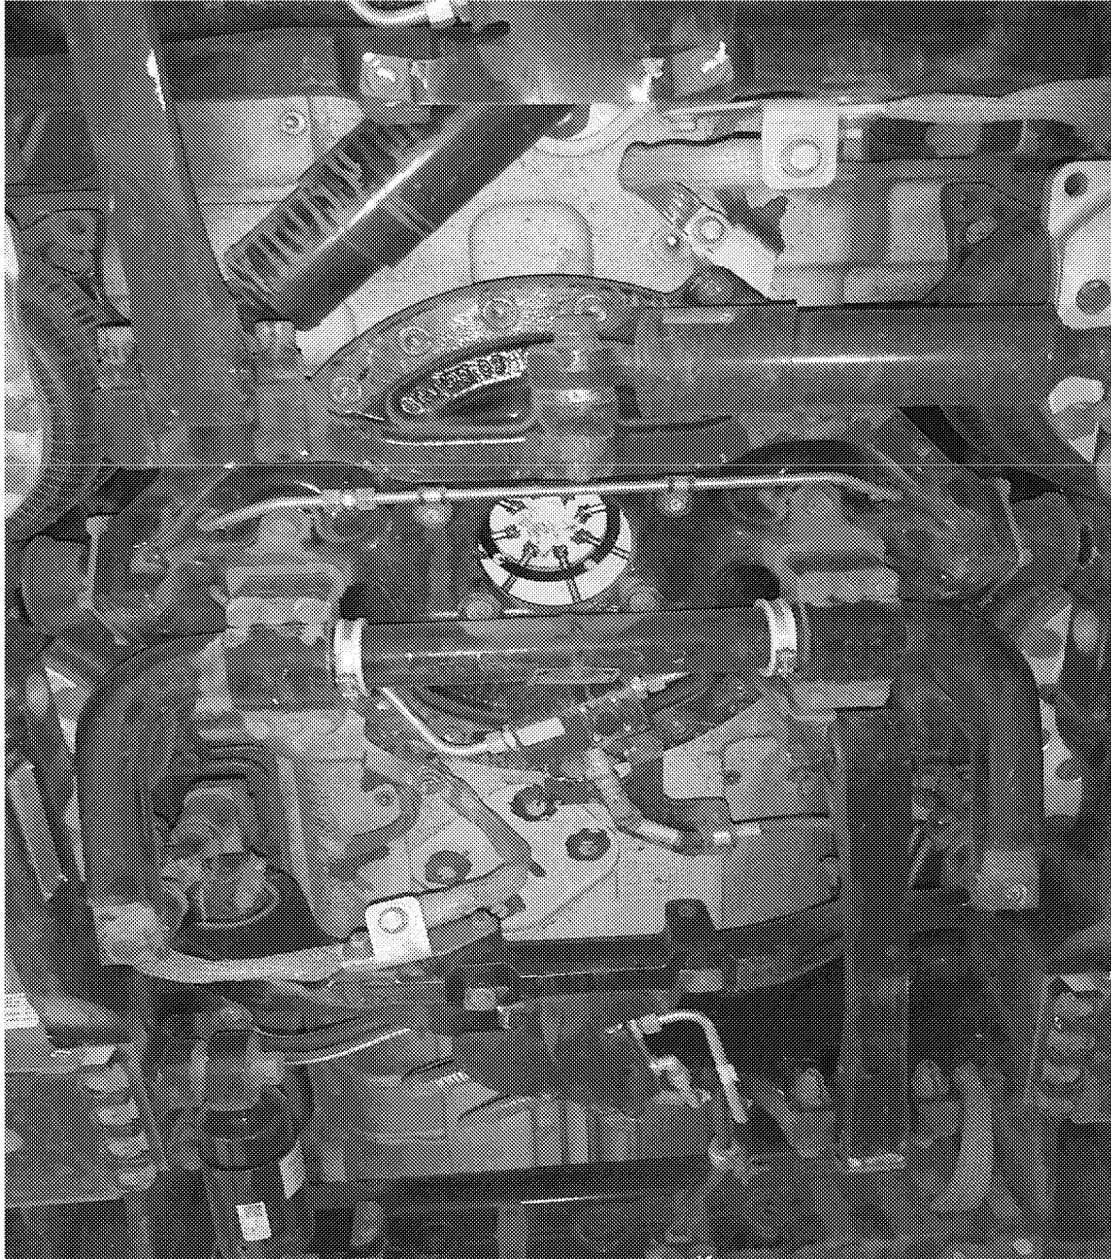
Figure 34. Bogie BP1

- Broken bolts on Loom brackets with the thread stubs stuck in bolster frame

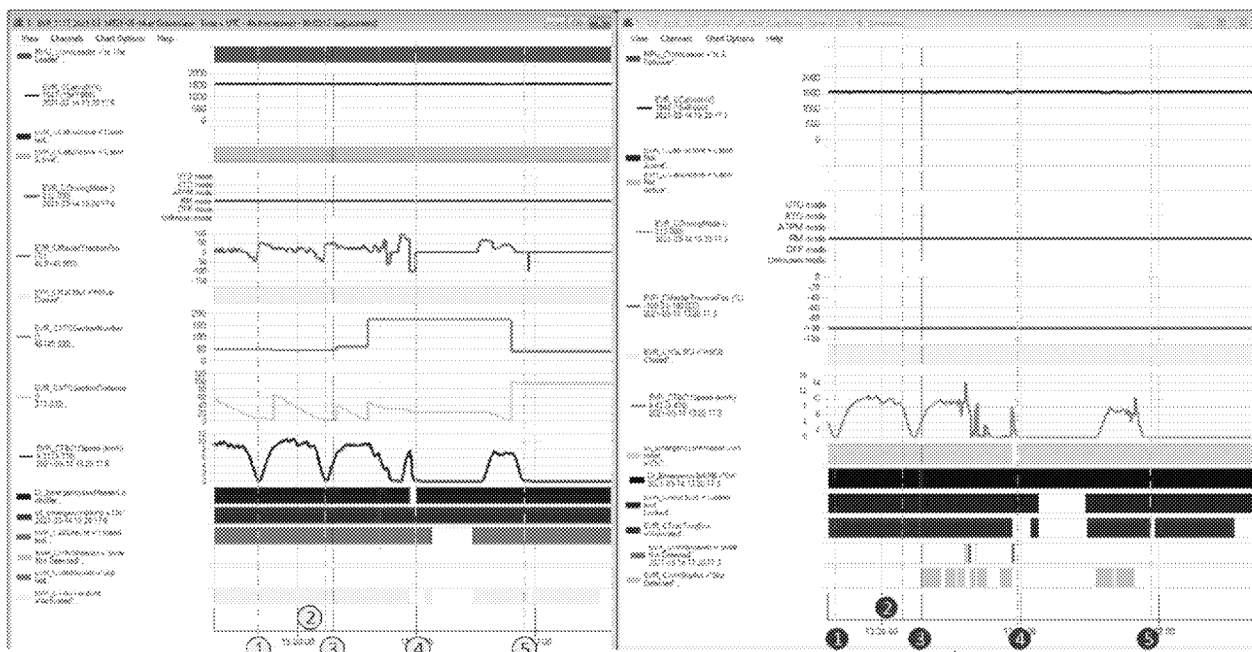
Figure 41. LRV EVR Logs – LRV17 [Left] & LRV 16 [RIGHT]

The event recorder logs for both LRV17 and LRV16 is shown in Figure 41. The corresponding physical location of the train (nose of leading and trailing cab) is marked as shown in Figure 1

The logs show that at all time the train were within the speed limits of the track. As well, it is evident mechanical brake on all bogies applied and released properly (evident by the presence of the traction authorization).

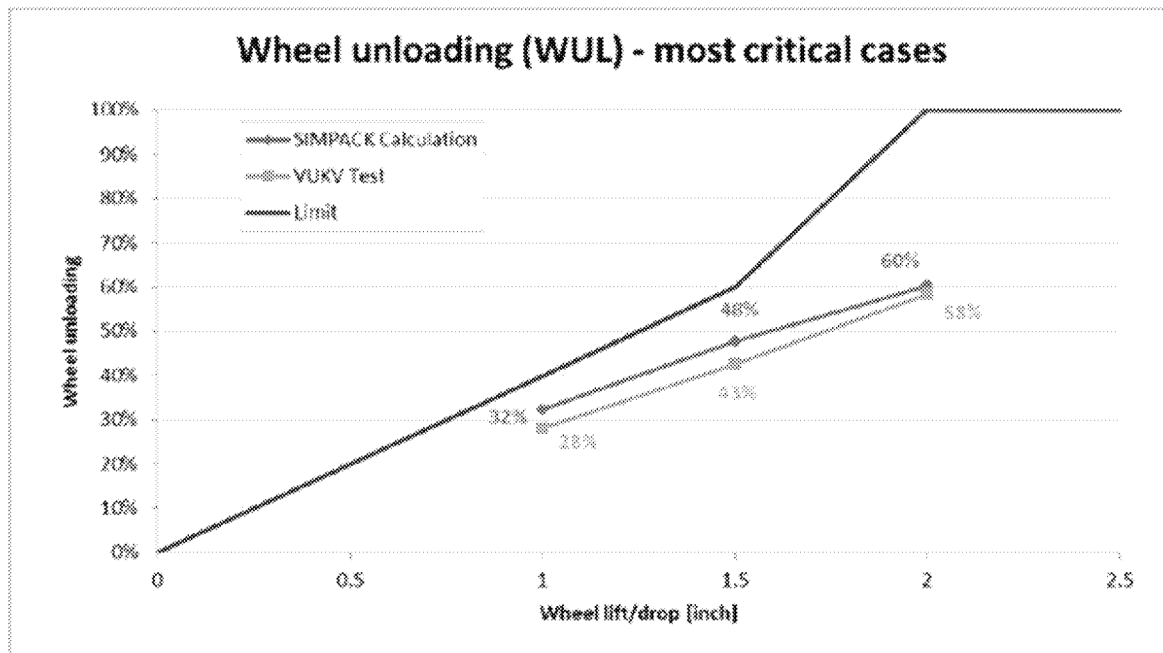
Figure 48. Comparison of simulation and test results of wheel load equalization test

The validity of the vehicle model for assessment of derailment safety has been checked based on wheel load equalization test. The diagram below (Figure 14) shows that the wheel unloading in case of single wheel elevation estimated by simulation fits with the test results, with a gap between simulation and test limited to 2-5% (simulations results being slightly conservative).

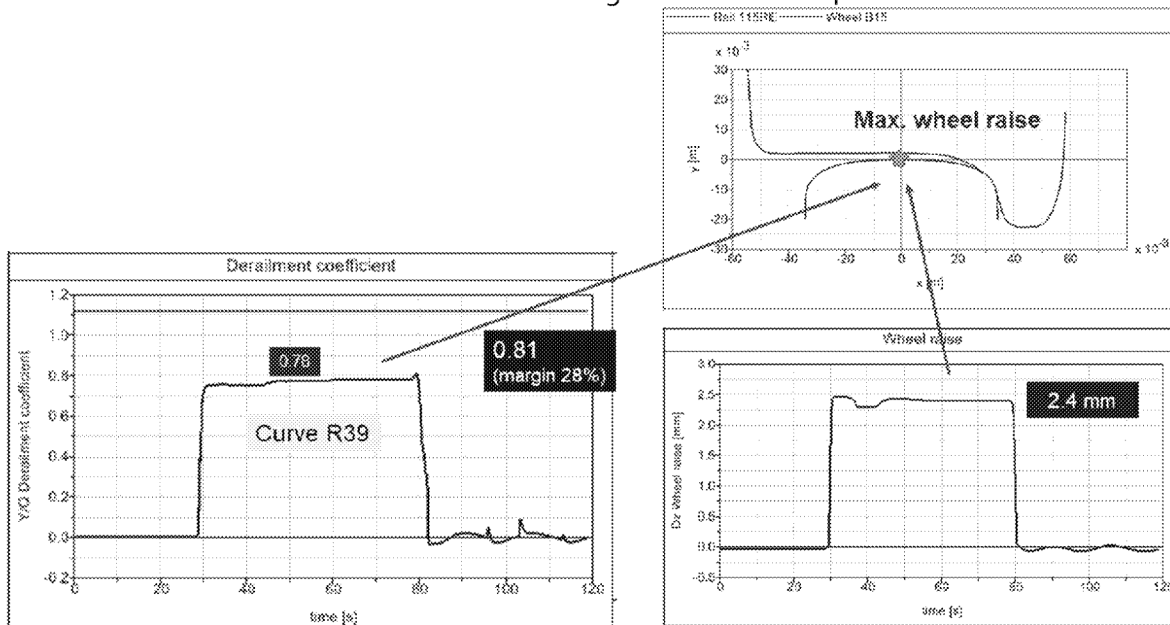
Figure 50. Case A – Time signal of L/V ratio and wheel raise at leading outer wheel

Case A – Reference conditions	
Vehicle mode	Nominal
Wheel/Rail profile	B15/115RE-8
Friction coefficient	0.5
Speed	Low (5 km/h)
Track geometry	R = 39 m, 7 mm cant, twist 3.7mm

In reference conditions the simulation shows no risk of derailment. Time signal of L/V ratio reaches its maximum at 0.81. Maximum wheel raise at leading outer wheel is 2.4 mm.

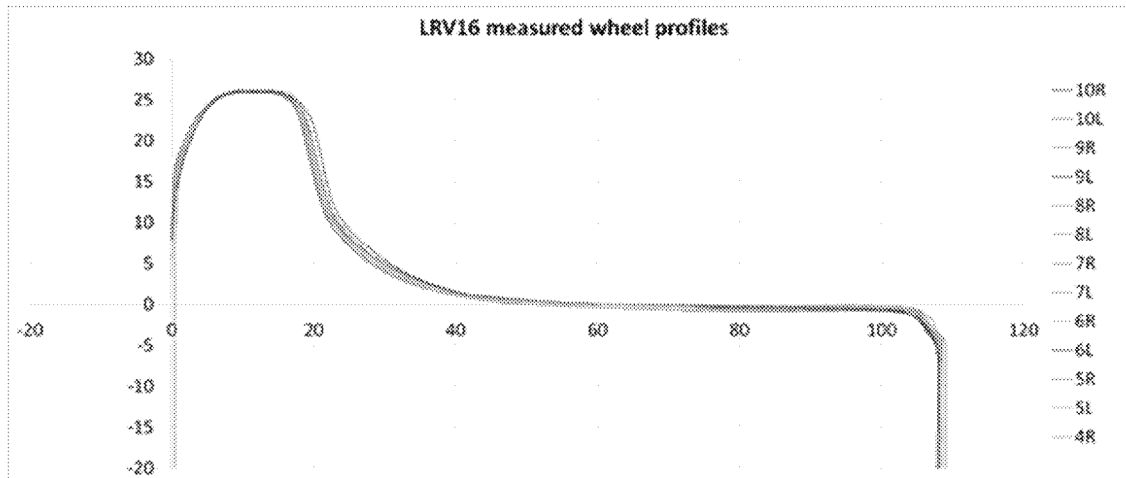
Figure 51. Measured LRV16 wheel profiles (Calipri measurements)

The measured wheel profiles of LRV16 correspond to worn B15 wheel profile. These profiles are not evolving in an unexpected way. The influence of wheel geometry on the simulation results is negligible. Nevertheless, it must be noted that increased wheel flange roughness linked to wheel wear may increase wheel/rail friction coefficient.

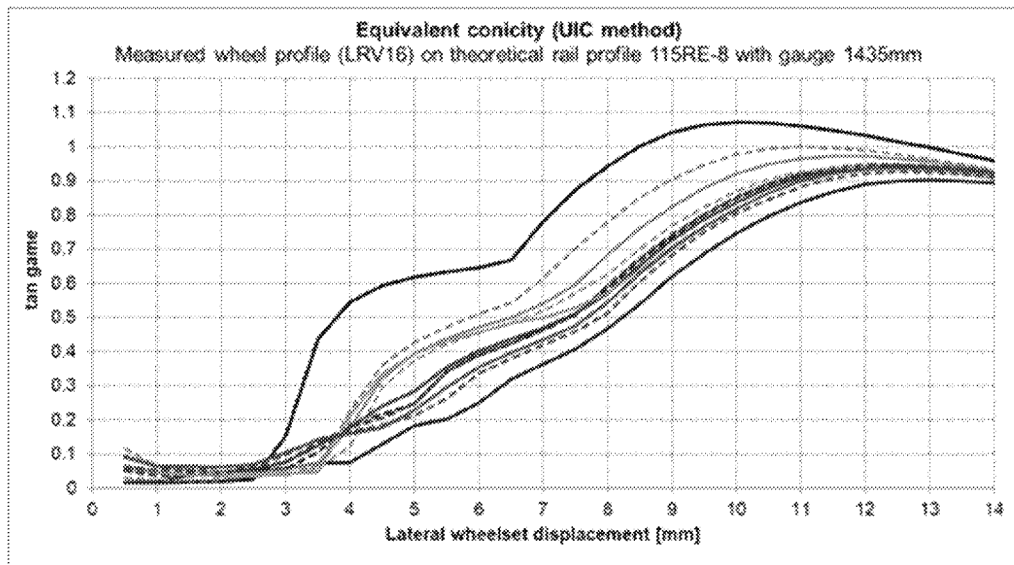
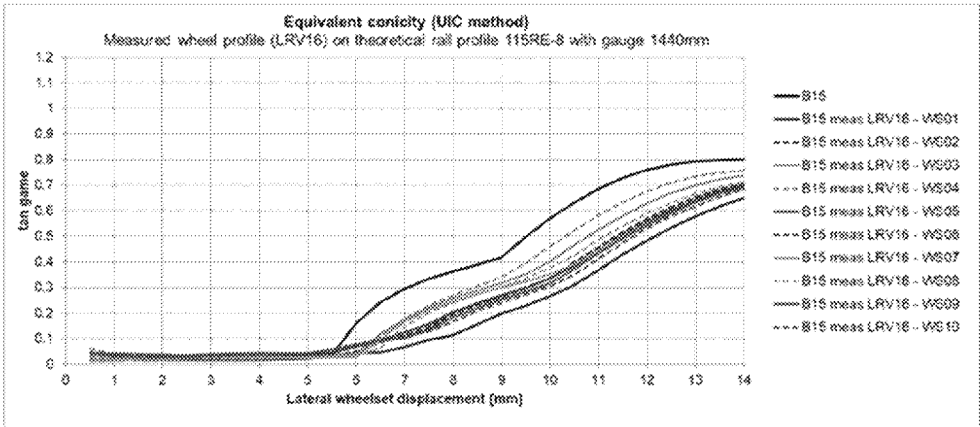
Figure 52. Comparison of track gauge influence on the equivalent conicity (UIC method)

The simulations with increased track gauge (1440 mm) showed little impact on the derailment safety margin: L/V ratio is 0.8, wheel raise is 2.7 mm.

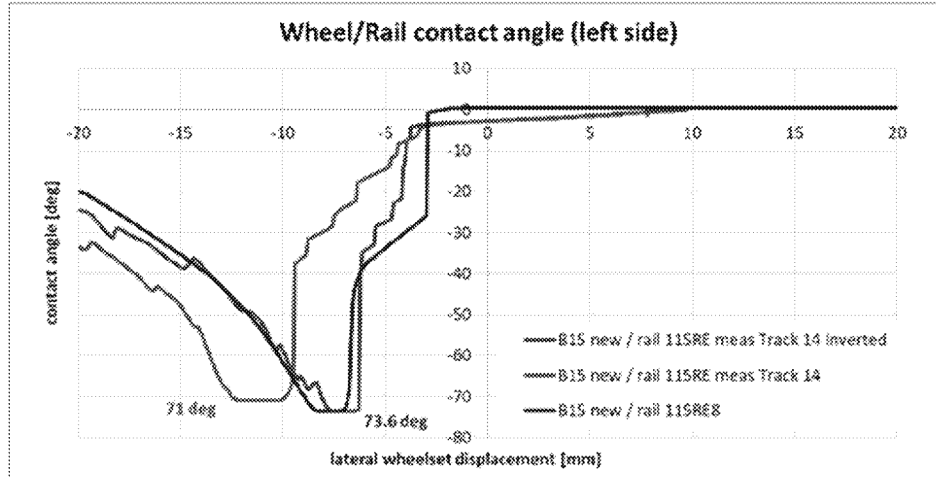
Figure 55. Influence of track 14 rails transposing on wheel/rail contact angle

The simulations with transposed measured outer and inner rails of track 14 showed the increase of safety margin by 6% compared to non-transposed rails. L/V ratio is 0.78, wheel raise is 3.2 mm. Wheel/rail contact comes back to nominal configuration.

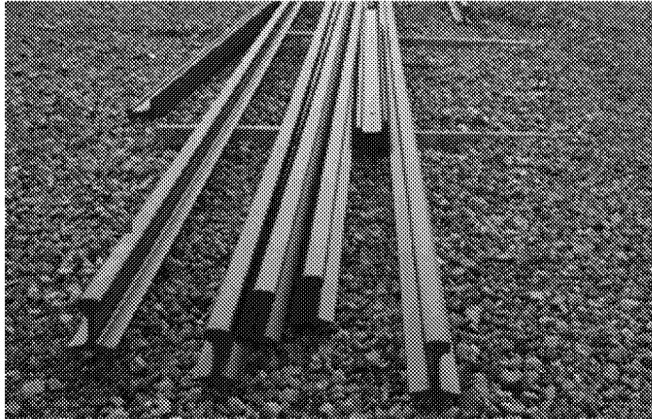
Figure 56. Rail Profile Captured [reference A]

- A. Profile of 2 piece of uninstalled spare rail in MSF

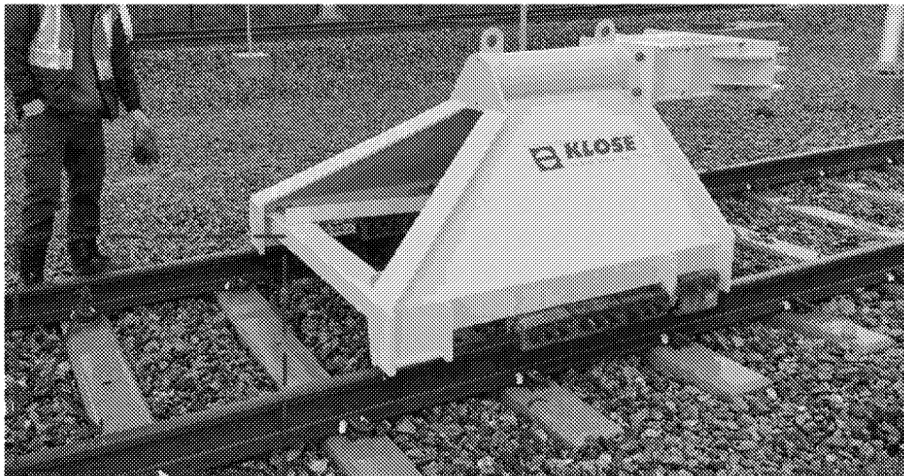
Figure 57. Rail Profile Capture [reference B]

- B. At BLR-Track 1 behind the rail arrestor

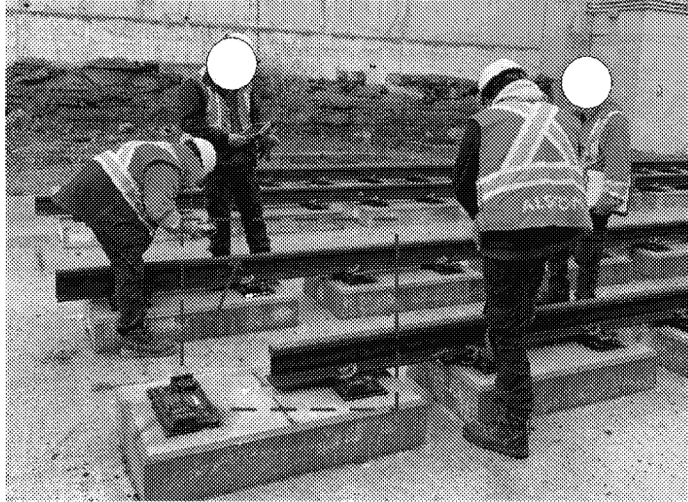
Figure 58. Rail Profile Captured [reference C]

- C. TUN-Track 2 behind rail arrestor

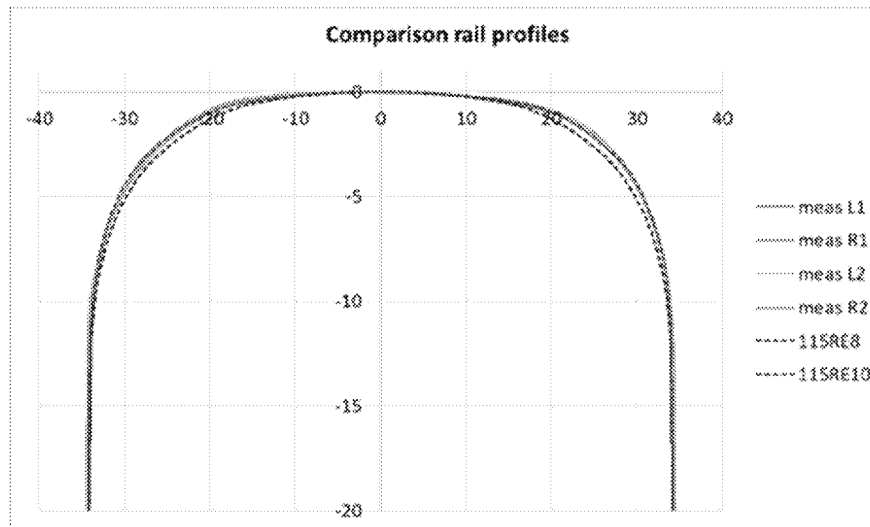
It was also observed that theoretical rail profile with 10" crown radius is more representative for the measured new rail profile in Ottawa, rather than 8" crown radius as per the design. Figure overlays the measured rail profiles against the theoretical 115RE8 and 115RE10 profiles.

Comparison of theoretical profiles 115RE-8, 115RE-10 with measured new rail profiles at MSF (reference A).

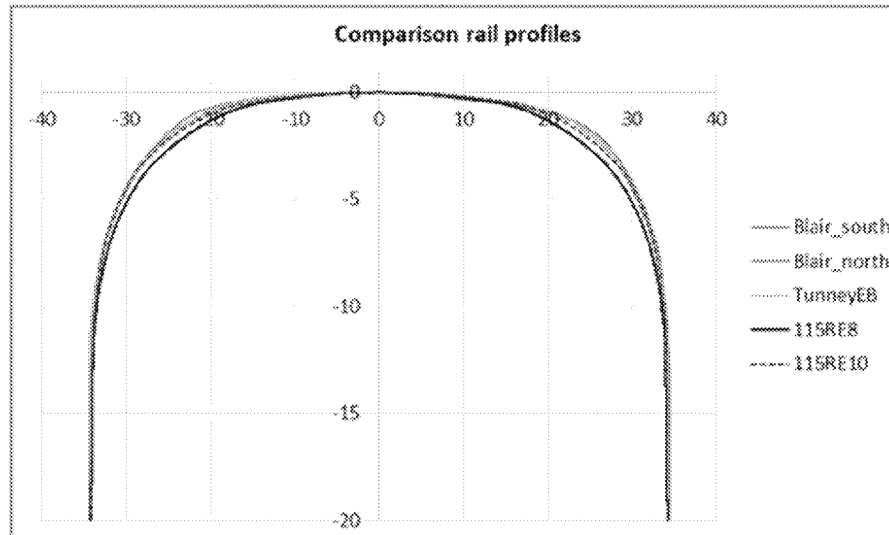
Comparison of theoretical profiles 115RE-8, 115RE-10 with measured new rail profiles at Blair (reference B).

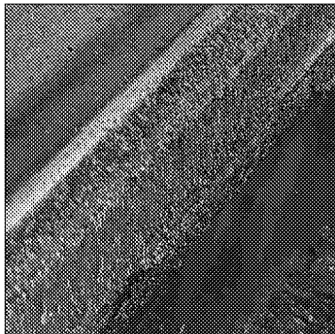
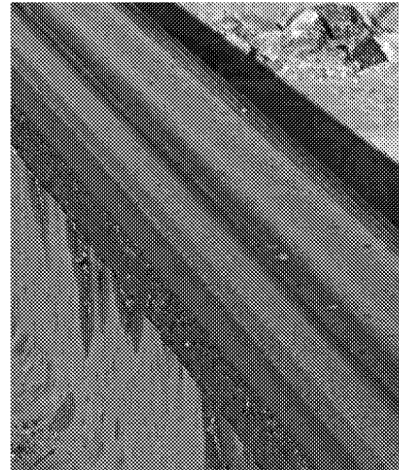
Before

Since this implementation, the gauge face on the rail has become noticeably less rough (based on visual inspection).

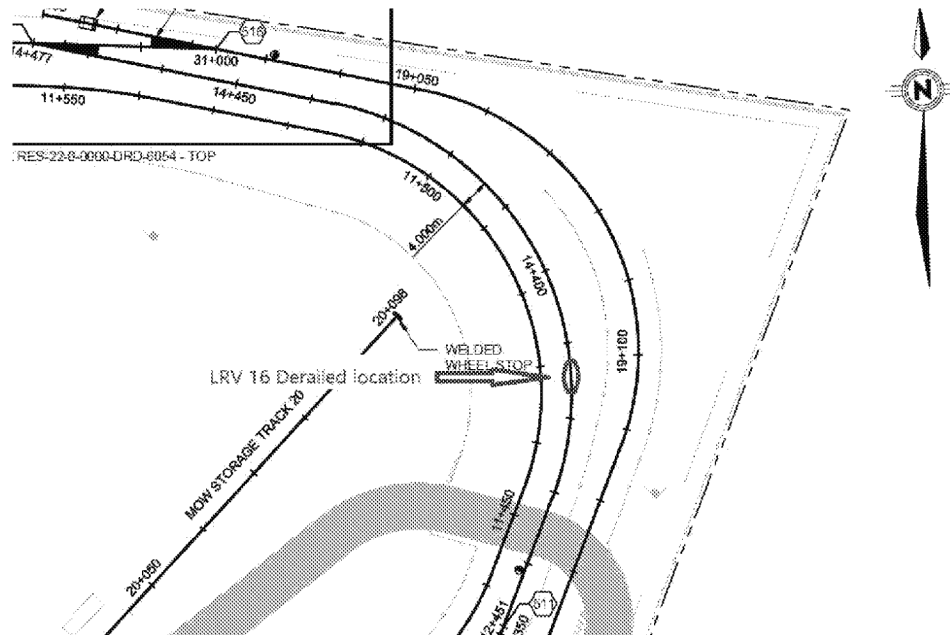
Figure 1 – Derailment location on Track 14 Curve 19 in the MSF Yard

On 14 March 2021, at approximately 13:19, Ottawa Confederation Line LRV 1116 derailed at low speed in the maintenance and storage facility Yard (MSF) during a routine move from the storage area to the handover platform. The derailment occurred on Track 14- Curve 19 at chainage# 14+386 (+/- 2 m) (Figure 1).

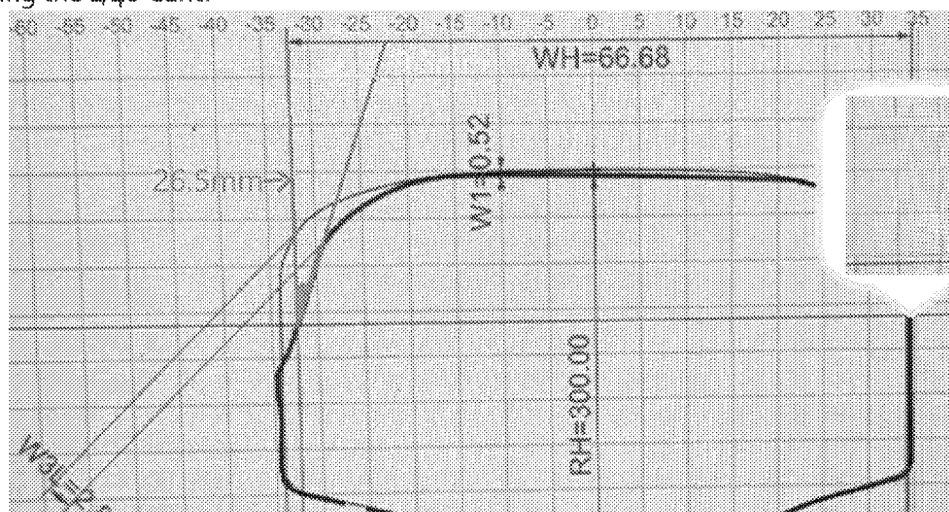
Figure 7 Gauge face angle calculation

By the Calipri measurement on the outer rail at the flange climb location (Chainage#14+386), the calculated Gauge Face Angle (GFA) is 18.29 degrees (Figure 7) at the flange climb location, after considering the 1/40 Cant.
