The purpose of this report is to document the investigation to the derailment and present the containment actions, root causes, and recommended next steps.

On 8th August 2021 at 20:16hrs, Ottawa LRV 1119 derailed approximately 110m after departing from Tunney's Pasture LRT station travelling in an Eastbound direction. The LRV eventually came to a stop approximately 165m after the derailment. See Figure 1 below.

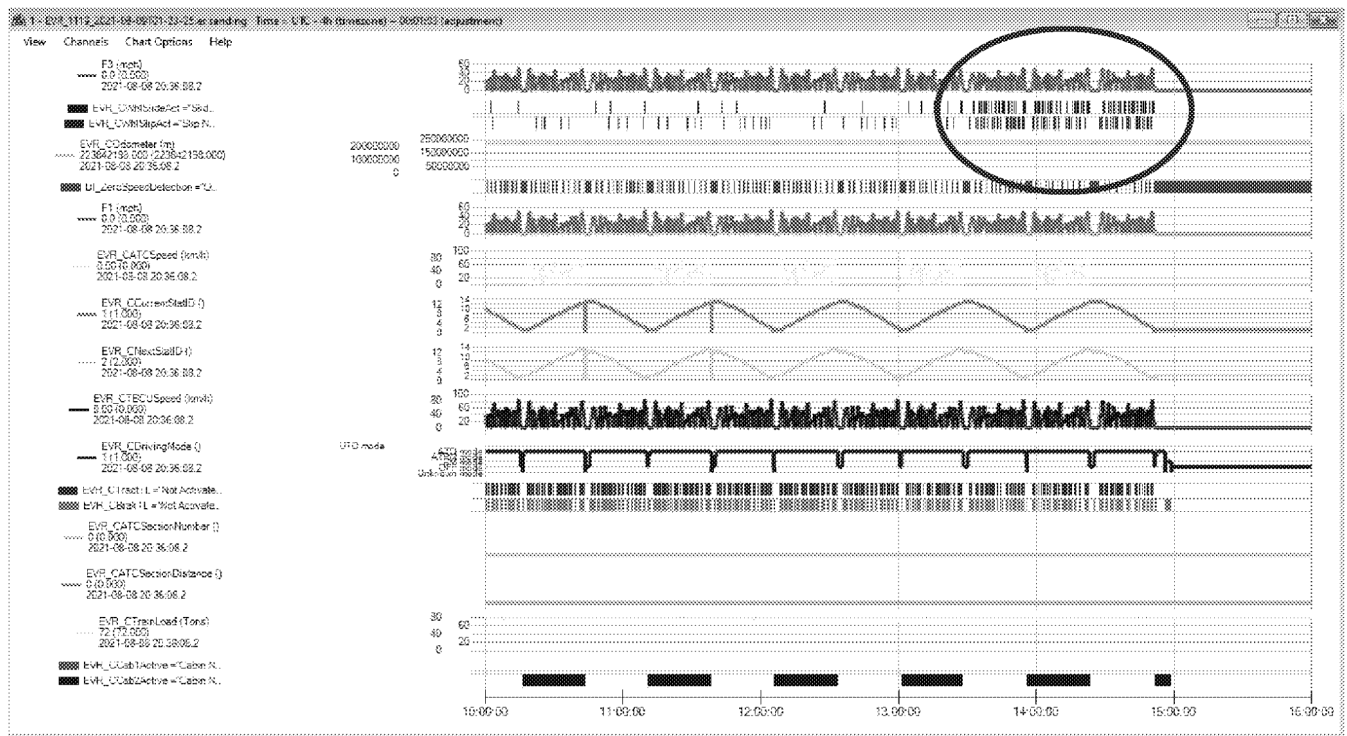
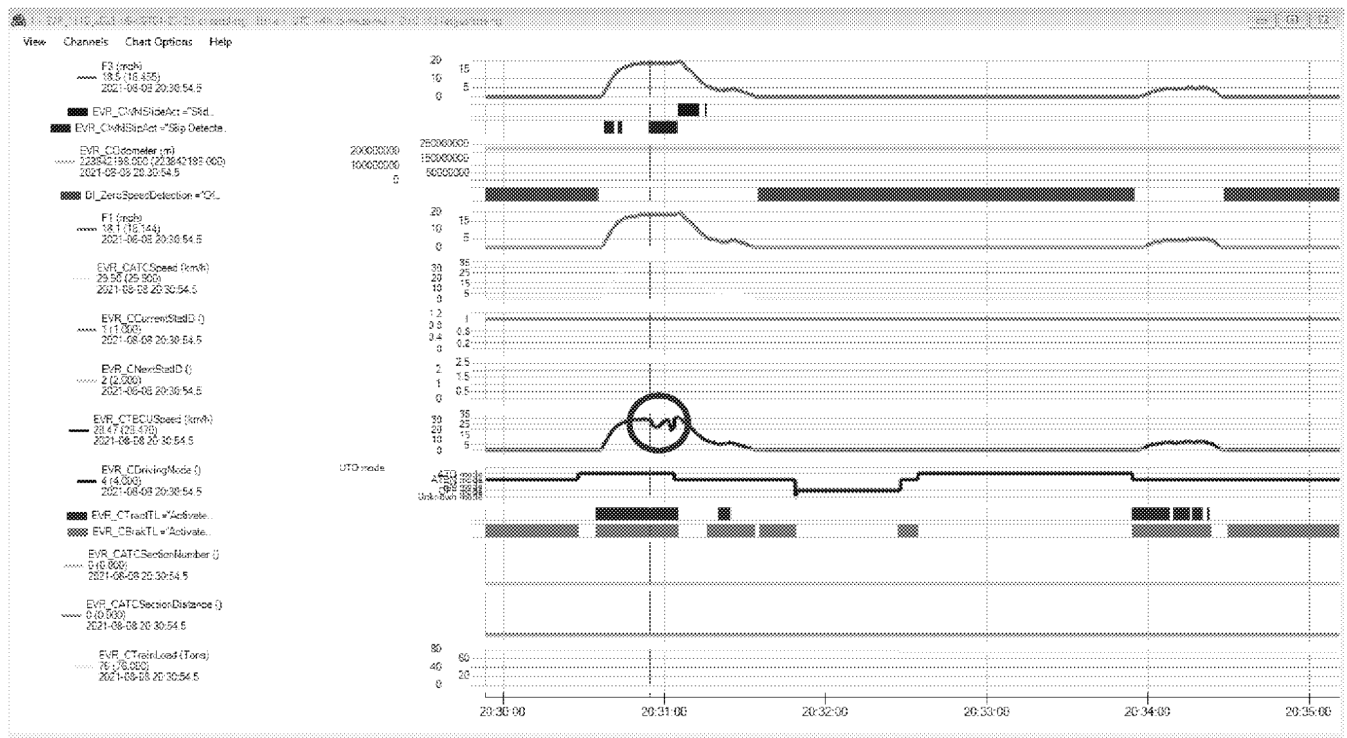
TS19 EVR

Over this period the train operated at what appears for all purposes at a normal revenue speed profile with the exception that TS19 had an unusually high number of spin slide events especially in the final 90 minutes prior to parking the train at Tunneys. See the two Event Recorder charts below showing TS19 and TS15

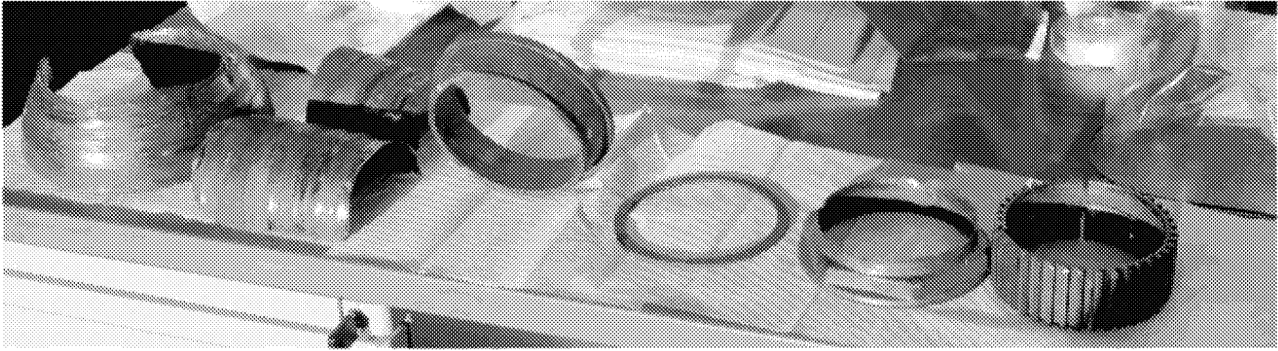
The following parts, arranged somewhat in the order of assembly, are hub assembly parts that were found at the derailment site distributed along the east bound section of the track after switch 302

In this sequence of parts, the only parts unaccounted for are the spacer between the thrust washer and the bearing race which was subsequently found, and the rolling elements of the inner bearing. 9 of 19 were ultimately picked up at the derailment location. None of the rolling elements of the outer bearing were found at the derailment site. Ultimately 4 of the 30 rollers from the outer bearing were found at uOttawa and at switch 309

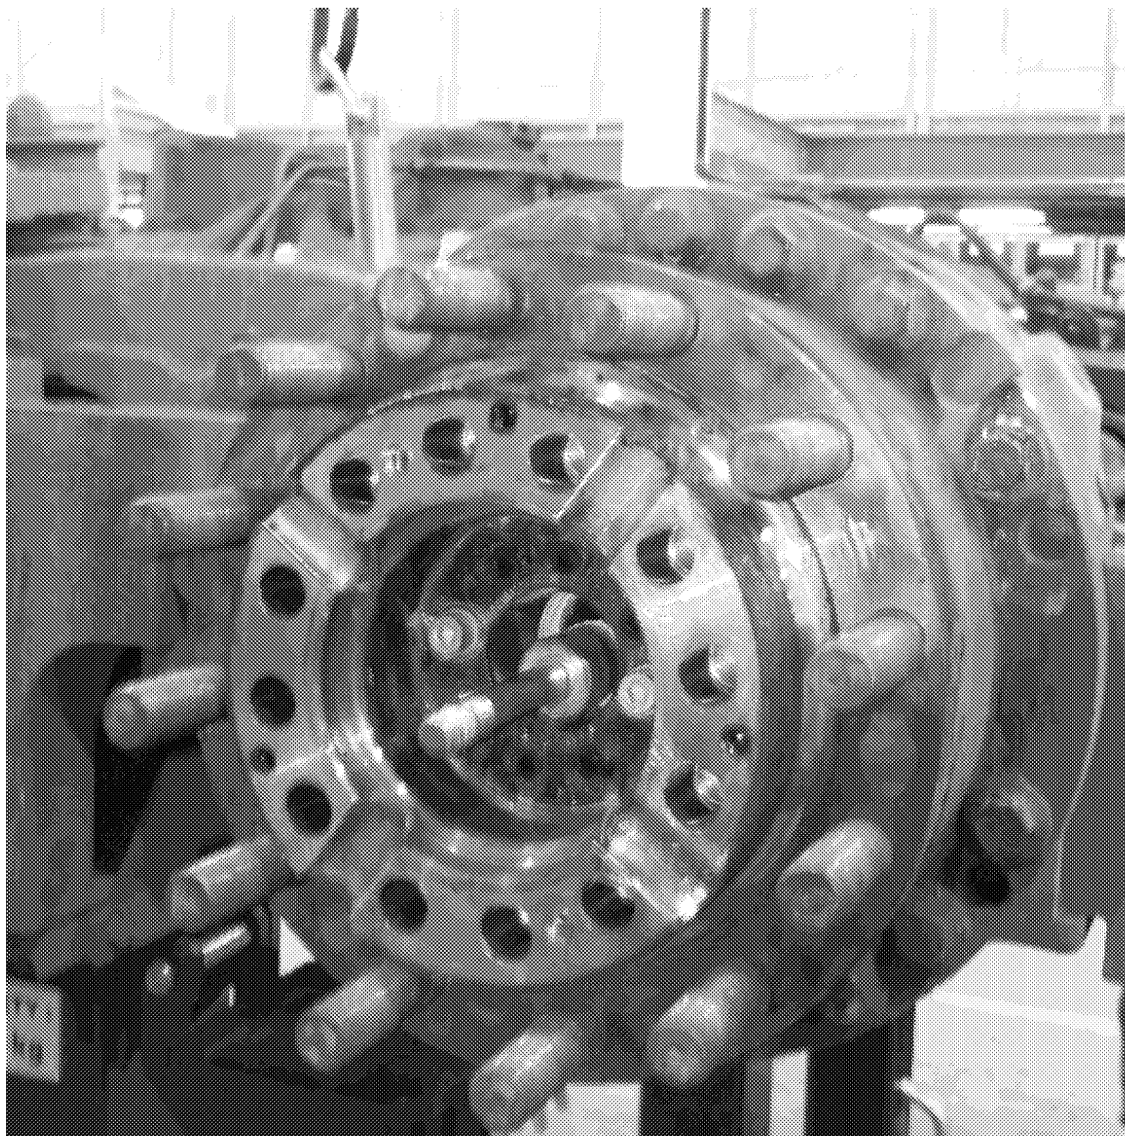
View of hub installed on the axle beam, ready for disassembly

Prior to the removal of the hub, the axle backlash of the axle splines was checked and found to be 20mm.

The defective hub, shown in figure 1 below is number 191843R

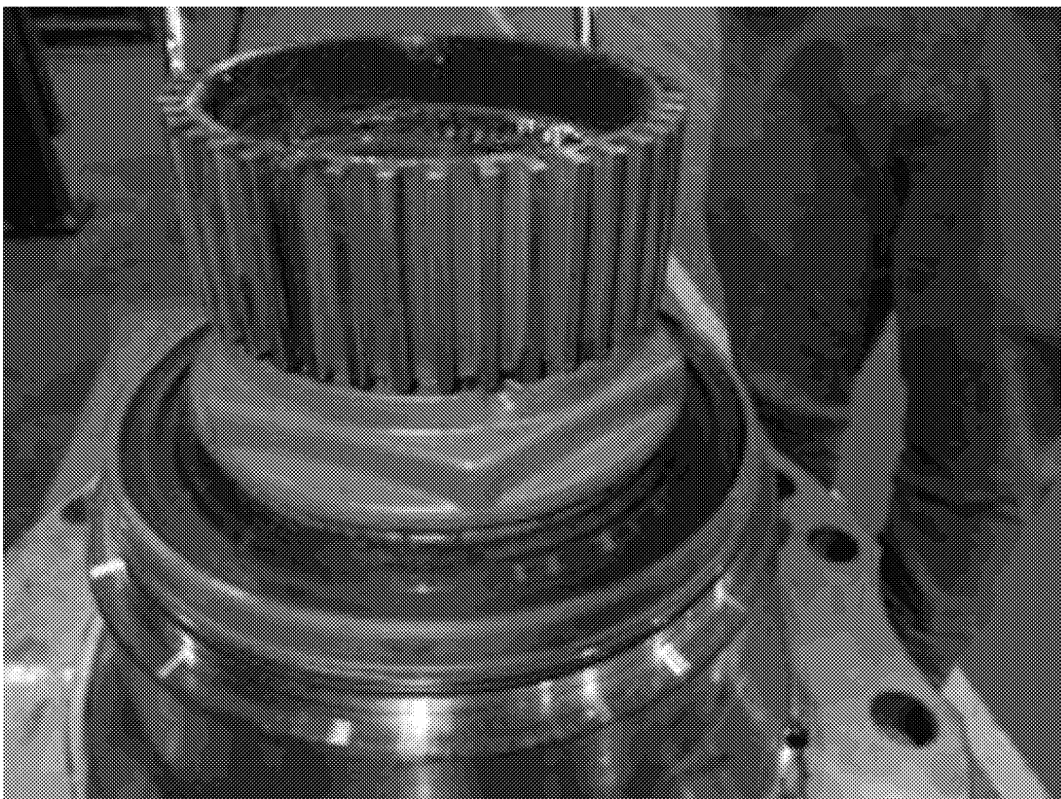
View of the speed sensor target wheel, and bearing retention nut

The cartridge was set on a bench, and the bearing retention nut was checked for tightness and for the depth of the mechanical "Swaging" of the nut into the shaft slots. One of the swage marks is visible in the figure below.

The nut was found to be completely loose, and could be turned back and forth within the width of the slot it should extend into.

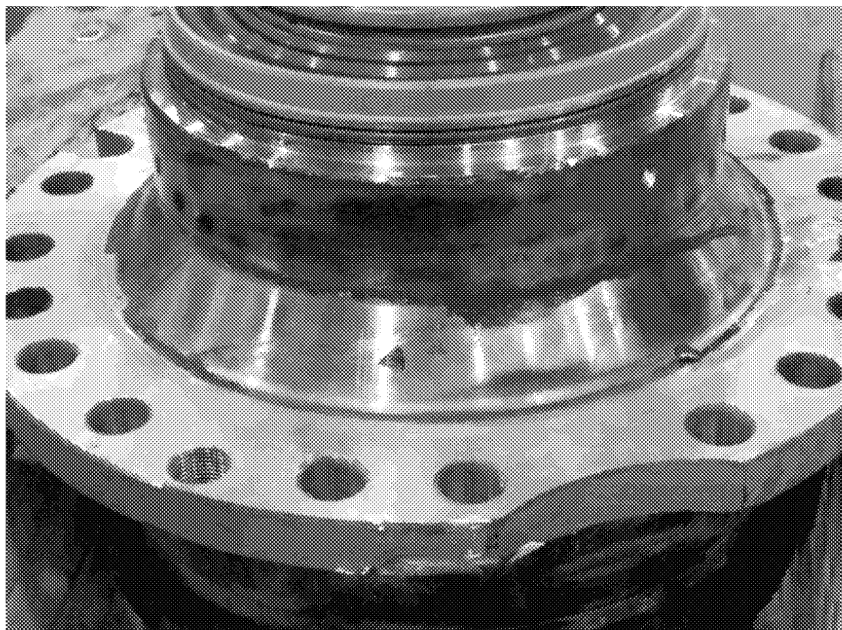
Opposite side hub assembly removed

The opposite side bearing cartridge was removed and inspected, overall while there was some discoloration it was less than on the side with large axial clearance in the bearing, The bearing locking nut was checked and found to be tight with no play.

As an overall comment, the condition of the rollers and race where the appearance was shiny and not "frosted" suggests that there is no damage from electrical discharge.

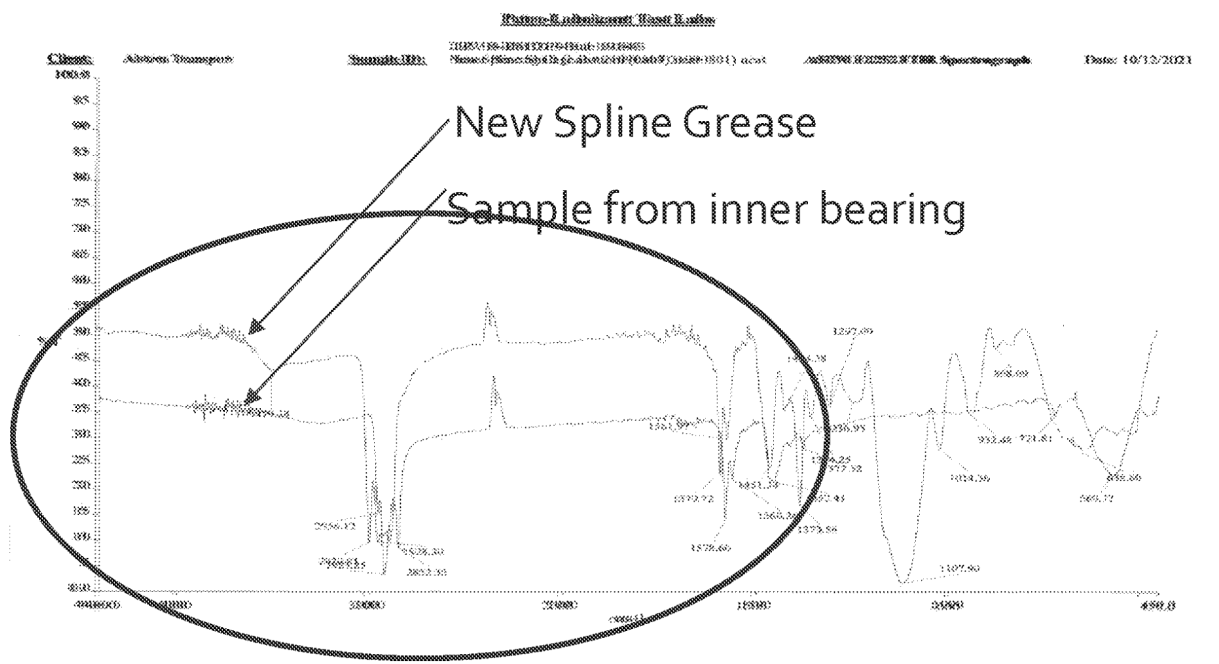
One sample taken from the inner bearing, exhibited a similar spectrum over the range of wavelengths between 1000 and 4000 nm to that of the spline grease.

This can be seen in the charts below that were overlayed in a photo editor for direct comparison

It is difficult to imagine a means of the spline grease entering the bearing area of the CBA.

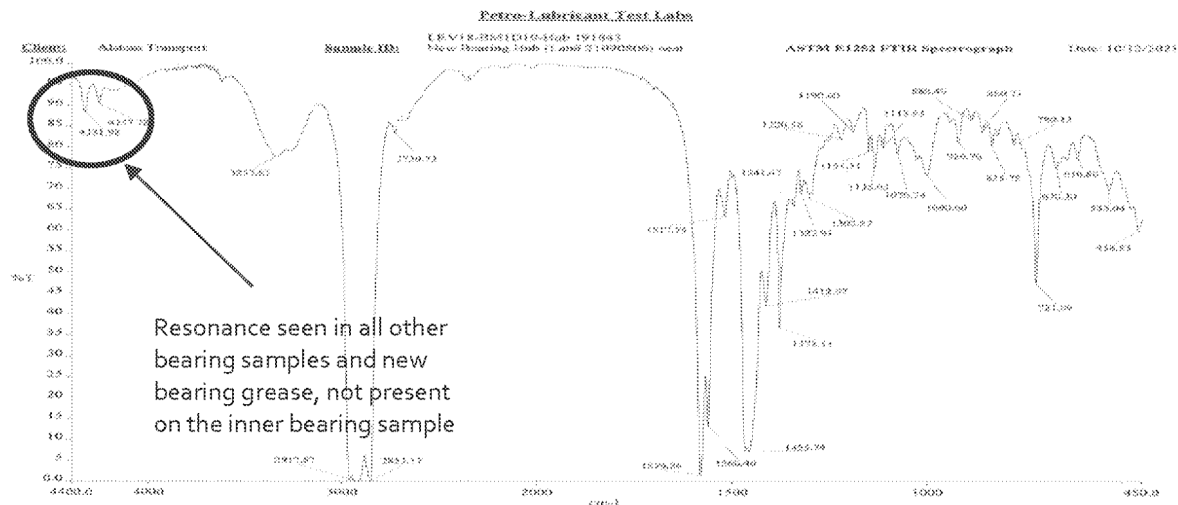
In addition, this sample is missing a resonance observed in all other samples taken from the internal area of the CBA, as can be seen below.

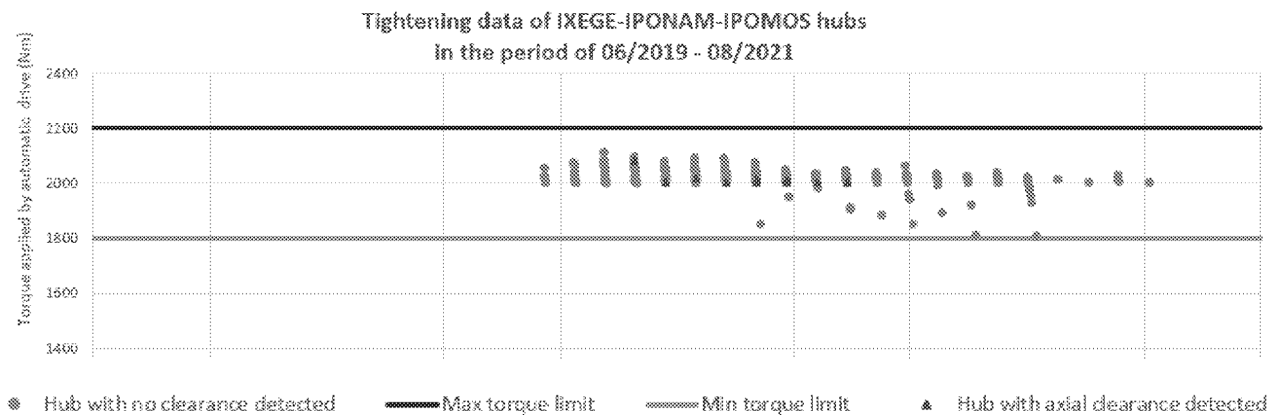
Figure 1. Historical data of retention nut tightening values during fabrication in Texelis 06/2019-08/2021

The measurement of residual torque values of the retention nut during the expertise of the hubs with the axial clearance revealed that there is no loss of initial torque value.

Taking into account the above-mentioned findings the torque application was excluded from the possible root-causes of the axial clearance apparition.

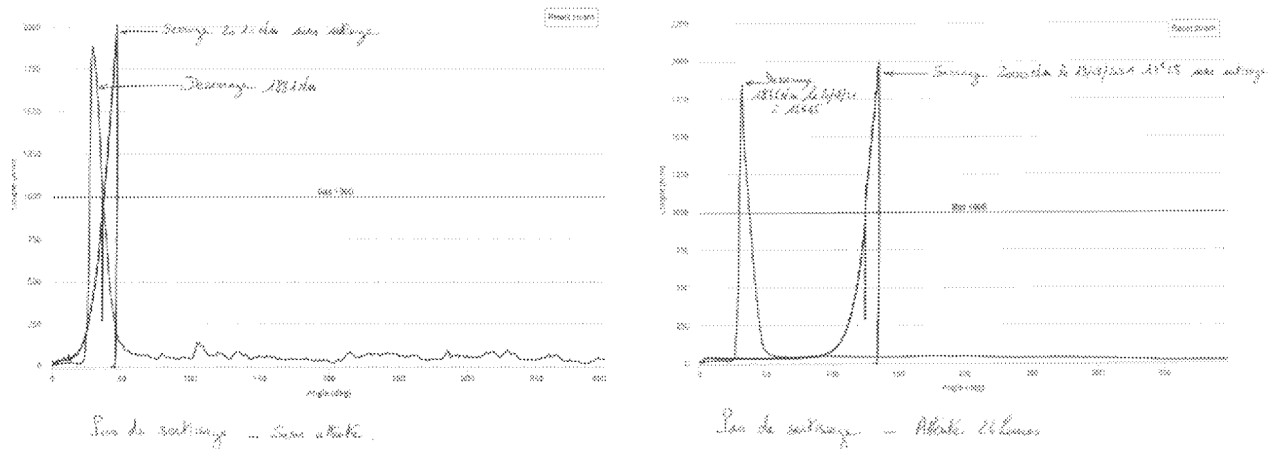
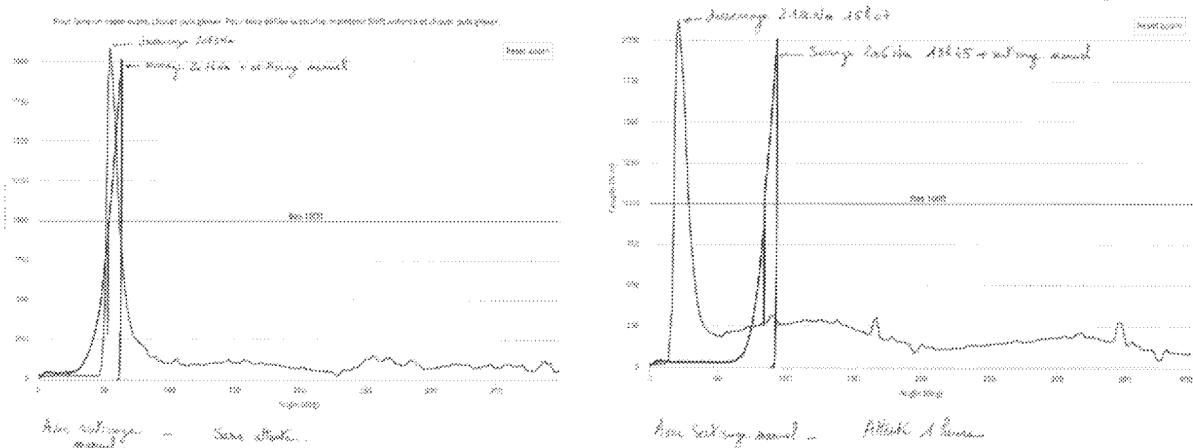
A series of tests were realized to determine the influence of nut crimping on the nut torque value. The first series of test consisted in a) tightening a nut to 2000 Nm without crimping and measuring the residual torque immediately after and b) tightening a nut to 2000 Nm without crimping and measuring the residual torque 1h after. The second series of test consisted in a) tightening a nut to 2000 Nm, manual crimping and measuring the residual torque immediately after and b) tightening a nut to 2000 Nm, manual crimping and measuring the residual torque 1h after. The resulting torque-angle curves are given on Figures XX.

We can conclude that crimping of the nut has no influence on the nut torque value.

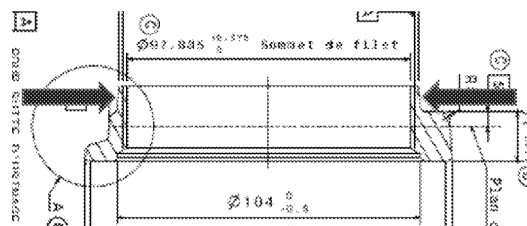
- before crimping ovalization of 0.02
- after crimping ovalization of 0.4

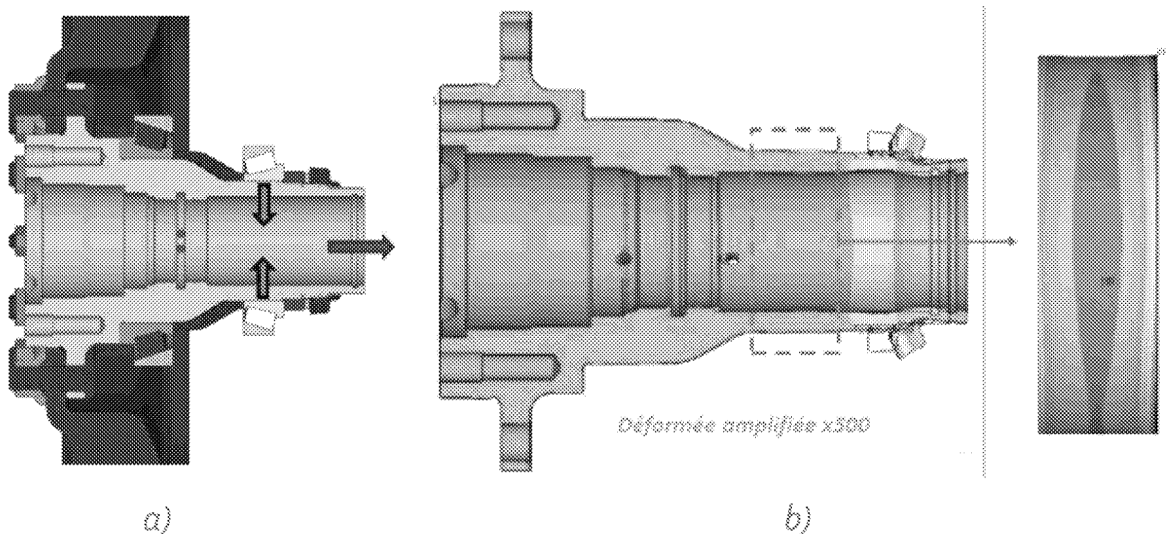
Figure 10. The effect of nut tightening on the hub: a) elongation of the hub body and subsequent diameter reduction; b) the reduction of hub diameter is of the order of 1-2 micron (blue area)

The tightening of the retention nut leads to the elongation ("stretching") of the hub body resulting in the reduction of the diameter of the hub. This is illustrated on Figure X, a. That diameter reduction, in turn, could cause the loss of fit of small bearing inner ring. To verify this hypothesis finite-element calculations of the hub model were performed. These calculations showed that under nominal torque of the retention nut (tension force of 100 kN) the reduction of the hub diameter is of the order of 1-2 microns, Figure X, b. Considering that inner ring tight fit during the assembly comprises between 19 and 39 microns the calculated reduction of hub diameter due to nut tightening has a negligible effect and is excluded from the possible root-causes.

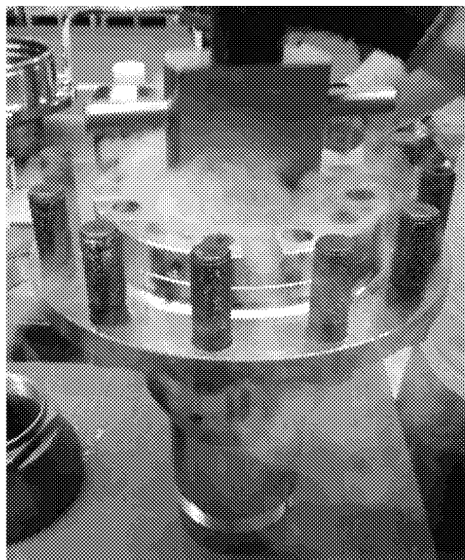
Figure 11. Cold fit of the flange on the hub.

- T0min: Cold mounting of the flange in the hub. Ambient temperature 18.4°C, hub temperature prior to mounting 17.6°C
- T12min: hub temperature 7.3 °C. Removal of the special tool of flange mounting
- T18min: Tightening of the retention nut (2000Nm/20°angle). Note: adjustment preload shim is installed.
- T23min: Start of axial clearance measurement. Hub temperature is 12.3°C
- T25min: End of axial clearance measurement. Registered clearance is 0,06mm
- T1h05: Hub temperature is 16.2 °C. Final torque tightening of the retention nut to 2017 Nm/21° angle
- T1h20: Axial clearance measurement on the hub (retention nut is not crimped). Registered clearance is 0,01 mm
- T8h27: Hub temperature is 18.1 °C Control of axial clearance: 0,01mm. Control of torque tightening: 2087 Nm with angle of 1.1°.

Performed test showed that cold mounting of the flange has no impact on the final axial clearance of the hub assembly.

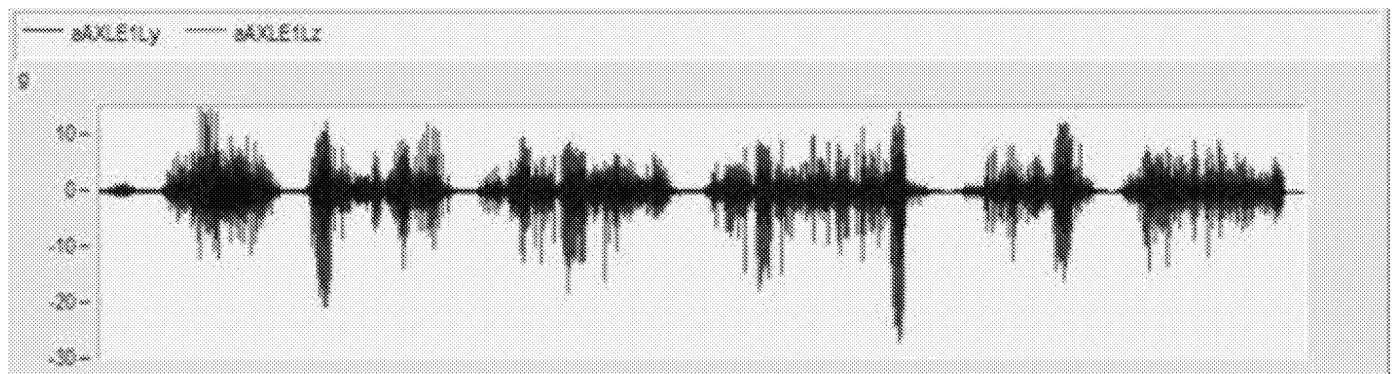
Axle Vibration Measured February 2021

The charts below show the lateral (y axis) and vertical (Z axis) acceleration measured on the bogie axle beam over the alignment.

The surveys show that while there is an overall improvement, i.e. reduction in vibration induced from the track, there remain spots that still lead to higher than normal vibration.

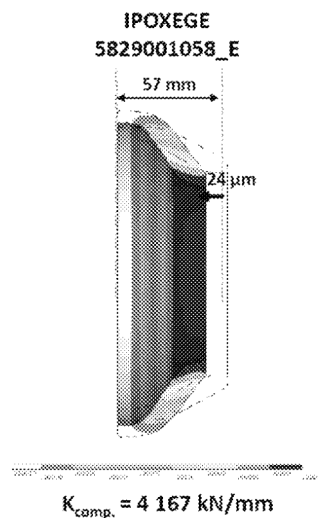
Figure 13. The deformation of the spacer under load of 100 kN

According to finite-element calculations the deformation of the spacer (pos.10, Fig.3) under the load of 100 kN remains in its elastic zone (when external force is removed the spacer returns to its initial form). Thus, the behavior of the spacer resembles the behavior of the spring washer. This behavior is rather favorable for the hub assembly in the sense of participation to conservation of the assembly pretension.

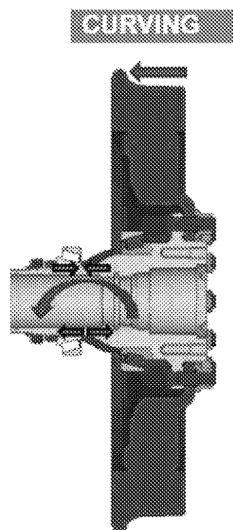
Figure 14. Influence of lateral force on the wheel hub

During the passage of the train in the curves considerable lateral forces are experienced by the wheelset (wheel flange pressed against the rail). These lateral curving forces could lead to bending of the hub and consequent axial and/or radial contact opening between the parts of the hub assembly illustrated on the Figure X.

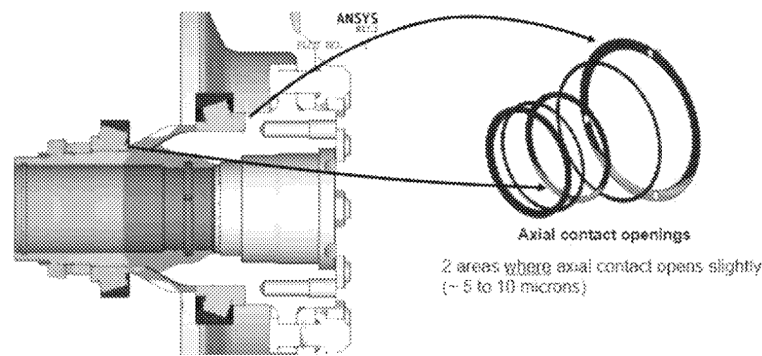
Figure 15. Areas of axial contact opening due to lateral curving forces

- Risk of axial contact openings (Figure X)
- Extension of the open contact when transversal load increases (Figure X)
- Contact pressure below the inner ring reduces when curve loads increase

Curves in OTTAWA present a transversal rail corrugation which potentially increase the risk of fretting corrosion.

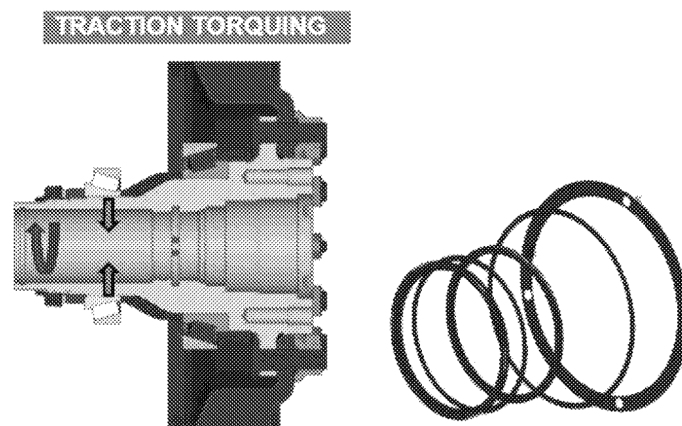
Figure 17. No contact opening due to traction torque

- No opening of the axial contacts due to transversal inertia. Torque generated at the bearing much lower than generated through curves.
- Limited contribution of the Inertia loads due to the gearbox. However, due to rail corrugation, combined effect with the curve loads increasing the risk of fretting.
