Ottawa LRT Independent Review Report

April, 2022
Confidential

City of Ottawa
c/o Singleton Urquhart
Reynolds Vogel LLP
150 King St West, Suite
2512
Toronto, ON
M5G 1J9

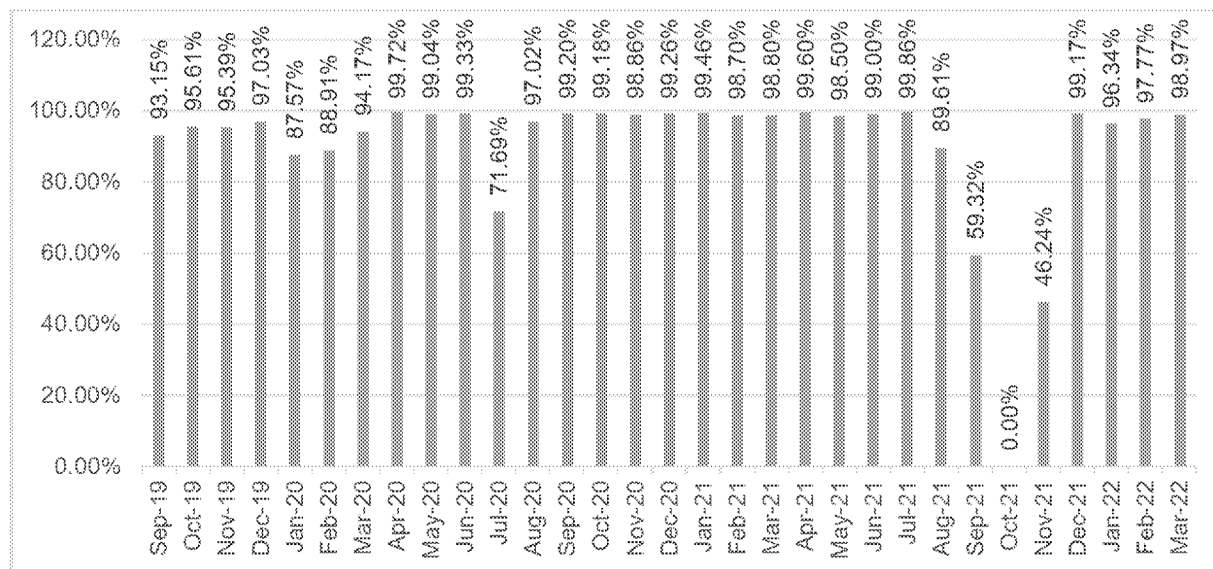
Figure 2.1: Aggregate Vehicle Kms Availability Ratios since September 2019

As captured in **Figure 2.1** below, the Aggregate Vehicle Kms Availability Ratios remained below the 98.0% ratio threshold (hence incurring Failure Points) during 15 of the 31 months between September 2019 and March 2022. More specifically, the 98.0% target was not achieved in September 2019 to March 2020, July and September 2020, August to November 2021, or January 2022 and February 2022.

The performance of Vehicle Kms Availability was notably poor in January 2020, February 2020, July 2020, and August to November 2021, when services were offline because of investigations related to malfunctions (including cracks in the wheels of the vehicles and derailments).

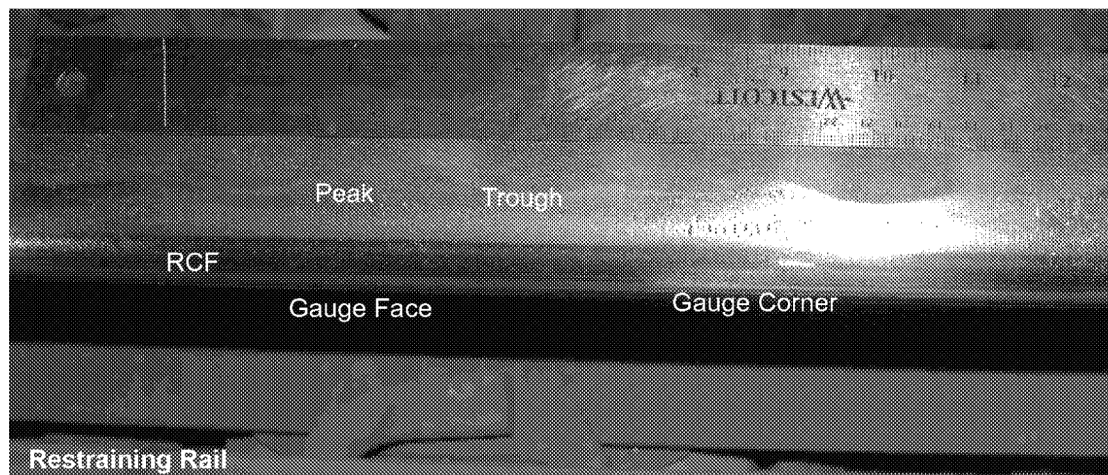
Figure 3.8: Corrugation on Low Rail of Curve 210 at 104+725

Corrugation on the low rail is located near the crown of the rail, **Figure 3.8**, **Figure 3.9** and **Figure 3.11**. There is also wheel contact on the gauge corner and the gauge face shown by the shiny polished surface. In contrast, corrugation on the high rails extends from the crown of the rail through the gauge and down the gauge face in the form of periodic side wear **Figure 3.10** and **Figure 3.12**. **Figure 3.12: Corrugation on High Rail of Curve 330 at 108+685** Figure 3.12: Corrugation on High Rail of Curve 330 at 108+685 shows two types of corrugation on the high rail, a long wavelength at the gauge corner with a shorter wavelength on the crown. There is evidence of plastic deformation occurring in the trough of the corrugation with plastic flow of the rail surface towards the field side away from the gauge corner, **Figure 3.9**. There is also some evidence of material breaking away “spalling” from the surface of the trough, **Figure 3.11**.

RCF in the form of head checks is present on the low rail on some curves, **Figure 3.8**, and **Figure 3.9**. No RCF is present on the high rail on the photographs examined.

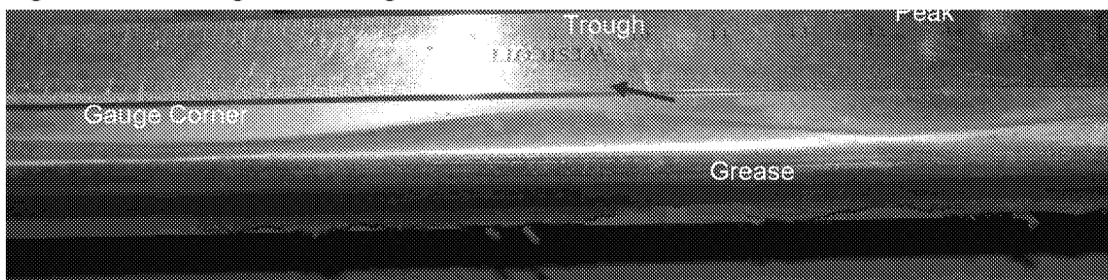
Figure 3.10: Corrugation on High Rail of Curve 220 at 105+115

Grease appears to be present on some curves, **Figure 3.10** and **Figure 3.13**, even though no track side lubricator is present, it is unclear if this is from the on board lubrication system or if it has been manually applied. Although the diagrams in the wheel flats report are not clear the locations with corrugation do not appear to be associated with low levels of adhesion⁴.

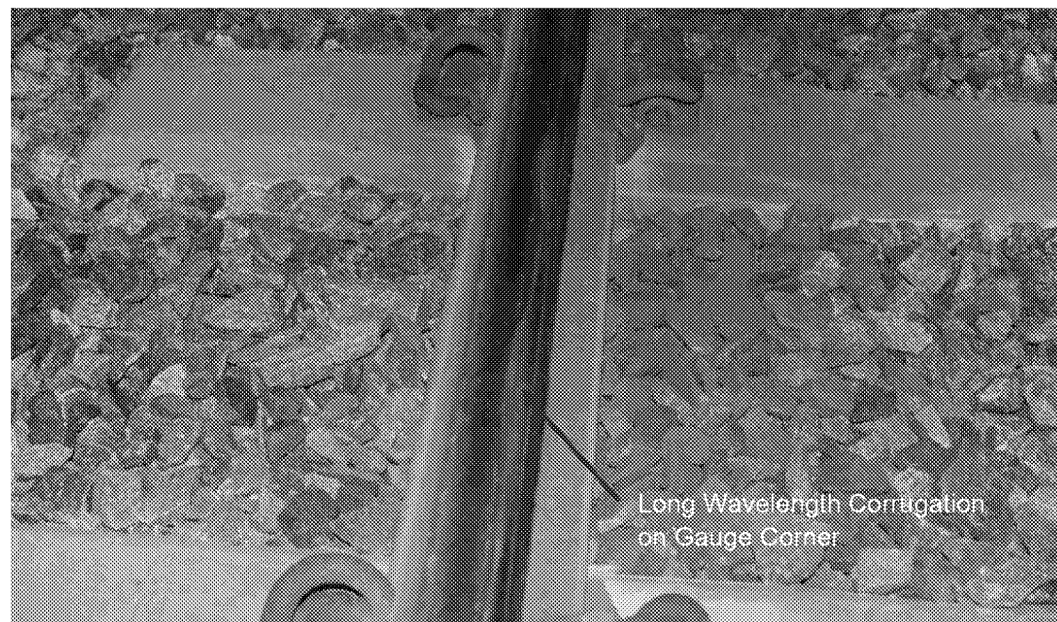
Figure 3.12: Corrugation on High Rail of Curve 330 at 108+685

The truck orientation through the curve results in a high angle of attack between the leading axle and the rail, resulting in high contact forces and hence, rail damage. The presence of two bands of corrugation with different wavelengths on E/B-330 and W/B-330 curves, **Figure 3.12**, provides further evidence for the difference in wheel/rail contact between axles on the same truck. With the gauge corner wear and corrugation likely to be produced by the leading axle and the corrugation on the crown of the rail by the trailing axle.

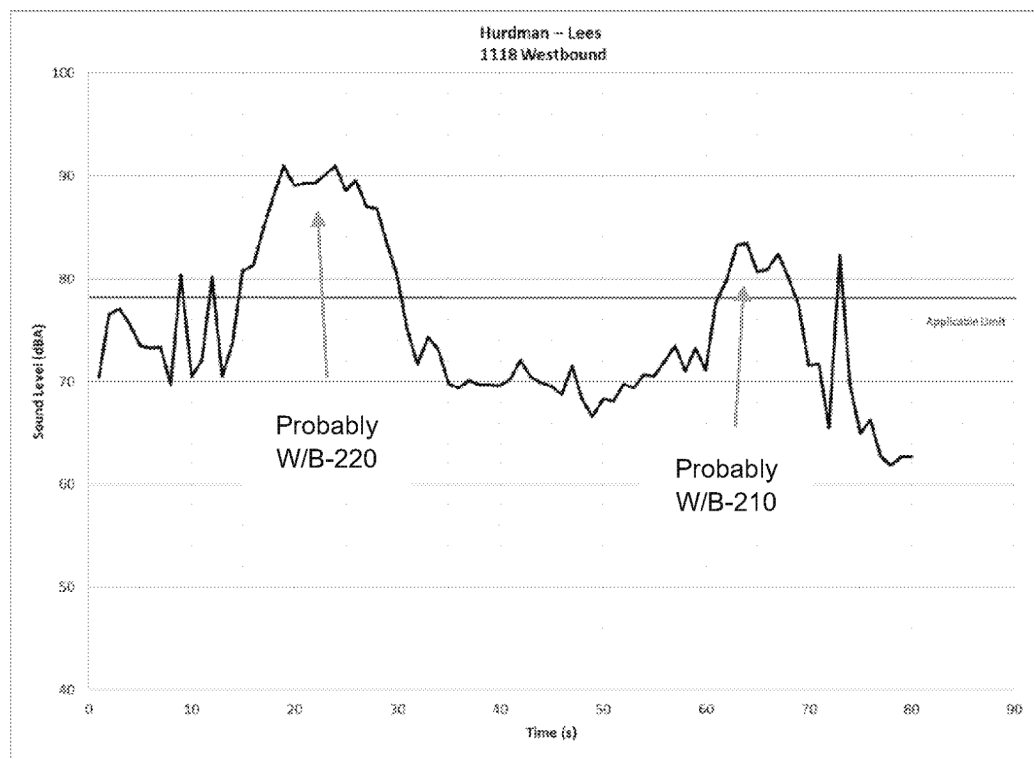
Figure 3.16: Noise Measurement between Hurdman and Leeds for Westbound track

The noise results are summarized as plots against the time between stations, an example is shown in **Figure 3.16**. As the results are measured against time without knowing the exact speed of the train during measurements it is not possible to determine the exact locations where the noise exceeds the maximum allowable values. Calculating from the average speed given in the report it is possible to determine that many of the noise and vibration peaks that exceed the limit are likely to be associated with the tight radius curves on the System where corrugation is present. The highest noise level measured is 91dB (exceeding the limit of 78dB) on the westbound track between Hurdman and Lees is likely to be associated with curve W/B-220. The locations with high noise levels also show high values of vibration.

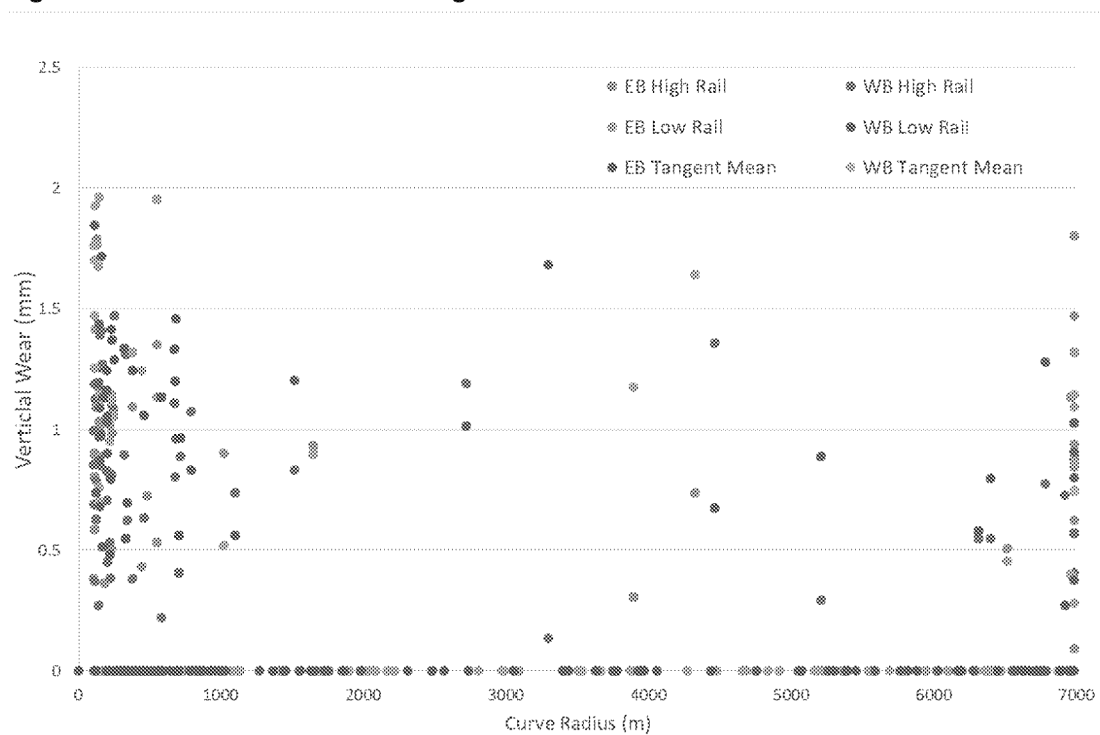
Figure 3.23: RailPod Vertical Wear against Curve Radius

The vertical wear of the rail shows wide variance between 0.5mm and 2mm with no obvious trend with curve radius. In contrast, side wear is greater on the tighter radius curves compared to shallow curves and tangent track. This is especially pronounced for the high rail where it is

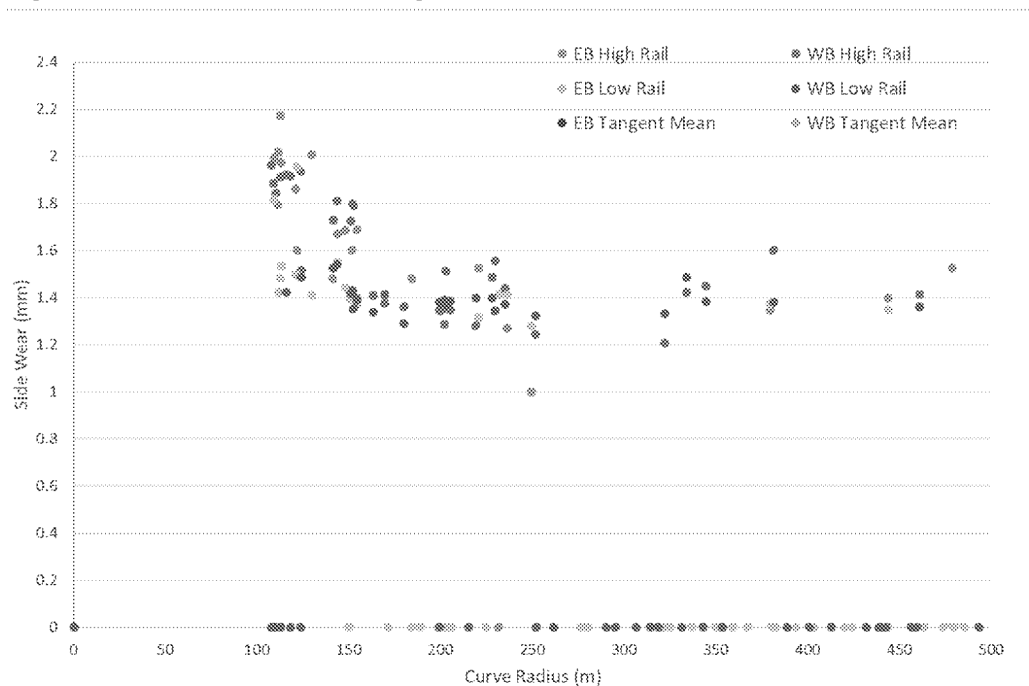
Figure 3.25: RailPod Side Wear against Curve Radius Less than 500m

around 0.5-0.7mm greater. Even on the low rail of the tightest curves there is a slight increase of 0.1-0.2mm, **Figure 3.25**. The reason that side wear on tangent track is not zero and the large spread in vertical wear is probably due to the manufacturing tolerance of the rail and measurement error.

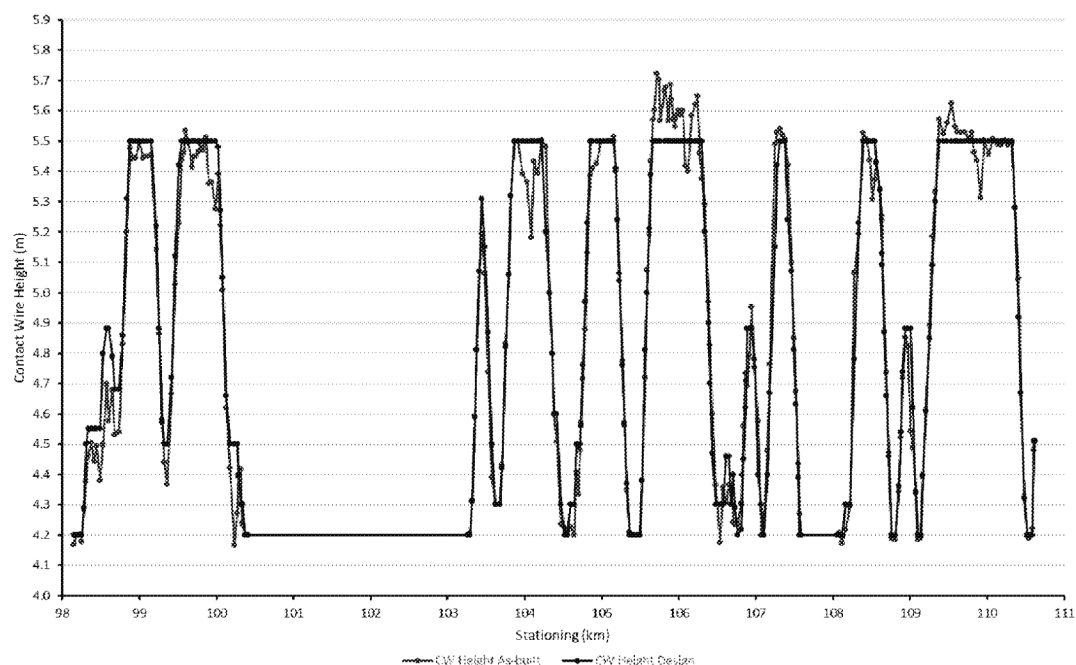
Figure 3.27: As-built v Design Contact Wire Height – Eastbound Track

Contact wire heights were reviewed in both the eastbound and westbound directions. **Figure 3.27** is provided to show graphically the eastbound contact wire heights (and is a reasonable proxy for the similar westbound representation). The as-built profiles (in red) are typical to those presented in the Alstom report.

It is noted that the contact wire heights may have been adjusted on site during construction due to other infrastructure as-built conditions, for instance at or near tunnel portals or overhead municipal bridges. Based on PA Schedule 15-2 Part 4 Article 8, there are a number of locations that do not meet the installation tolerance of -13 mm to + 25 mm, for open route sections. Note data for the tunnels sections was not available at the time of the analysis.

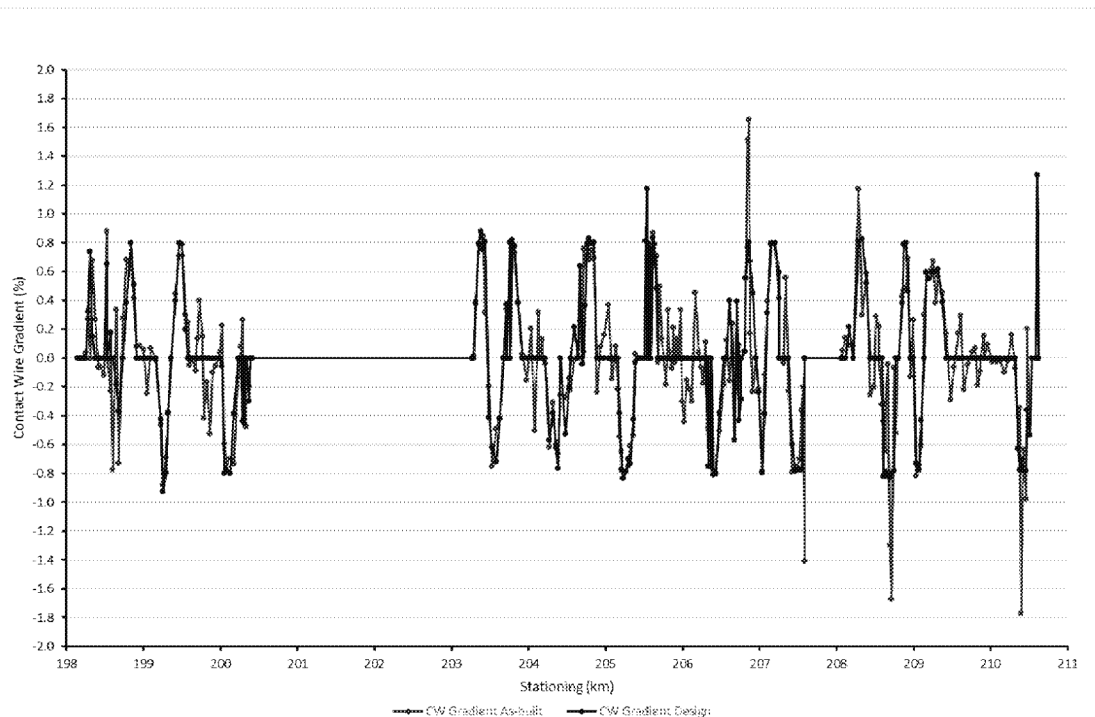
Figure 3.28: As-built v Design Contact Wire Gradient - Westbound

Contact wire gradients were also reviewed in both the eastbound and westbound directions. The contact wire gradient for the westbound track is shown graphically in **Figure 3.28**, and is a reasonable proxy for the findings for the eastbound track. The allowable design grading for both eastbound and westbound tracks (ref CAN/CSA C22.3 No. 8-M9, as per Table 4-8.5 in PA Schedule 15-2 Part 4 Article 8, Section 8.5 (c) (i)) is replicated in Table 3.2.

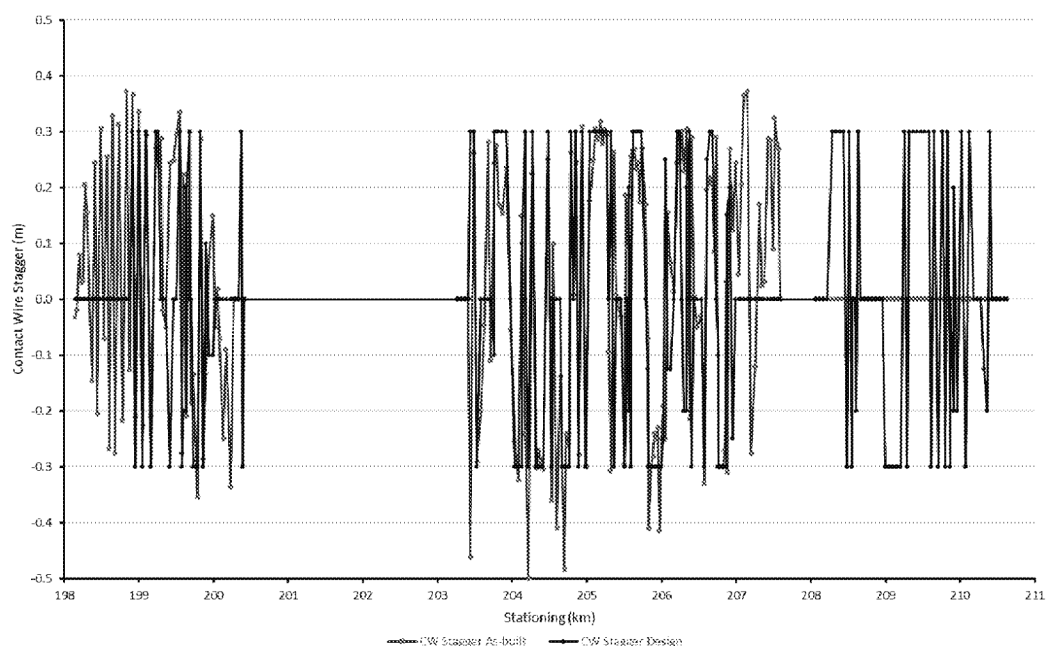
**Figure 3.30: As-built v Design Contact Wire Stagger – Westbound Track**

Based on PA Schedule 15-2 Part 4 Article 8, there are a number of locations that do not meet the installation tolerance of -25 mm to + 25 mm. This has resulted in the staggers being either smaller or greater than the design and could affect the contact wire/pantograph interface. Note the as-built and design values for the tunnel sections were not available at the time of the analysis and has not subsequently been provided.

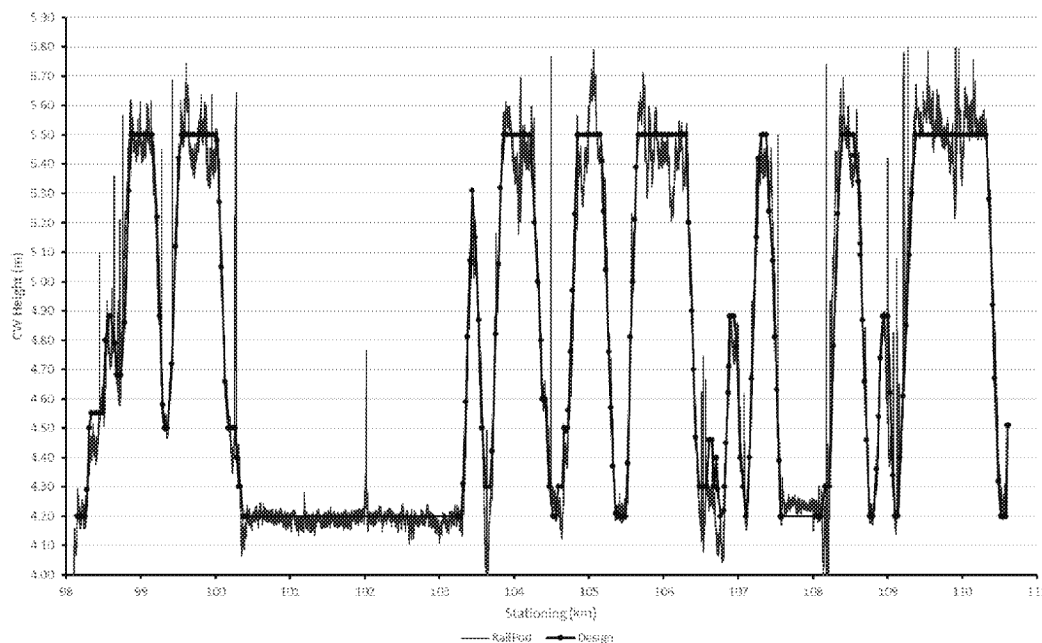
Figure 3.31: RailPod Data V Design Contact Wire Height for Eastbound Track

A comparison of the RailPod contact wire height data, measured in September 2020 and part in February 2021, for both the eastbound and westbound tracks, was compared to the Project Co design, similar to that in section 3.2.1.5 and are shown in **Figure 3.31** and **Figure 3.32**. Note that some spikes occur as shown within the RailPod data due to gaps in the OCS or potentially due excessive movement of the measuring machine and can be disregarded.

Based on the new as-built data, after the modifications had been carried out, and the RailPod survey, it is evident that the overall OCS has been improved and that, at these locations, the contact wire heights and grading are more in line with the design. However, there are still a number of locations that do not meet the grading or tolerance requirements, as specified in PA Schedule 15-2 Part 4, Article 8. And so, while the risks listed above may have been reduced, it is not possible to say that they have been brought into alignment with PA requirements.

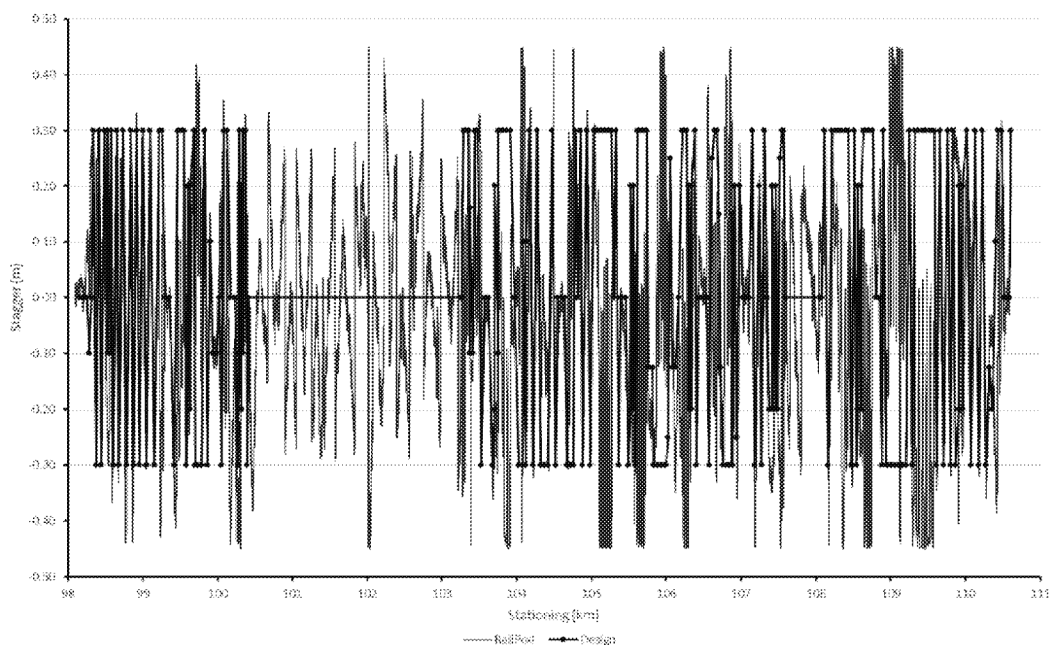
Figure 3.33: RailPod v Design Contact Wire Stagger – Eastbound Track

A similar exercise was carried out using the RailPod data for the stagger of the contact wire and is shown graphically in **Figure 3.33** and **Figure 3.34**.

It can be seen on the basis of the charts provided that there is an overall improvement of the OCS, but again, there are still a number of locations that do not meet the requirements of PA Schedule 15-2 Part 4, Article 8.

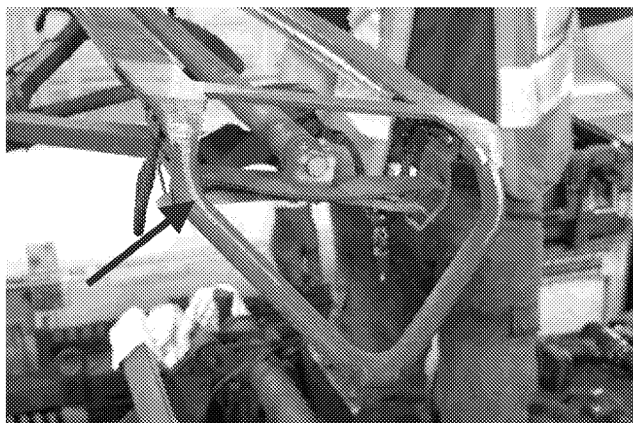
Observations have shown that the pantograph horn is hitting the contact wire at crossovers and turnouts, causing undue wear **Figure 3.35**.

Figure 3.35: Wear on Pantograph Horn

In addition, there is a risk, with extreme temperature ranges experienced in Ottawa and the potential of additional ice loading, that the pantograph could hook-over the crossover contact wire and cause major damage to the OCS and pantograph including:

- ✱ Broken/bent cantilevers
- ✱ Contact and messenger wire ripped down and or broken
- ✱ Damaged or broken dropper and jumper wires
- ✱ Broken/deformed pantograph head and arm assemblies

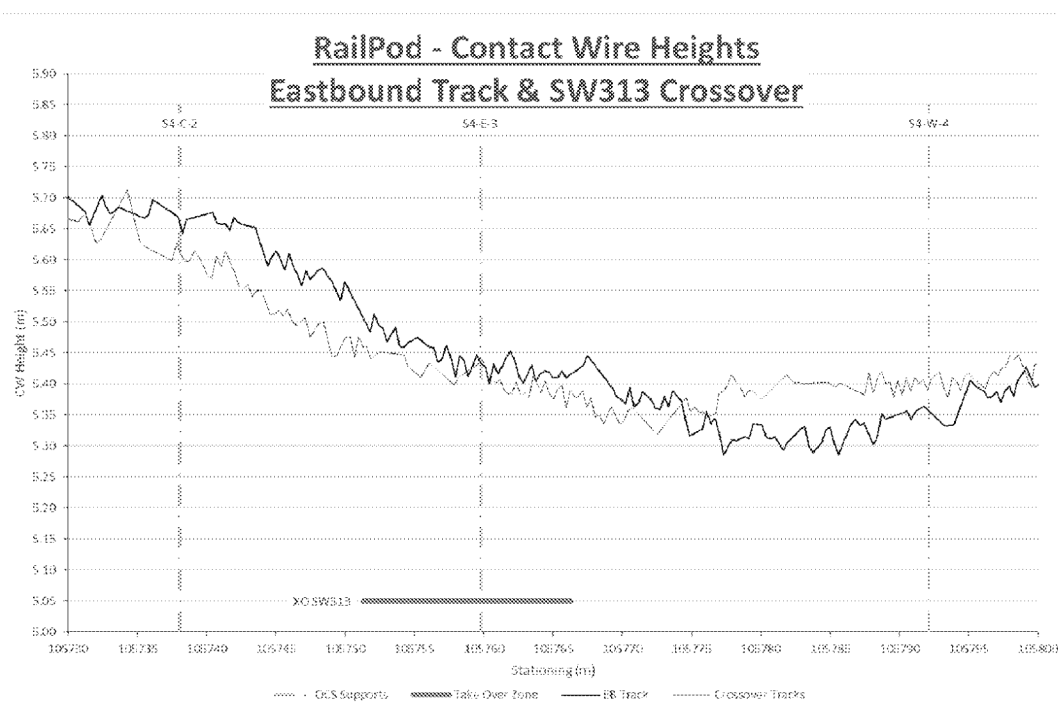
TableFigure 3.36: RailPod Data Analysis of SW313 Crossover Wire Heights

A typical example of where this is occurring is at crossover SW313 on the eastbound track. On the video, reference Gx060037-6 – at 16 seconds in, a sound can be heard as the pantograph hits the crossover wire. From the RailPod survey the observation can be confirmed as the crossover wire, within the take-over zone is lower than that of the main as shown in Figure 3.36.

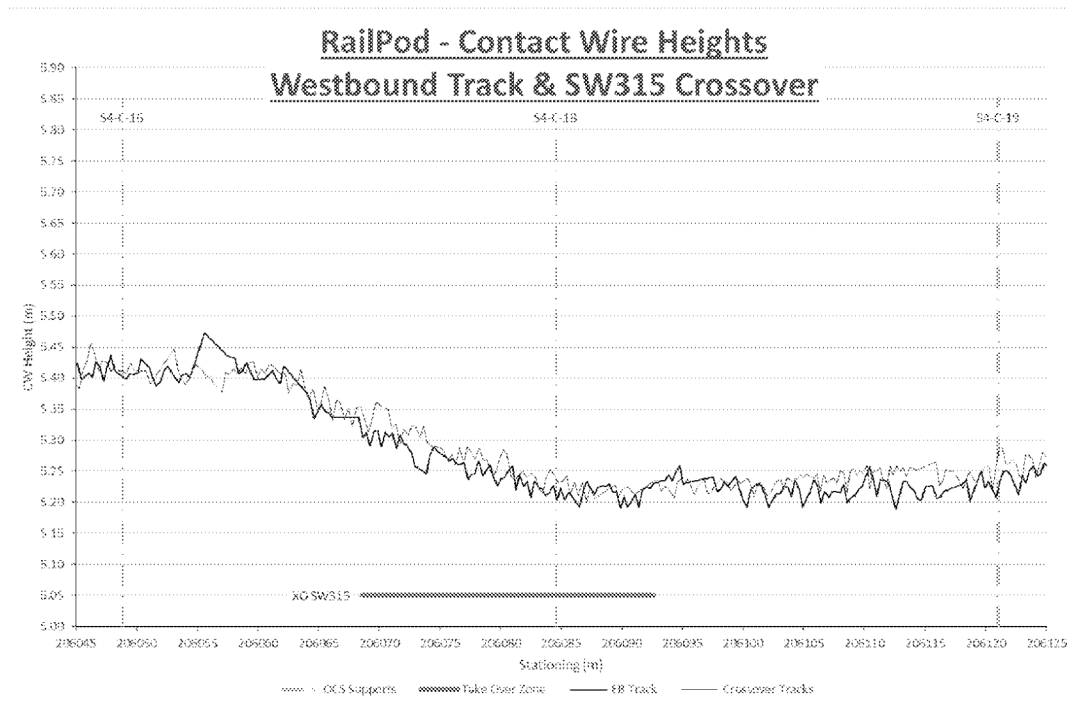
Figure 3.37: RailPod Data Analysis of SW315 Crossover Wire Heights

Similarly where the take-over is satisfactory, SW315 crossover on the westbound track, as observed in the video, reference Gx060037-6 at 52 seconds in, and the RailPod data as shown in **Figure 3.37**.

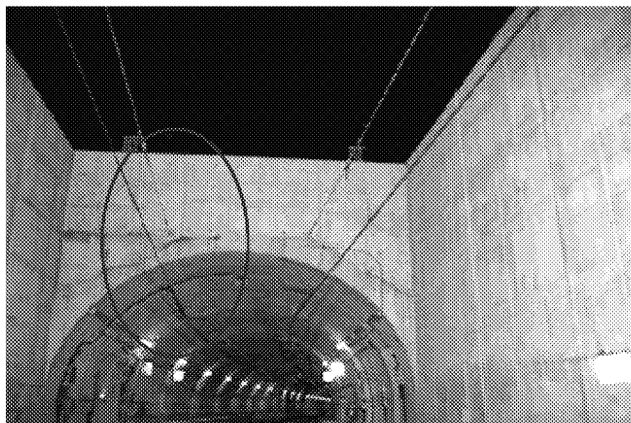
Figure 3.38: Messenger Wire to OCR Jumper Wire

The continuity of the messenger wire and contact wire are critical to supply the required current to the light rail vehicles without overloading any one individual wire **Figure 3.38**. To reduce the likelihood of a failure, the existing installation should be checked as soon as reasonably practical, and additional jumpers installed as necessary.

In accordance with Good Industry Practice for design and construction, Mott MacDonald recommended that messenger wires be bonded to the aluminium OCR at all OCS to OCR transitions, at both downtown tunnel portals and on both side of St-Laurent station over both tracks. The bonds installed should provide, as a minimum, equal ampacity to the messenger wire, reference Calgary LRT, Conductor Rail Installation Design Manual.

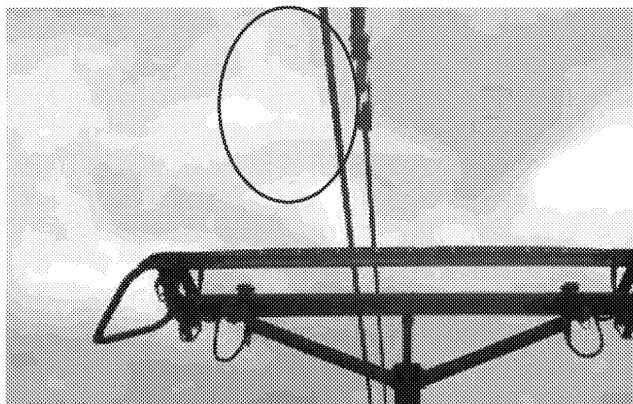
Figure 3.39: Messenger Wire Cut-in Insulation

Mott MacDonald recommended that the messenger wires be bonded on both tracks, to provide continuity, with as a minimum, a wire of equal ampacity to the messenger wire.

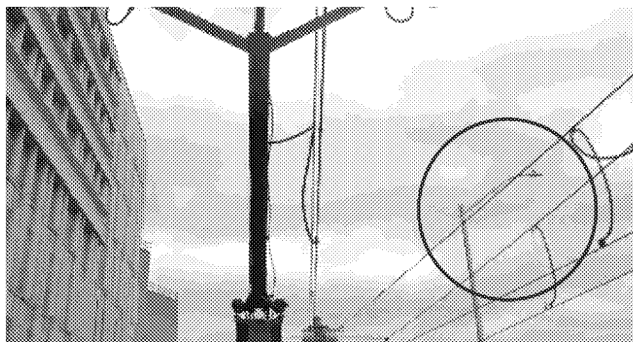
Figure 3.40: OCS to OCS at Crossovers and Turnouts

In accordance with Good Industry Practice for design and construction, Mott MacDonald recommended that a second full-section or a MW to MW jumper is installed to provide equivalent ampacity of the sections of OCS **Figure 3.41**, reference Calgary LRT, Phoenix LRT, Santa Clara LRT.

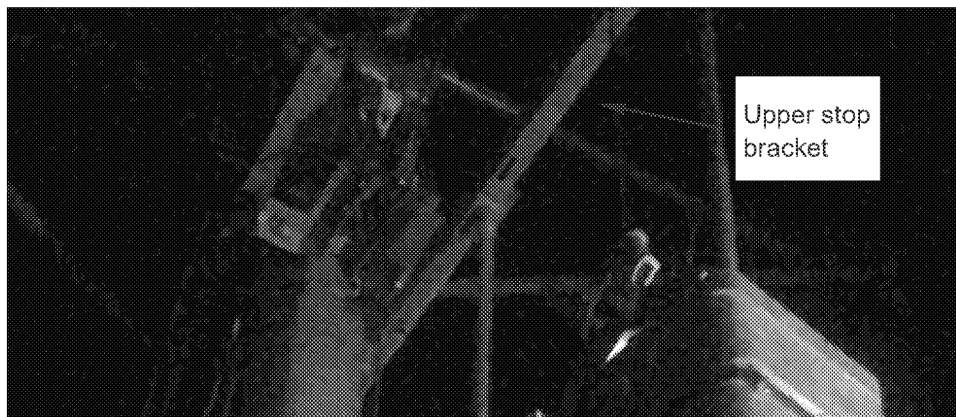
- The low and high stop support brackets, as seen in **Figure 3.42**, the low stop support angle is installed in a different orientation and the high stop support bracket angle appears to be a different size.
- The guide tube to support angle fixing clamps, as can be seen in **Figure 3.42** and **Figure 3.43**, are external type which is different to internal ones as shown on the design drawing.
- The yoke plate assembly and balance weight hangers.

Figure 3.42: Upper Stop Support Bracket

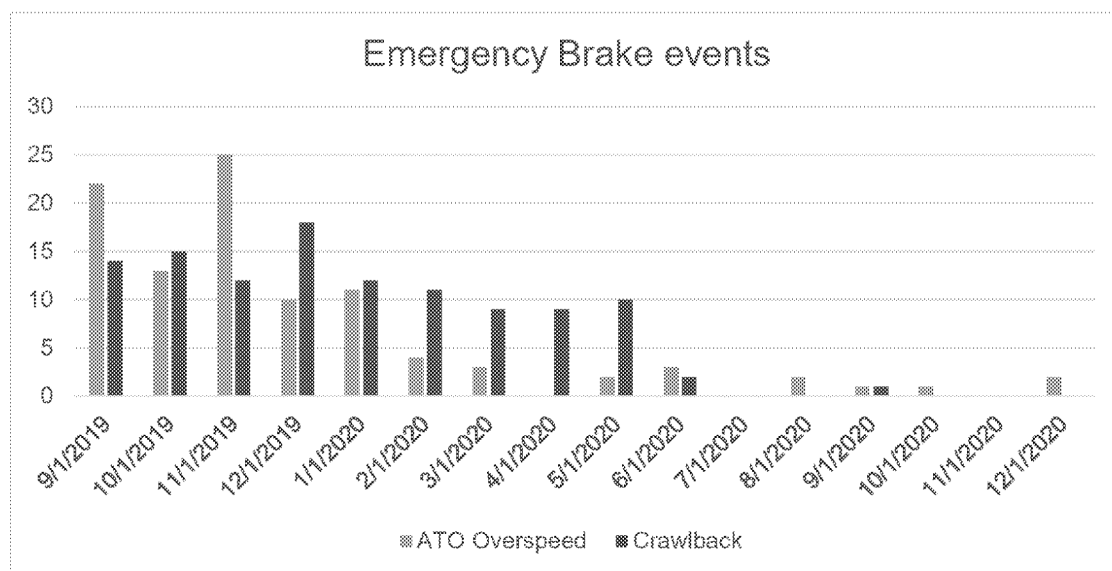
As visible in **Figure 3.45**, from June 2020 onwards, the number of EB due to unauthorized crawlback events has decreased significantly which could be following the upgrade of the Thales CBTC software.

Figure 3.45: Overview of Emergency Brake Events (Overspeed in ATO and Crawlback) Per Month

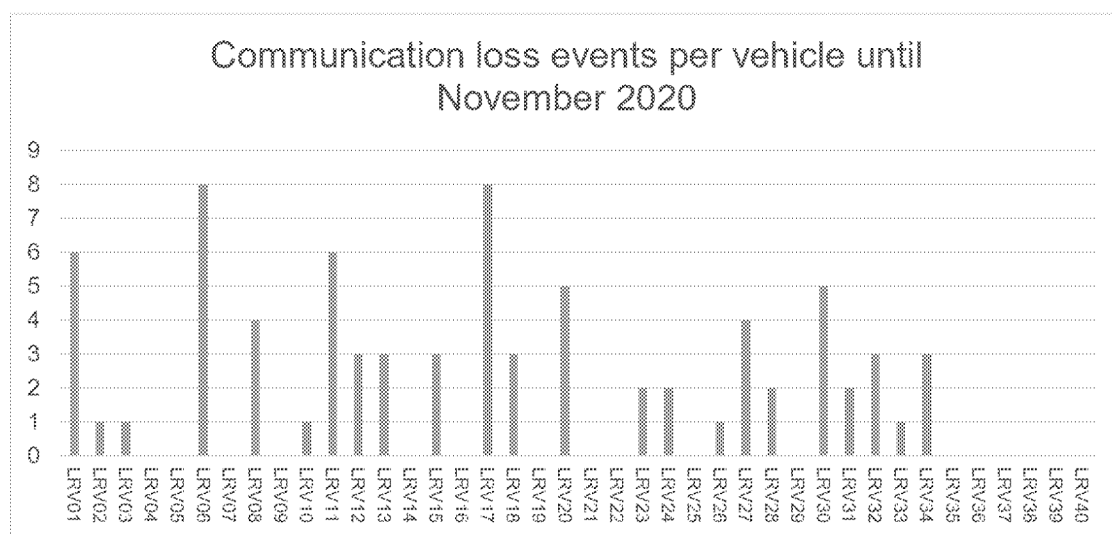
The issue of communication losses has been analysed in the incident logs. **Figure 3.46** shows the number of times each vehicle was involved in a communication loss event. When operated in coupled mode, an event is allocated to both vehicles. It is visible that LRV06 and LRV17 have experienced most events, followed by LRV01 and LRV11. In 15 of the 39 events (38%), either LRV06 or LRV17 was involved. The figures are not adjusted for distance driven.

The analysis reveals that some vehicles experience a larger number of communication events than others, which indicates that this could be due to isolated vehicle issues. Additional technical and reliability analysis of vehicles experiencing an increased number of communication issues could indicate the actual cause of the issues.

Figure 3.46: Communication Loss Events Per Vehicle. When Operated in Couple, an Event is Allocated to Both Vehicles

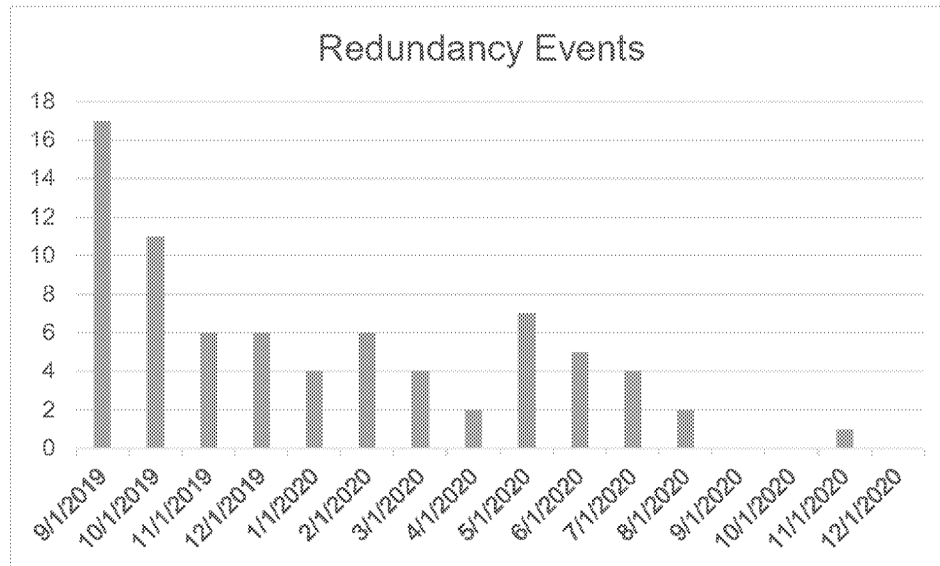
Figure 3.47 shows that system events related to redundancy were most frequent during the first months of operation. From November 2019 through July 2020, the events occurred at a rather stable level. It is normal that switchovers occur occasionally, with the redundant architecture preventing impact to operations. As such, the early problems with redundancy events are

considered to be start-up problems of the CBTC system and current occurrence rates are considered normal.

Figure 3.47: Redundancy Events (ZC, LSRS, CSRS or ATS Operating on Backup System)

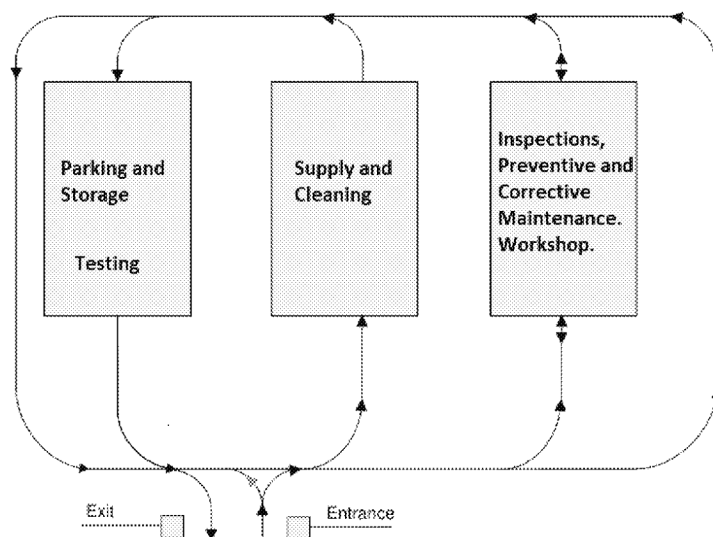
Figure 3.49: Recommended possible direct train movements within an MSF

One of the main challenges presented by the yard and shop layout design is the lack of a circular track loop and operational flexibility/redundancy within the current layout as it requires the need to carryout numerous reverse vehicle movements. This makes vehicle movements more difficult especially when there are operational irregularities and potential conflicting movements between maintenance and operations and could lead to conflicting moves and potential risk of derailments. A circular track loop would allow for efficient flow of vehicles when launching the service and on its return for servicing and maintenance and minimizing train and personnel movements. According to the German VDV Recommendation on the Design of Depots for LRVs and Tramcars, the direct possibilities of train movements indicated in **Figure 3.49** should be possible within a well-designed MSF. These movements are not possible at the current Ottawa LRT MSF.

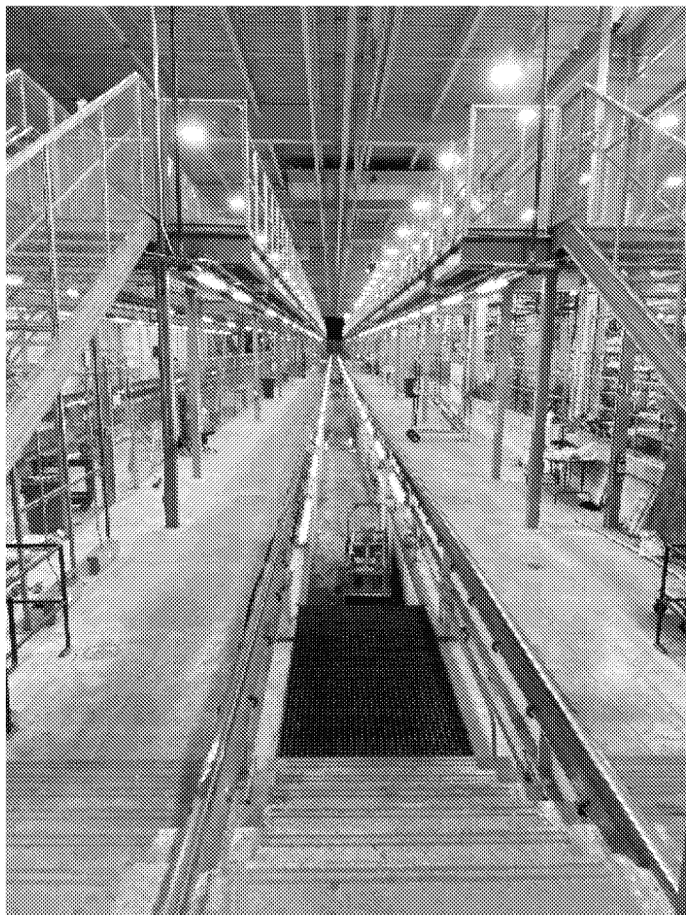
MSF 1 was previously used by Alstom to assemble the first 46 vehicles of the project's Stage 1. It appears that many different parts not used on the assembly of these vehicles are still sitting next to the tracks, and the status or configuration control of these parts is unknown which could lead to incorrect/incomplete items being fitted to vehicles. Also, the stock left in the work areas leaves the shop looking disorganized and cluttered (**Figure 4.1**).

Figure 4.1: (a) (b) (c) (d): Parts Laying Out on the Floor Shop of MSF1 Next to Tracks 1 - 4

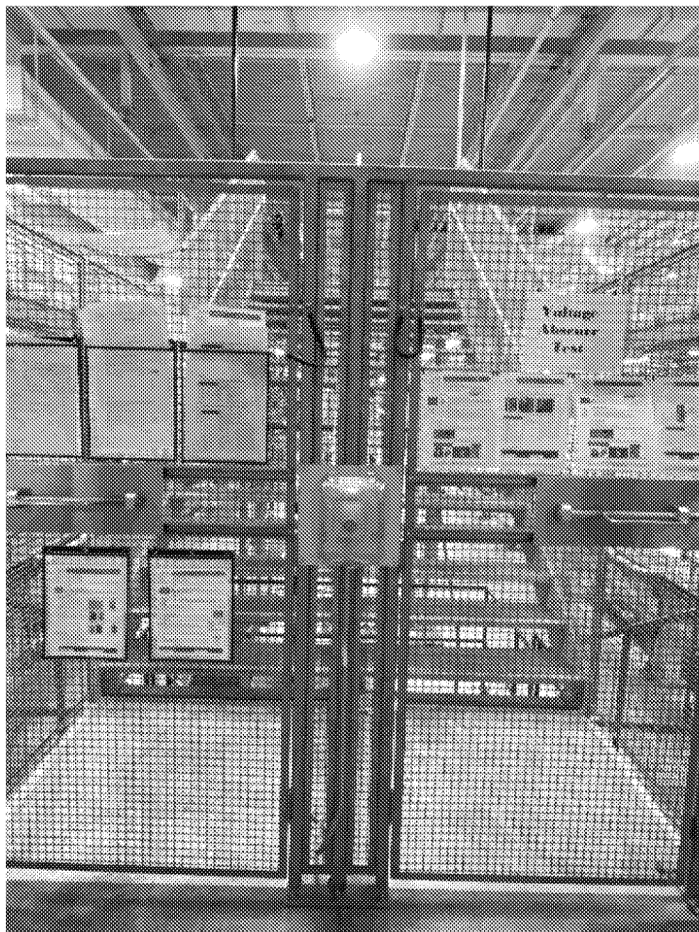
Both LMBs have OCS, access to the mezzanine is restricted to authorized personnel only (**Figure 4.3**).

Figure 4.3: Restricted Access to Mezzanine Area of LMB 1 and 2

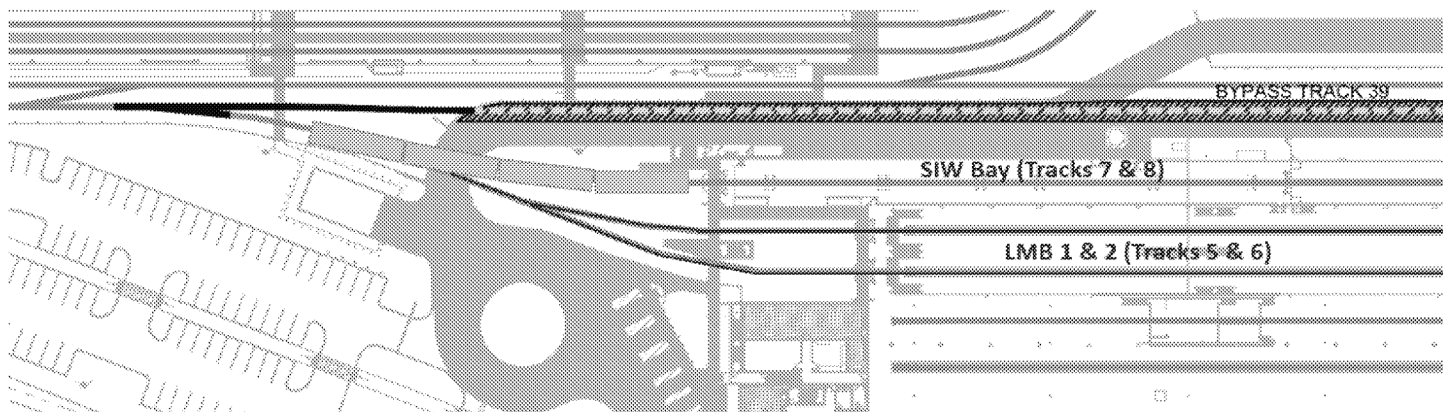
LMBs 1 and 2 currently present two access issues. Access from the east side of the shop can be restricted by vehicles waiting outside the SIW Bays located on tracks 7 and 8 (**Figure 4.4**).

Figure 4.4: MSF1 Access Issue to LMBs 1 and 2 When a Vehicle is Outside the SIW Bay

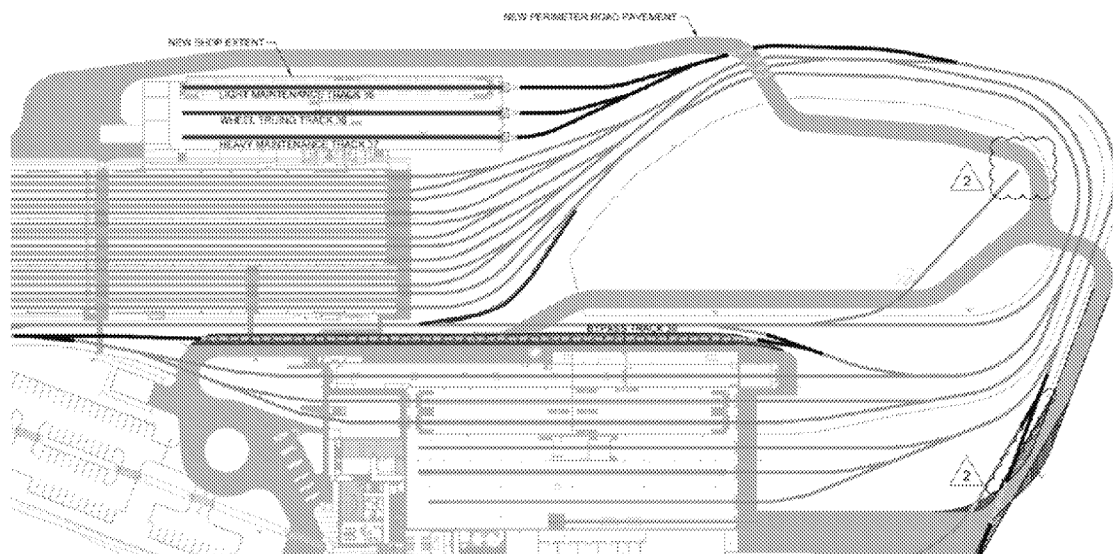
Figure 4.8: Other Potential Vehicle Launch Tracks

Other tracks could be used for launching vehicles for revenue service including bypass track 39 and track 22 (**Figure 4.8**). The Mott MacDonald team was informed that bypass track 39 is not used and has not been commissioned as it is part of the project's Stage 2. This constraint adds further to the limited operational efficiency and flexibility of the MSF track layout.

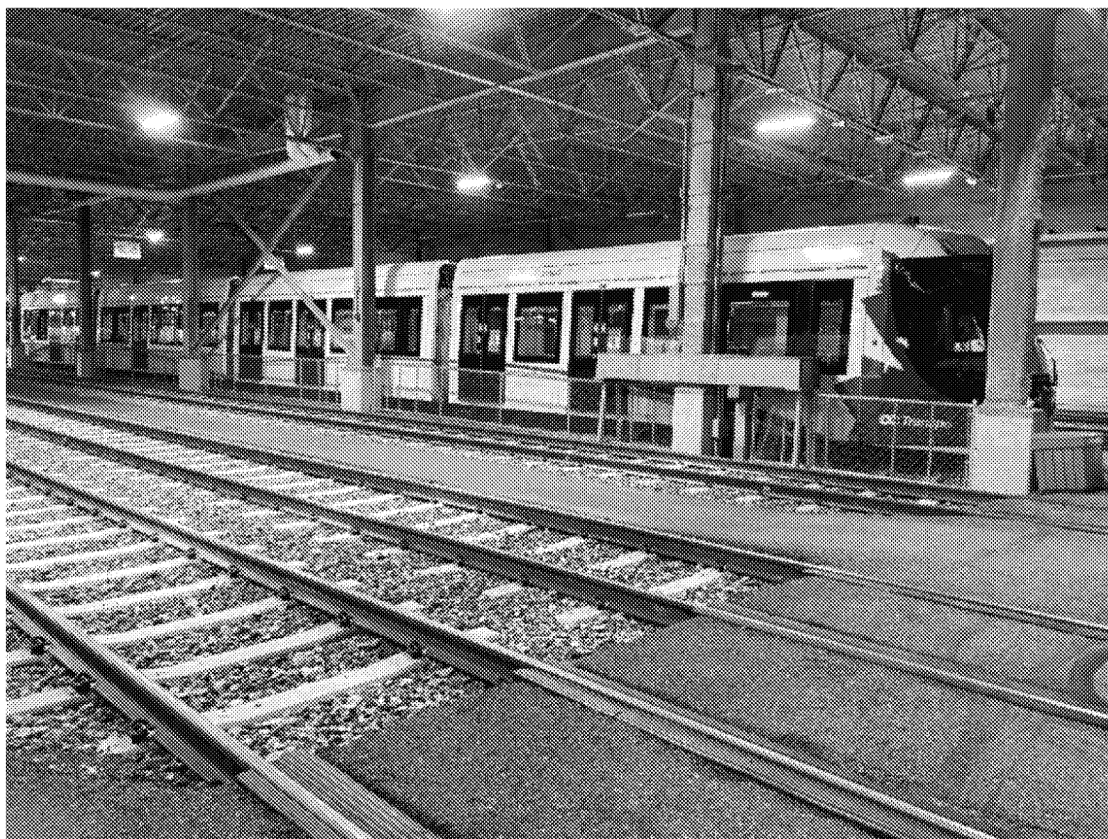
The design of the storage shed also presents challenges to perform preventative maintenance on the vehicle, most specifically daily inspections, and pre-departure inspections. Chain link fencing divides the storage shed at the centre of the building, which does not allow a reasonable working space to open the side skirts on one side of the vehicle. Due to the proximity of the dividing fences, the entirety of the daily inspection cannot be completed in the storage shed if the vehicle is parked on the centre 2 roads (**Figure 4.9** and **Figure 4.10**). In this situation, access to the vehicle exterior is limited to one side of each vehicle and is gained via paved walkways which creates not only a potential risk for the operator accessing the vehicle due to limited clearances but also a risk of the inspection missing a defect or potential safety check.

Figure 4.9: Dividing Fence at Storage Shed and Limited Staff Access Between Tracks with No Walkway
