Ottawa LRT Independent Review Report

April, 2022
Confidential

City of Ottawa
c/o Singleton Urquhart
Reynolds Vogel LLP
150 King St West, Suite
2512
Toronto, ON
M5G 1J9

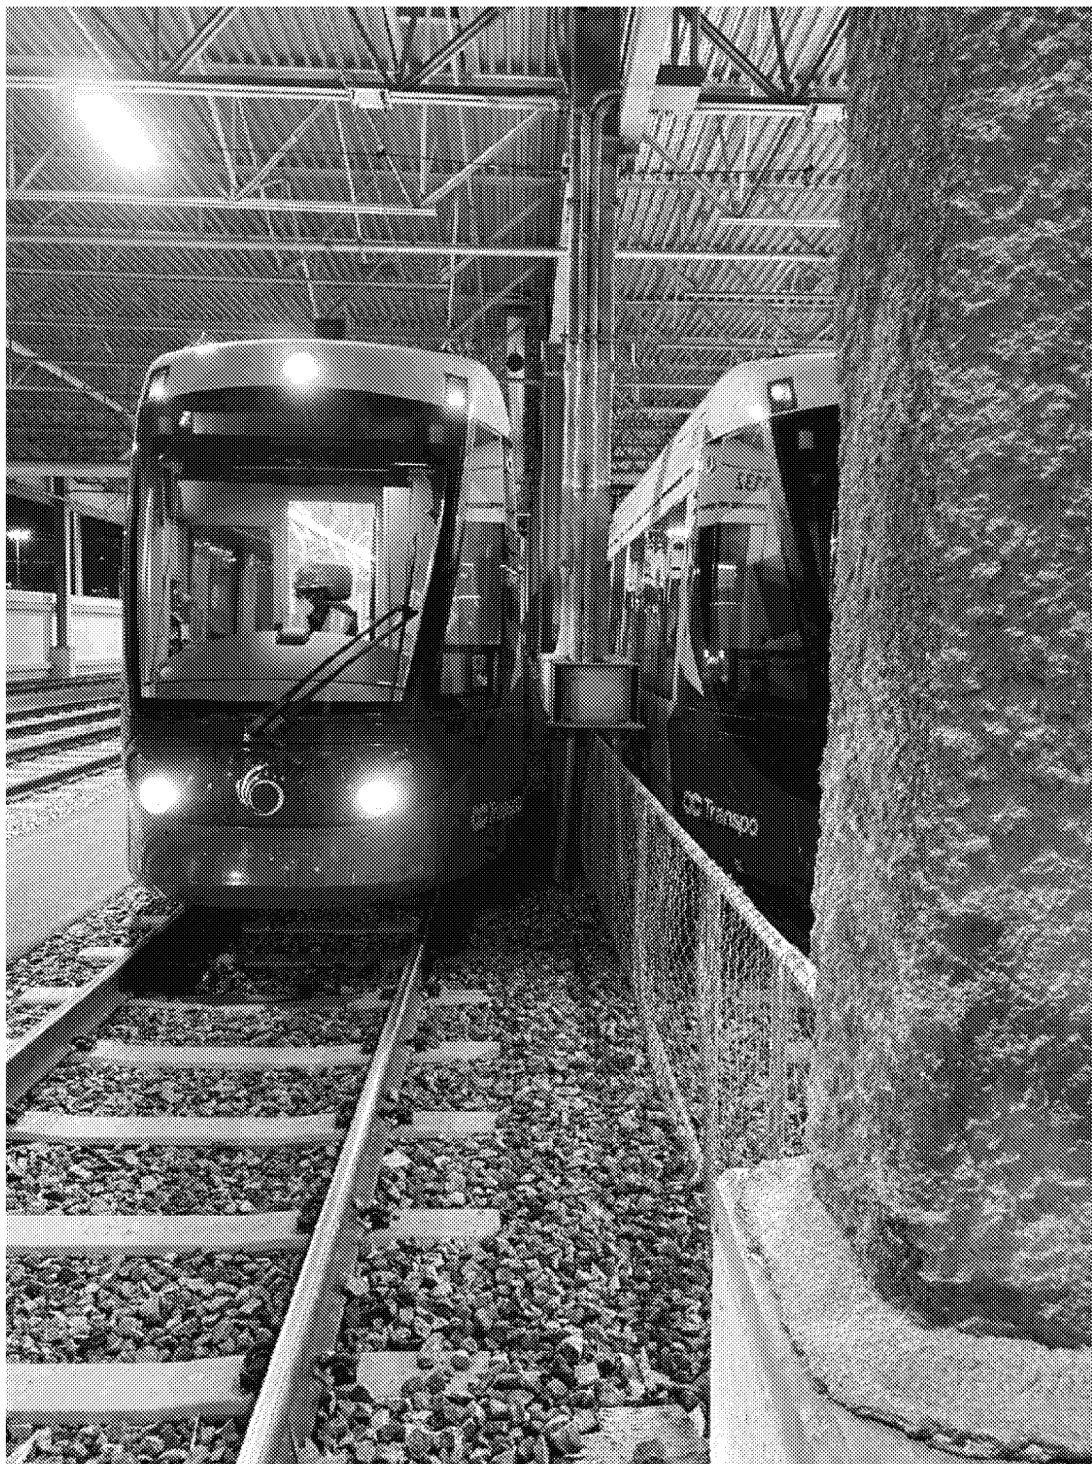
The design of the storage shed also presents challenges to perform preventative maintenance on the vehicle, most specifically daily inspections, and pre-departure inspections. Chain link fencing divides the storage shed at the centre of the building, which does not allow a reasonable working space to open the side skirts on one side of the vehicle. Due to the proximity of the dividing fences, the entirety of the daily inspection cannot be completed in the storage shed if the vehicle is parked on the centre 2 roads (**Figure 4.9** and **Figure 4.10**). In this situation, access to the vehicle exterior is limited to one side of each vehicle and is gained via paved walkways which creates not only a potential risk for the operator accessing the vehicle due to limited clearances but also a risk of the inspection missing a defect or potential safety check.

Figure 4.10: Dividing Fence at Storage Shed with No Staff Access or Safety Clearance

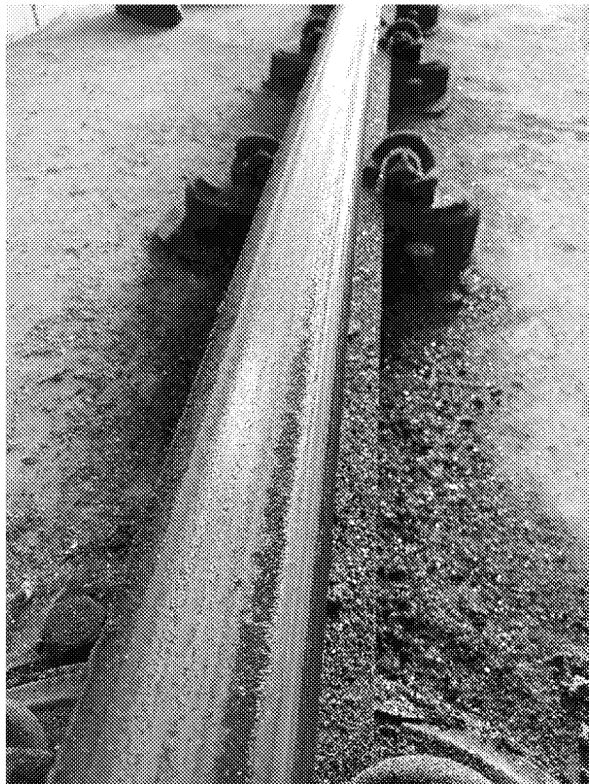
Figure 4.18: Grease on Top of Rail at East Connector

Large amounts of sand are deposited along the E/B connector track before it joins the mainline track. At this location, there is a significant longitudinal gradient, and it is assumed that the excessive use of lubricants (see above) causes the wheels to slip/slide, hence the (excessive) use of sand.

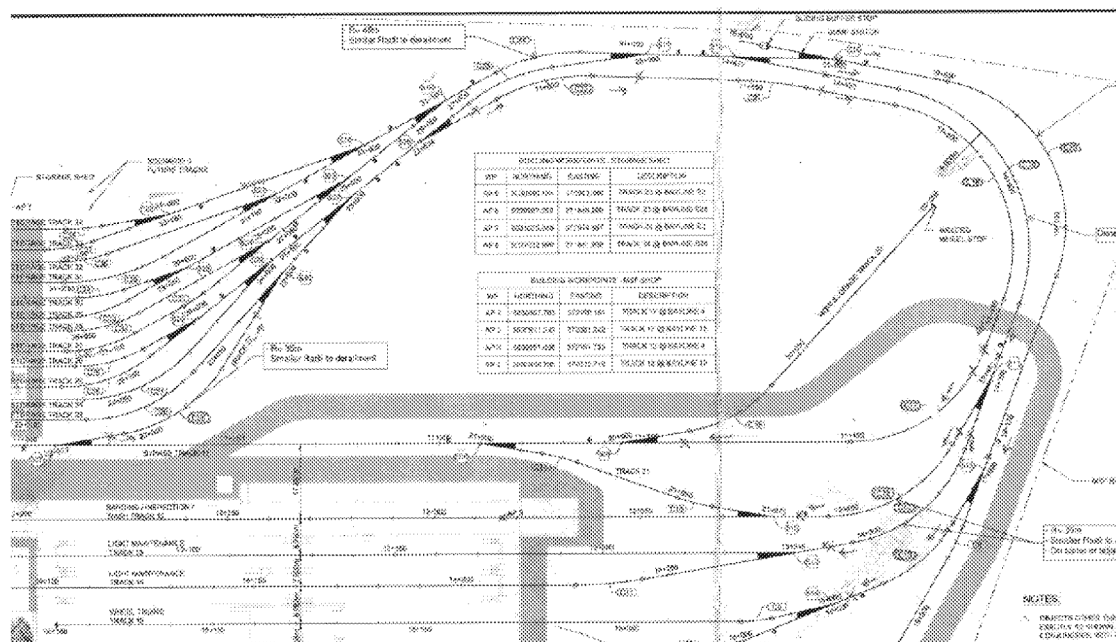
Figure 4.20: Sample Track Measurements

Throughout several curves, kinks in the rail at weld locations have been observed. At some of those locations the gauge is as tight as 1430mm or as wide as 1443mm.

Confirmation has been provided by the City that at initial construction, the pre-bent rails were cut such that only fully pre-bent sections of rails were welded together. Since initial installation, the rails through C19 have been transposed with each other, and thus were cut and re-welded, potentially resulting in the kinks observed if not aligned properly prior to welding. The cause of the kinks at the other curves however remains unknown.

The gauge through curve C17 is very inconsistent, gauge widening has been observed but also tight gauge down to 1430mm (at weld on inner rail).

Rails through C19 have been transposed with each other (swapped). Plastic spacers between the shoulder and the rail have been replaced to widen the gauge, however gauge widening is inconsistent with significant kinks at welds. The gauge varies between 1435mm (at welds on inner rail) to 1443mm (C19), the gauge through C18 and C20 is more consistent.

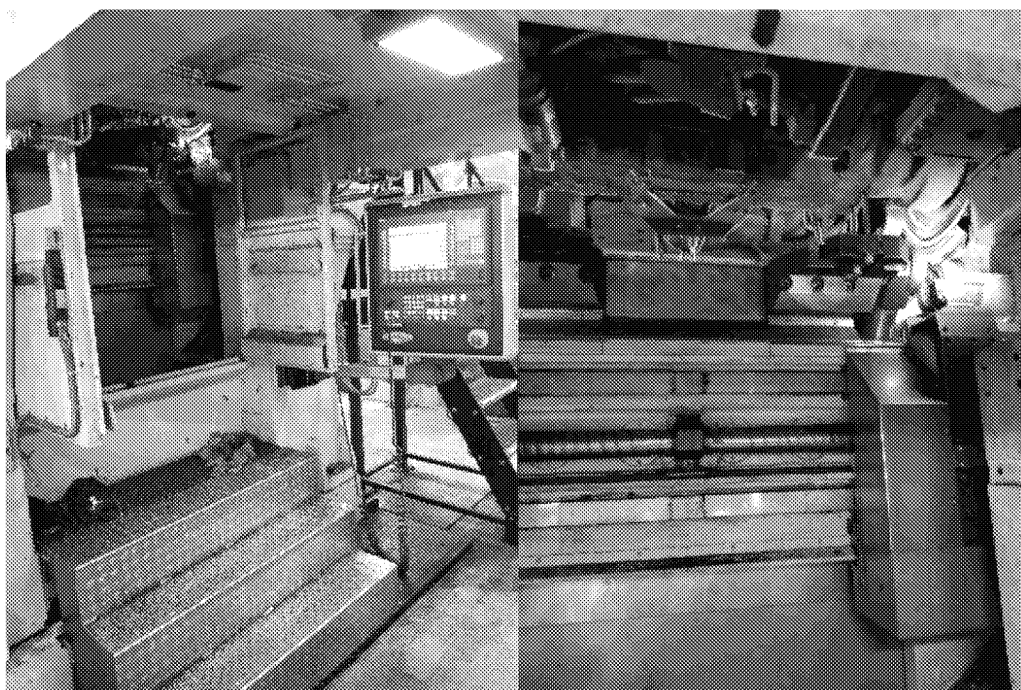
Figure 4.26: Hegenscheidt U2000-150D Underfloor Wheel Lathe

The wheel lathe (**Figure 4.26**) used is a Hegenscheidt U2000-150D Underfloor Wheel Lathe supplied by the NSH USA Corporation ([Hegenscheidt U2000-150 Underfloor Wheel Lathe | NSH USA Corporation \(nsh-usa.com\)](http://Hegenscheidt%20U2000-150%20Underfloor%20Wheel%20Lathe%20|%20NSH%20USA%20Corporation%20(nsh-usa.com)))). This machine is capable of tandem machining of two wheel sets simultaneously but was at the time only using one machine head and therefore one wheel set at a time was being machined which is not an efficient method of operation. The machine is also a CNC lathe with automatic positioning, machining and measuring processes available to the operators. Unfortunately, not all of the automatic functions of the machine were being used with the machining process being manually set up and controlled by a member of the team. The automatic measuring of the wheel set was used both before and after the wheel set was machined.

The operator also mentioned that additional wheel lathe operators had recently been trained on the machine so there were now a larger number of personal that would be able to work on the fleet's wheel truing program.

It is considered unusual to have a large number of the maintenance team trained and using the wheel lathe in an MSF. Most facilities have a small, dedicated number (depending on the demand for the work) of their technicians trained and able to operate the wheel lathe as this creates higher levels of skill in the lathe operator as their experience with the machine grows. Having a dedicated team of technicians that operate the wheel lathe provides for high levels of skill within this group as they have a higher frequency of interaction with the machine and its controls, workings and results.

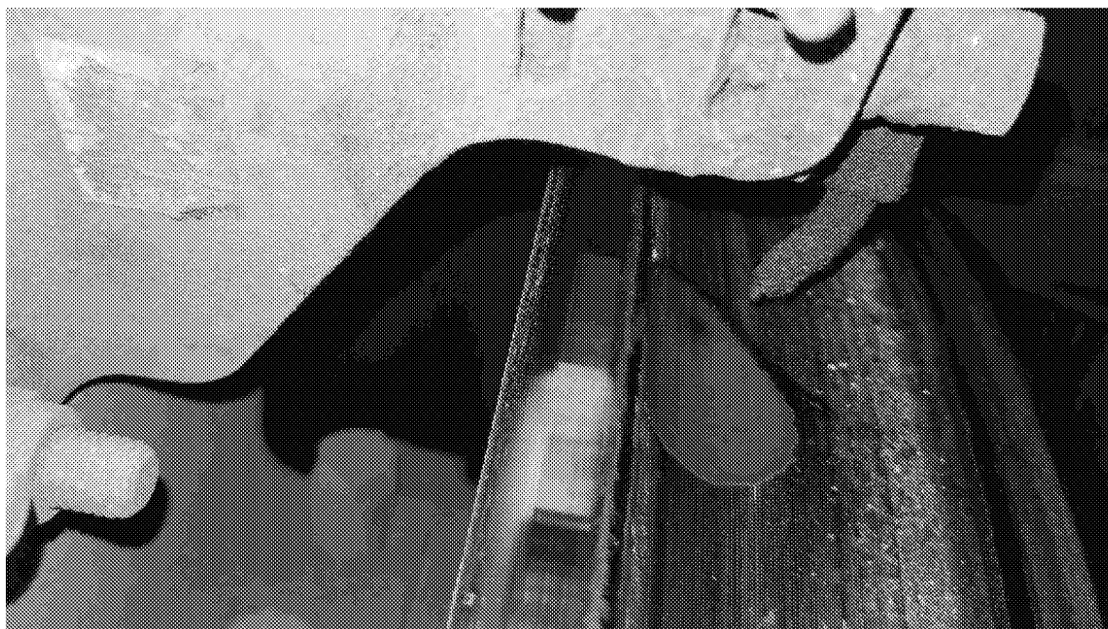
Figure 4.27: Wheel Flange Lubrication Location

the gap (page 7 of 17, item h.) between the spray nozzle and the outer diameter of the wheel, however this procedure fails to identify the location of the spray nozzle. The procedure refers to the location of the systems mounting block and its distance from the wheel not the spray nozzle. As shown in the image below (**Figure 4.27**), the alignment and volume of oil delivered by this system can easily apply an amount of oil that leads to the wheel tread having oil in an undesirable area leading to wheel slide situations arising.

It is recommended that Alstom review the procedure and the maintenance instructions related to the setting of the flange lubrication equipment following wheel truing and wheel replacement in order to ensure the alignment is related to the relevant wheel diameter and flange position. This may also require a formal re-training of staff to ensure they are aware of the process necessary to ensure the alignment is correct and made aware of the implications of incorrectly setting the flange lubricator spray nozzles.

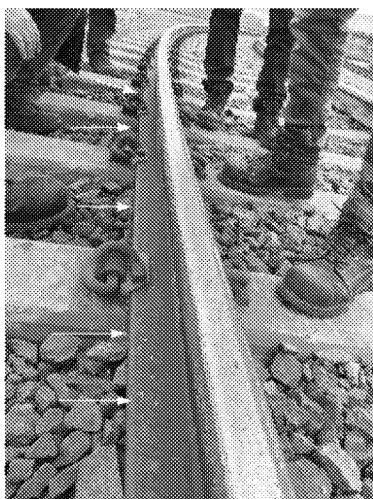
Figure 5.1: Metal Shavings Along Rail Curve 19

The incident was reported and investigated in Alstom's Incident Report TN-018 Version A (dated 10-11-2020). In this report (page 8 of 25), Alstom have presented an image (**Figure 5.1**) showing evidence of excessive rail gauge face wear from contact with the wheel flange.

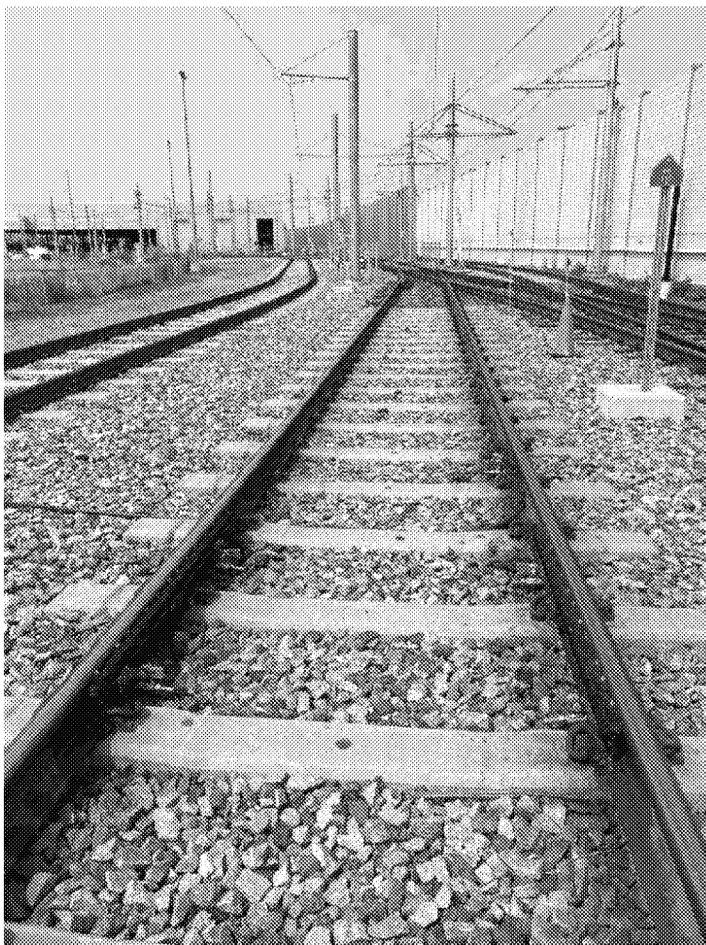
Figure 5.5: Wheel Flange Lubricator

Another item viewed during this site visit and as a result of the derailment on curve 19 on track 14 is the installation of a track-mounted wheel flange lubricator (**Figure 5.5**). This device supplies a lubricant at both rails on curve 19 on track 14. The lubricator applies the oil/grease to the wheel flange as the train passes over the device in either direction. This device does not meter the amount of lubricate applied to the wheel flange as it is a coating bath that the wheel flange will pass through. The track-mounted devices are fed from a reservoir and pumping device installed close by the location. However, the level of oil/grease being picked up by the wheel flanges while passing over the lubricator equipment is being applied in excessive amounts which leads to the lubricant being spread onto the rail crown surface from the passage of the wheels leading to potential wheel/rail adhesion issues (e.g., wheel spin/slide).

This wheel flange lubricator should be assisting in the ability of the wheelsets to pass through the curve with less likelihood of the wheel flange climbing the rail and causing a derailment, however, the evidence of the metal shavings on the rail near to the curve suggest that the wheel flange is still in heavy contact with the rail at this location.

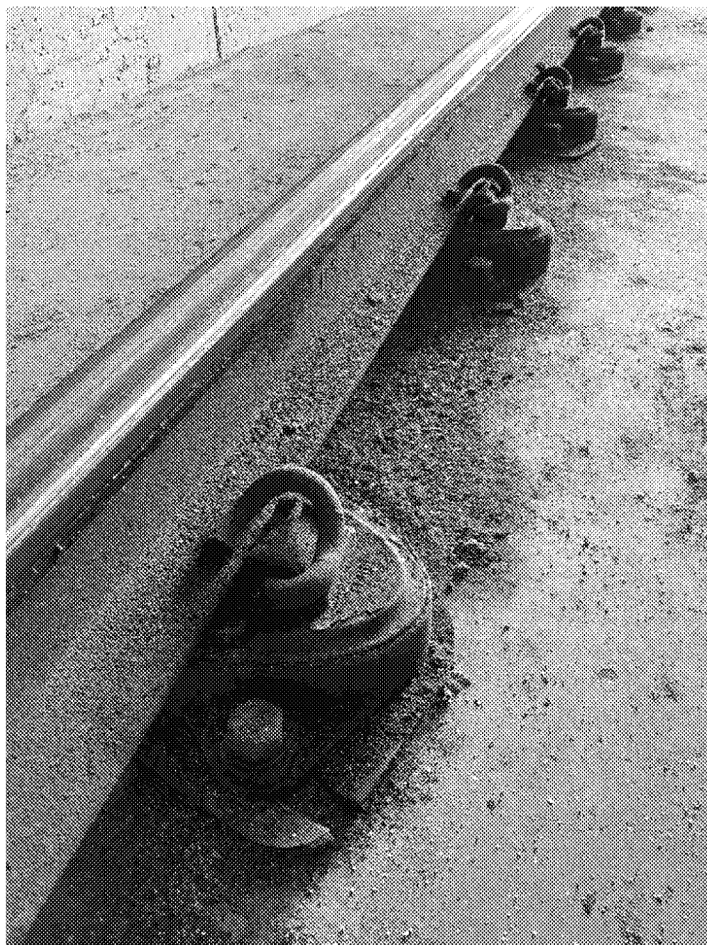
Figure 5.6: Manual Grease Application Location at East Connector Tunnel

Four of the five containment actions from the report were based on the vehicle. Item 4 calls for manual regreasing of all exit/entry tracks into the MSF.

Inspection of the rail found grease on both the gauge face and crown. It is clear that grease is being applied to the gauge face. There is significantly more grease on the rail crown in the area where grease is applied manually, than on the rail through the rest of the connector tunnel. The sand on the rail foot and tunnel floor in this area is also contaminated with grease.

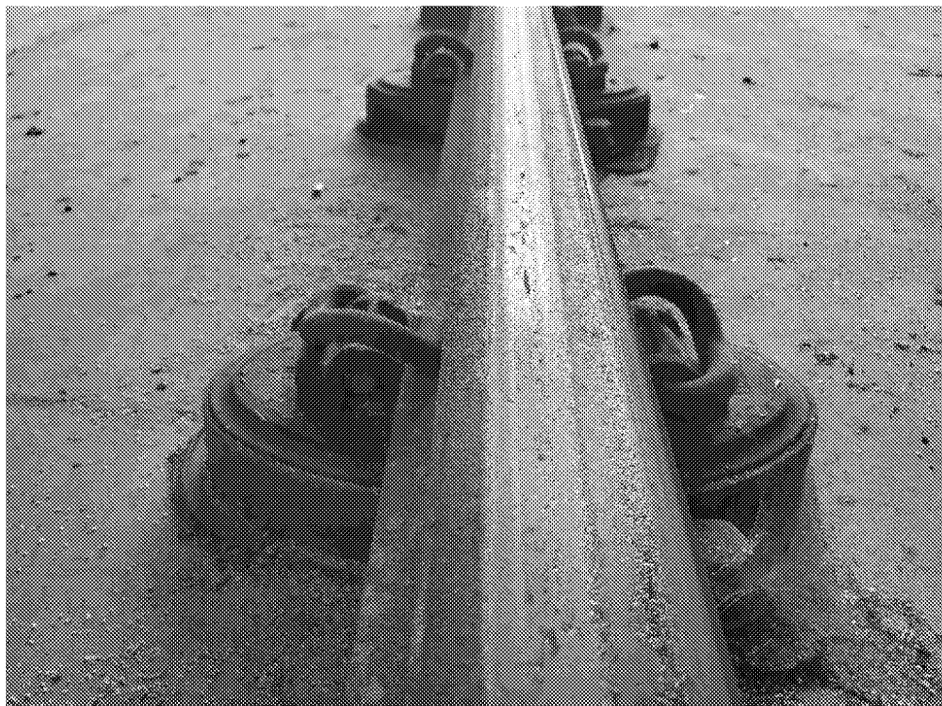
Figure 5.7: Grease on Rail Crown at Manual Grease Application Location

The presence of grease on the rail crown either from manual application to the rail or from the vehicle bourn flange lube applicators will have a significant impact on the tractive effort of the vehicle in both acceleration and braking.

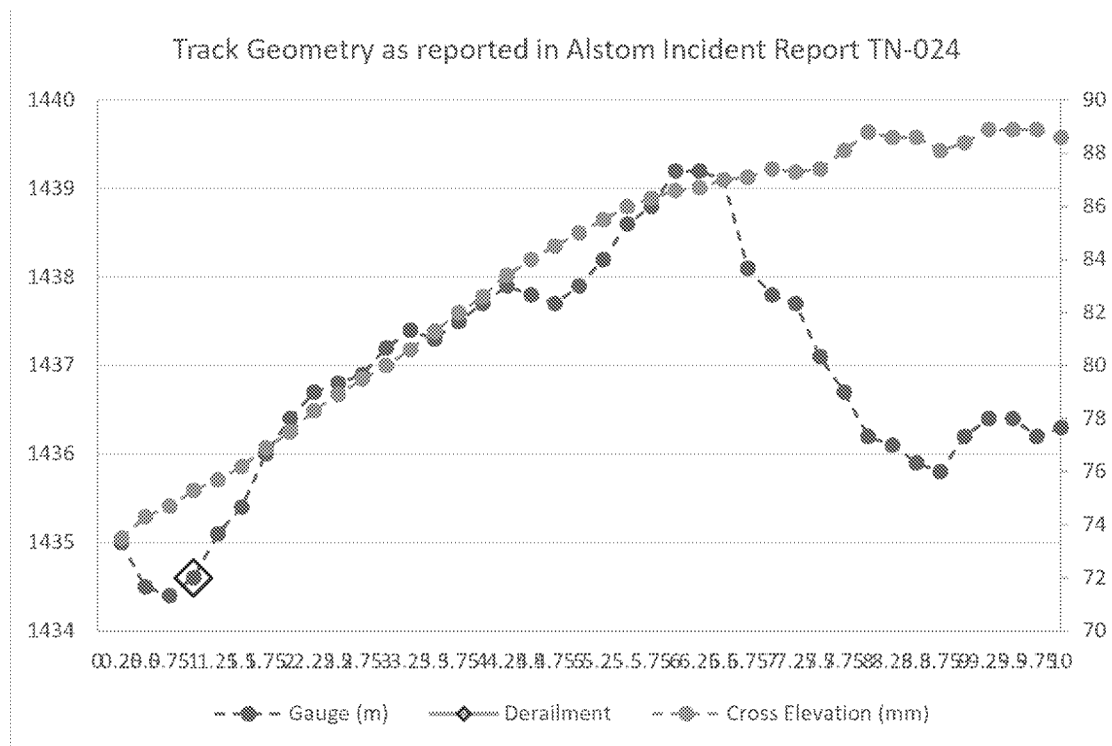
Figure 5.11: Track Geometry as Reported in Alstom Incident Report TN-024

The Alstom incident report contained 10m of gauge measurements which include the suspected location of the derailment. If the connector tunnel is considered part of the yard, all of these gauge measurements are within the reported tolerances. It is worth noting that the location identified for the rail climb and therefore derailment location is just after the tightest gauge location. There is also a note in Alstom's incident report TN-018 for LRV1126's yard derailment that "per best practices of fail, it is recommended to have gauge widening in sharp curves." The connector tunnel's tightest curve radius is 55.15m.

Inspection of the East Connector Tunnel showed that at least some of the conditions leading to the derailment of LRV 1126 still remain. No changes to the rail to address the tight gauge were mentioned or discussed as part of our site visit, nor was extending the checkrail to protect against another derailment in the same location.

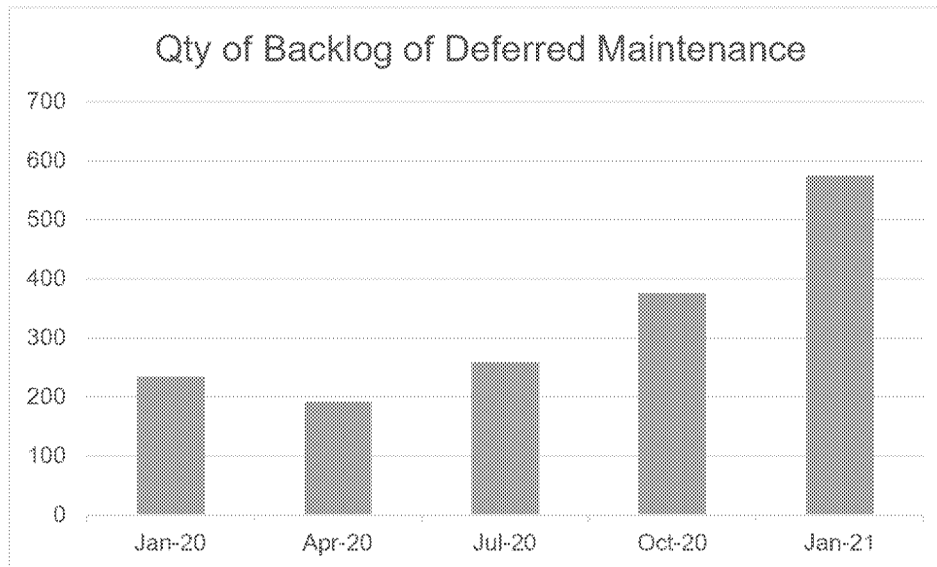
Figure 3.57: Quantity of Backlog of Deferred Maintenance

Additionally, there are 40 tasks which have been deferred for 12 months, and another 28 which have been deferred for 15 months. Of these 28 tasks, eight were not continuously listed in every quarterly report. It is not clear if these tasks were re-opened or if they were not included in the deferred maintenance backlog list.

This information combined with the improved availability reporting indicates that Project Co is focusing maintenance resources into keeping the fleet in service, but other maintenance tasks are accumulating. This will be compounded by two factors. First, once the passenger numbers return to a more normal state the COVID-19 reduced service will end, and full/normal service will resume. This will increase demand for service vehicles. Second, based on our Brampton on-site Vehicle Inspector observations it appears that Alstom are using uninstalled new parts originally destined for new vehicle assembly, as well as components from vehicles already delivered to support maintenance activities. Once the full fleet of vehicles have been delivered, these resources may not be available.

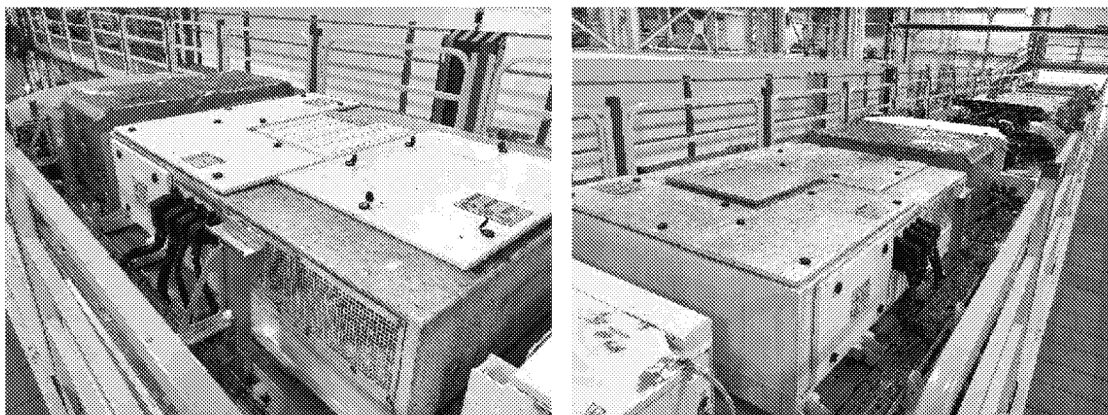
Figure 3.58: Examples of traction converter containers at Brampton

These examples of traction converter containers appear to have already been in service on a vehicle still under assembly at Brampton. Note the difference between other new roof equipment containers and the carbon-stained equipment containers, and a mix of both modified/unmodified line inductor ventilation covers.

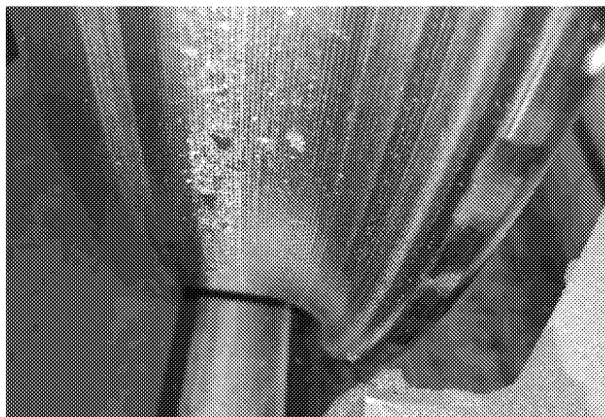
Figure 3.61: Coarse Machining Lines Observed During Site Inspection

During the on-site inspection, vehicle wheels which had recently been reprofiled on the wheel lathe were observed. The wheel shows coarse machining lines on both the tire tread and flange. This is typically related to the cutting feed and speed settings of the machining process.

A coarse surface finish increases the potential for the wheel flange climbing against the rail gauge face, potentially causing a derailment. This is especially of concern on the outer rail of a sharp curve and/or switch blade tip.

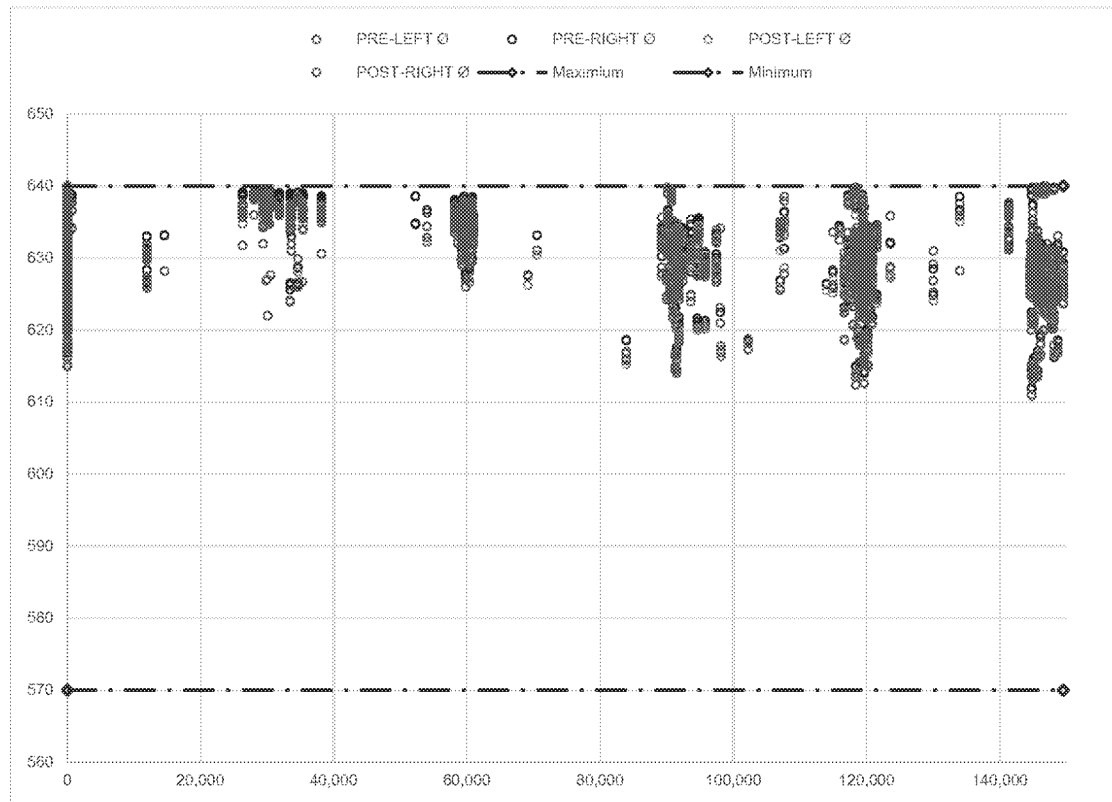
Figure 3.63: Chart of Wheel Diameter Pre and Post Wheel True

The wheel diameter data illustrated in **Figure 3.63** below shows clusters of data sets around regular mileage thresholds, with no wheels near the minimum diameter yet. The chart illustrates the magnitude of zero mile entries as mentioned above.

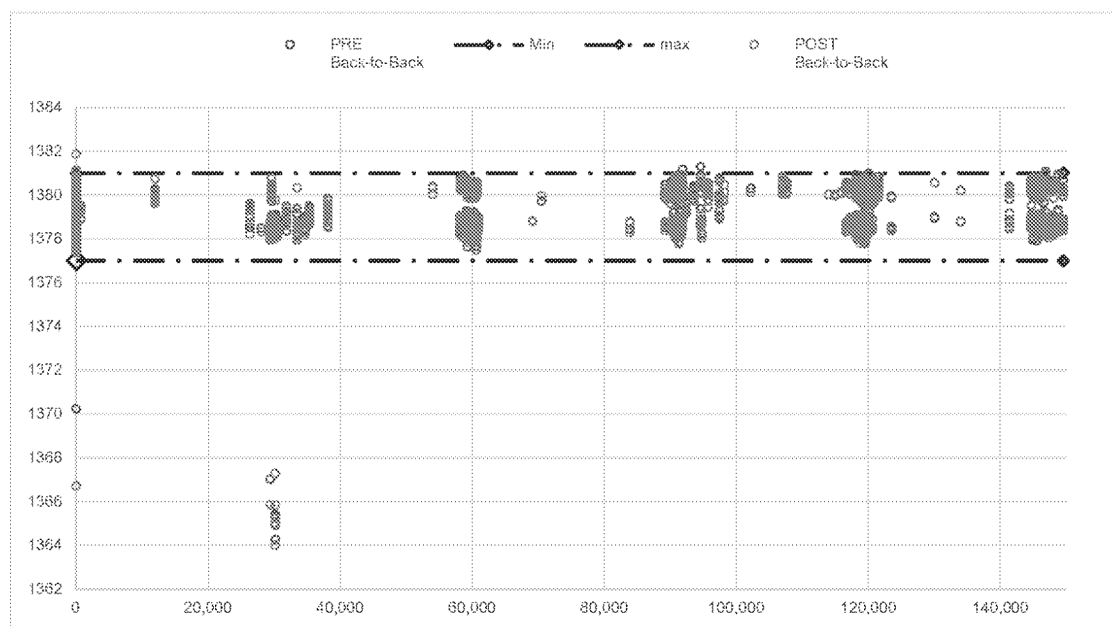
Figure 3.64: Chart of Back-to-Back Measurements Pre and Post Wheel True

The back-to-back measurement is a measurement of how far apart the two wheels on an axle are from each other. This is a key data point, as this controls where the wheels interface with the rail gauge face and safe passage through special trackwork without risk of potential derailment. The data shows a cluster of data points around 30,000km, but none after. This is a good indication that corrective measures were taken; however, it does raise the concern of how long those vehicles ran with an out of tolerance back-to-back measurement. It is possible that these vehicles were delivered in this state. Noting that back-to-back dimensions are critical to wheelset guidance through switches and interaction with restraining and guard rails.

Wheel flange and tread profiles and wheel diameters should be carefully managed, and wheel wear measuring and recorded carefully, including knowing the current wheel flange height/thickness (new/worn), tread wear/hollowing, and wheel diameter limits, as any misalignment of one profile, including out of tolerance wheel diameters relative to the other, will affect wheelset conicity, and hence stability and curving performance. The tread, when newly profiled, needs to comply with the requirements set out in the respective standard, for example BS 5892, Parts 3 and 6, EN13260 and AAR Manual of Standards and Recommended Practices. It is recommended to validate the wheel flange and tread profiles, and wheel diameters are being maintained in accordance with the relevant standards and Good Industry Practice.

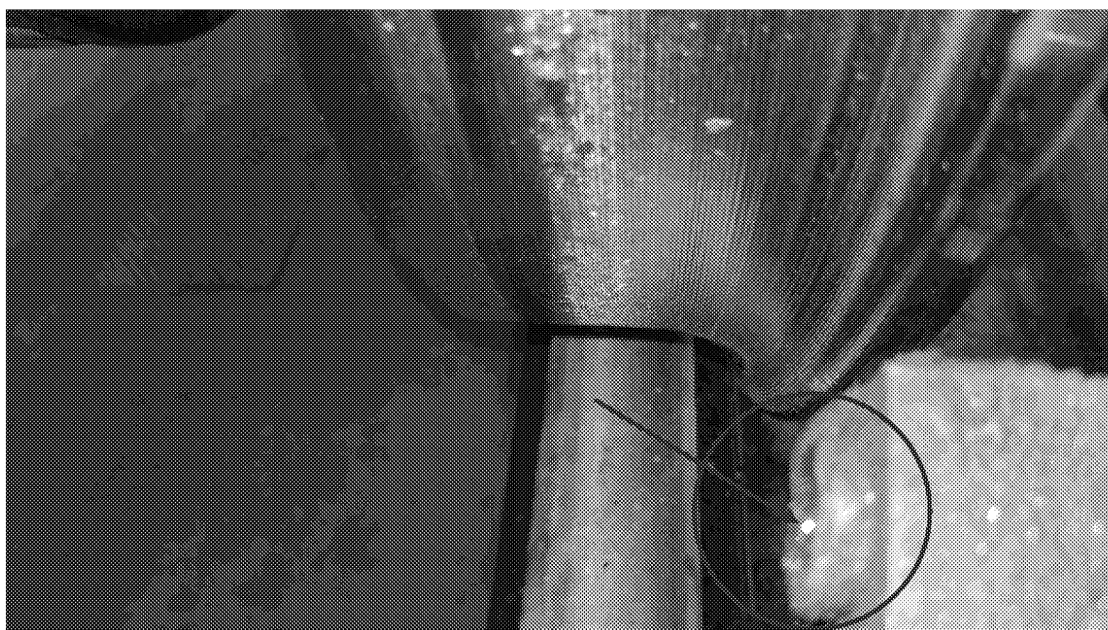
Figure 3.65: Missing Flange Lubrication Spray Nozzle

During the on-site visit, it was possible to inspect the on-board wheel flange lubrication system on a sample vehicle. There is only one truck/bogie (LCC1) out of the five installed on each vehicle that is fitted with this system, which includes four lubricant spray nozzles (one for each wheel). While inspecting the equipment, we noticed that one of the four nozzles was missing (see **Figure 3.65**), which would mean the adjacent wheel flange does not receive any lubricant. The missing spray nozzle may result in lubricant leaking onto the running rail surface during the operation of the lubrication system, which is automatically operated on a pre-set timing basis. This could lead to the oil being spread along the rail head by the passing wheels and potentially creating slip/slide conditions for not only this vehicle but others that follow.

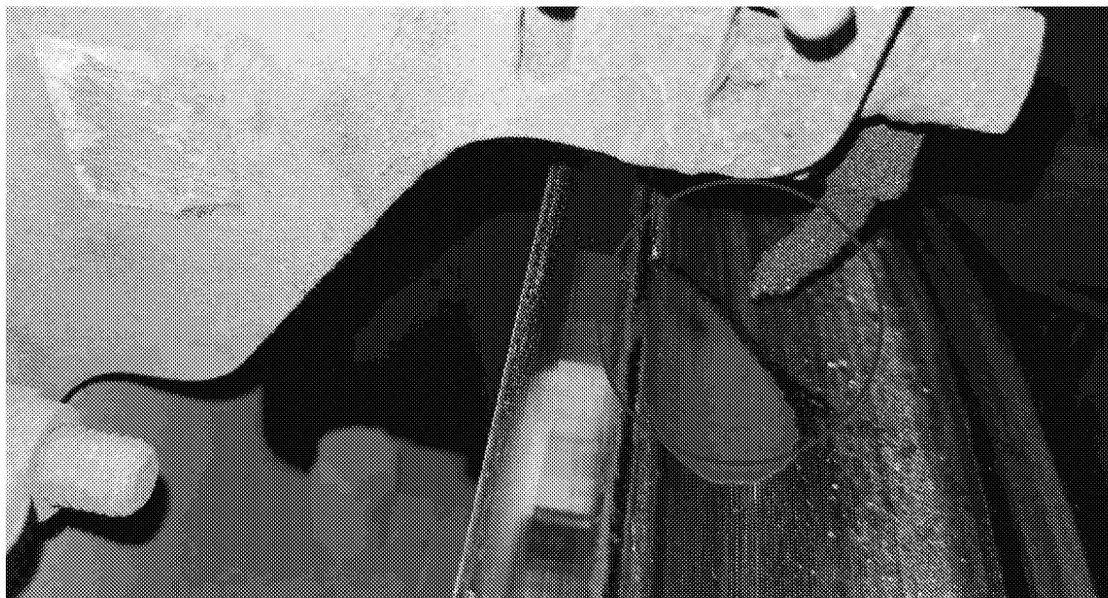
Figure 3.66: Incorrectly Set Flange Lubrication Spray Nozzle

It is important to note that the gap clearance setting between each spray nozzle and the wheel flange is critical in ensuring the lubricant is ejected at the correct angle to ensure the flange is lubricated correctly. Otherwise, the amount of lubricant either does not contact the correct area of the flange or it sprays onto the wheel tread, which is likely to result in the wheel transferring the lubricant onto the rail surface (see **Figure 3.66**). This compromises the friction on the wheel tread, leading to wheel slip/slide situations and inherently prevents the lubrication intended for the wheel flanges from being transferred/applied to the gauge face of the rail.

Maintenance staff indicated that the lubricant reservoirs are “topped up” every two months or so even though reservoir is small. The on-board lubricant reservoir needs to be monitored to determine usage to determine the maintenance intervention timescales, as it is not recommended to run between maintenance intervals with no lubricant being applied otherwise the flange/rail conditioning will be lost, which may result in having increased rail/rail wear and potential noise.

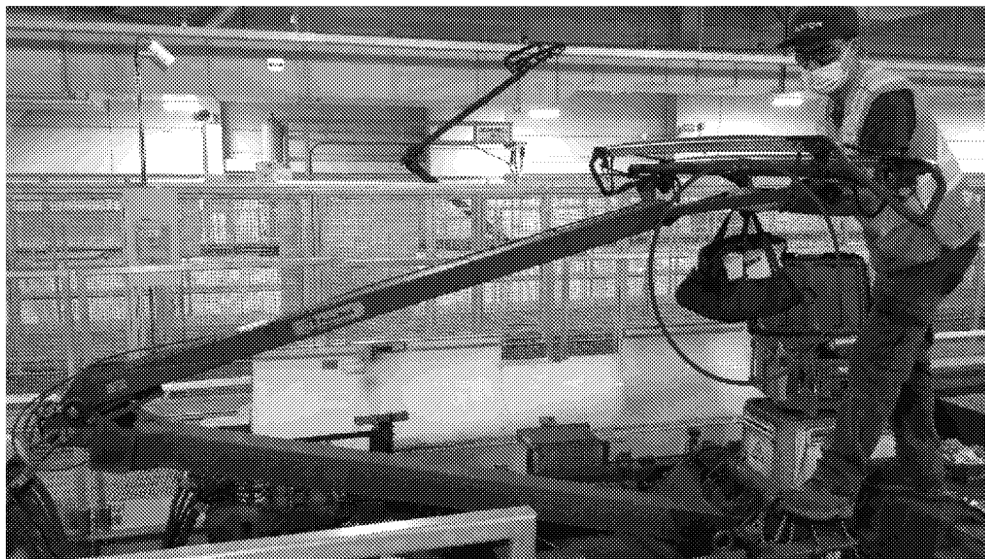
Figure 3.67: Current Project Co. Pantograph Force Check

One of the mitigation items specifically mentions ensuring the pantograph spring tension or contact force is set correctly. During an on-site visit, the process of measuring and adjusting the pantograph contact force was observed.

The process includes the use of a tool bag with 23 lbs of weight hung from the pantograph head, and pantograph position checks were observed at three positions: low, medium, and high. The spring pressure was adjusted until the pantograph head stayed stationary. This weight value and upward force checking process could not be validated against the OEM requirements.

The procedure adopted by Alstom does not align with typical OEM maintenance requirements, and therefore the actual force setting cannot be assured. A copy of the OEM maintenance procedure was requested but has not been provided.

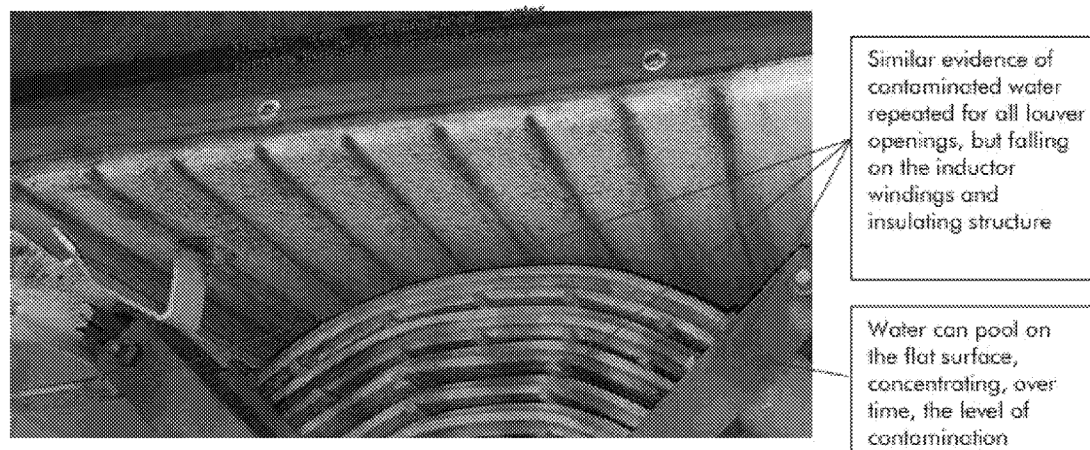
Figure 3.69: Inductor Compartment of a Typical Traction Case, After 75000 km

- ✱ Pantograph carbon dust deposits
- ✱ Copper particles from the OCS
- ✱ Salt used from de-icing the roads on over-bridges
- ✱ Water ingress

According to the line inductor failure reports, peaks in failures tend to occur in late December / early January, on days with precipitation and when the temperature is just above 0°C. This is shown in figure below. This implies that failures are most common on rainy and/or freezing rain and/or wet snow mix. On days below 0°C when it is snowing without precipitation, there are no reports of failures. Snow, while it may enter the present louvered ventilation cover design in small quantities, will largely blow off the top of the cover due to train motion. Rain, however, can flow across the surface of the cover, run directly in the louvers in concentrated streams and carry contaminants with it. This is illustrated in the chart below.

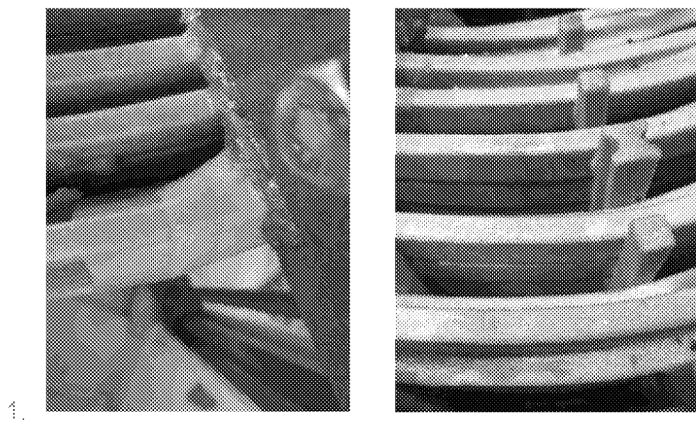
Figure 3.71: On the Left the Prototype; On the Right Serial Number 169

Alstom have identified quality issues within the insulation impregnation process. Below illustrates the difference between the prototype (B1841 – AY00000206364) and the failed line inductor (serial number 169).

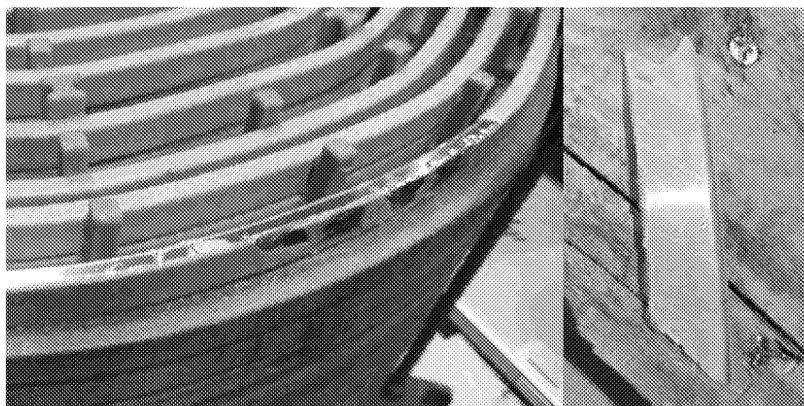
Figure 3.72: Serial number 169: Single Layer of Nomex on the Individual Conductors

On each conductor (serial number 169) there was a single, non-overlapped layer of Nomex. This is a quality issue, as two layers of Nomex should be applied when constructed.

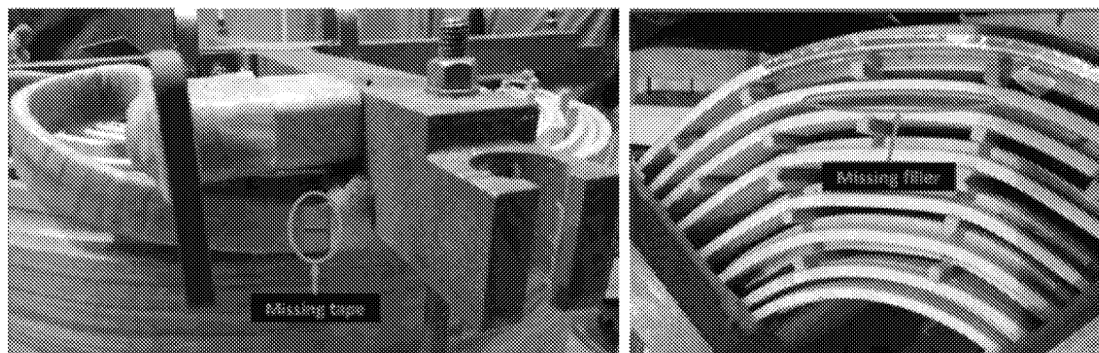
Figure 3.73: Serial Number 169: Missing Tape and Filler

Tape and filler are not present. Filler is used to avoid accumulation of dust and contamination between the turns.

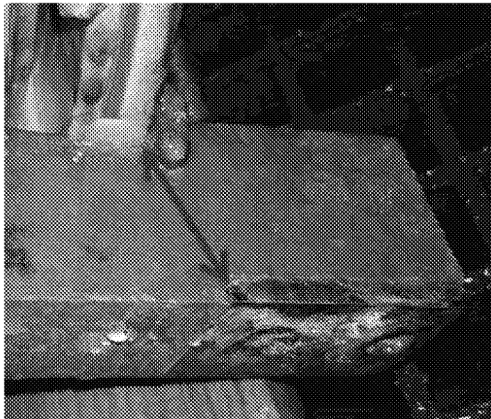
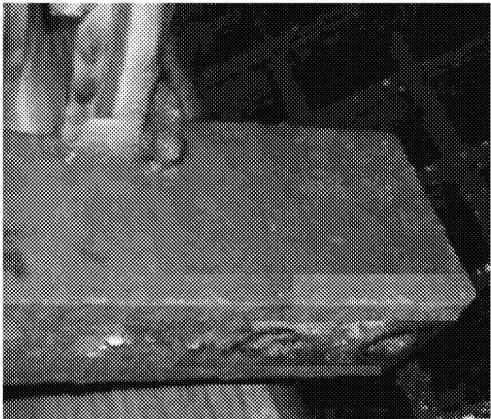
Figure 3.78: Proposed Creep Distance Improvement

Still to be addressed is the clamping assembly of the inductor, with current design and proposed modifications illustrated and discussed below. Alstom state that this has been seen in some cases to have been the end of the tracking path from the windings to the chassis.

<p>Current Design:</p> <p>The Inductor clamp bar is integrated into the bottom insulating support and the mounting. This part is grounded and the distance to the outer layer of the coil is very marginal.</p>	<p>Proposed design:</p> <p>This plate should be reduced in width and embedded into the channel and sealed during the VPI process to increase the distance to the exposed parts and / or change the breakdown from creep over the surface to breakdown through the solid insulation.</p>

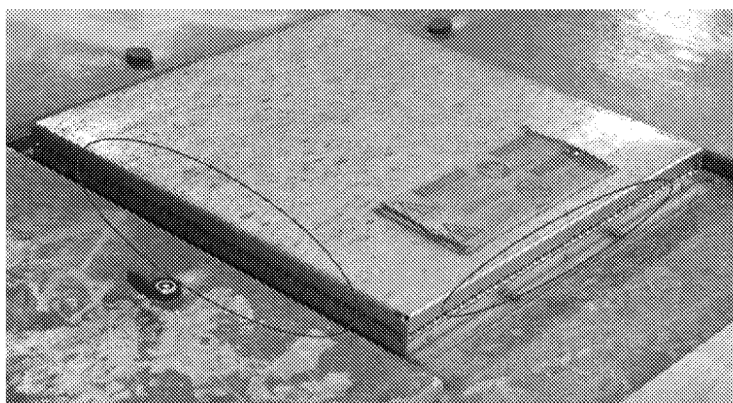
Figure 3.80: New Line Inductor Cover

These documents contain information regarding the next steps for mitigation, although they have not confirmed if the small ventilation holes on the new type of line inductor cover could provide sufficient ventilation to the inductors, especially if the holes became blocked by snow, leaves or other contaminants. Should the airflow be restricted, this could lead to potential overheating and deterioration of the line inductors insulation and result in more short circuit/flashovers.

Since these modifications were implemented, and despite requests, there has been no evidence/documentation to demonstrate there is adequate airflow passing through the ventilation holes /temperature of the inductors or use of testing equipment such as: anemometer for air flow, or thermometer for temperature.

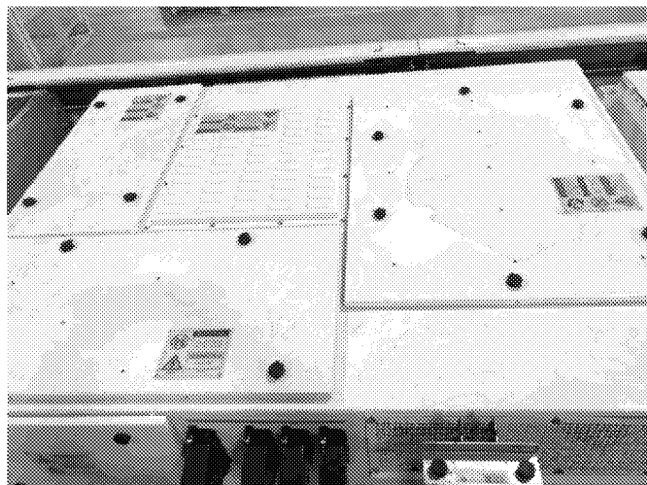
Figure 3.83: Previously Used Traction Converter Installed on LRV1152

During the pre-shipment inspection at Alstom's Brampton facility on March 16, 2021, it was observed by Mott MacDonald's Resident Vehicle Inspector that it appeared that previously used traction converters from revenue vehicles have been installed on 1152, see Figure 3.83 below. Noting that other subsequent new LRVs have also been observed with used equipment mounted on them.

This assumption is based on the fact that the line inductor ventilation cover shown above is of the original design, with the ventilation openings on the top of the cover (**Figure 3.83**). As previously discussed, the revenue fleet has been undergoing a modification/rectification program since mid 2020 to replace the cover and to rework/replace the inductors as part of the Rectification Plan. Following this finding, Mott MacDonald have since carried out a close inspection of the photographs taken from previous pre-shipment inspections of 1149, 1157 and 1151, this has identified that in addition to 1152, discussed previously above, the other three vehicles also had the original design of cover fitted. These observations are rather discerning as they demonstrate a lack of configuration control between what has been implemented by Project Co on the revenue vehicles and what is being supplied by Alstom on the new vehicles being manufactured at their Brampton facility.

Without further investigation, it is unknown whether the modifications/rectification work identified in the Rectification Plan has also been carried out to each of the line inductor units. Therefore, there is a risk of reintroducing equipment into the Ottawa fleet that has the potential to fail in service, as encountered previously. Also, if our assumption is correct and the traction converters identified, with the original design covers, have been previously removed from revenue vehicles due to earlier in-service failure/faults then there is a further potential risk of repetitive problems being reintroduced into the fleet. Without a robust configuration management system in place to provide the necessary control and traceability of previous faults/repairs/modification status there is a likelihood the fleet and ultimately the passenger service will suffer both in the short/long term.

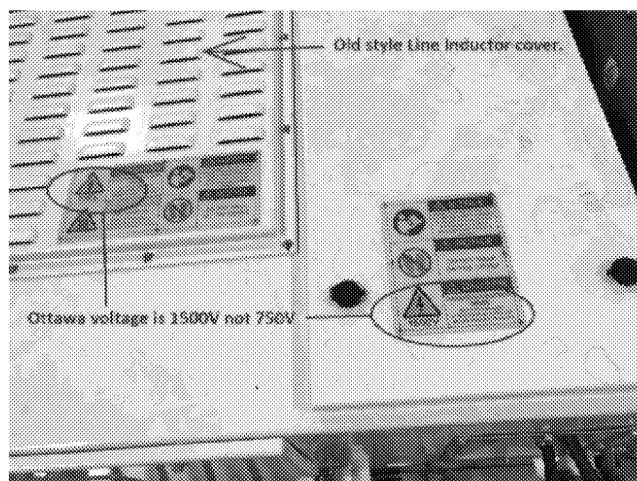
Figure 3.84: Propulsion Converter Indicating the Wrong Voltage and Using the Old-Style Line Inductor Cover

To add further concern about configuration concerns, it was also noted during the pre-shipping vehicle inspections that the high voltage warning tag plate installed on the ventilation cover, indicates 750V instead of the 1500V used for the Ottawa vehicle (**Figure 3.84**). In this case the configuration issue also presents a safety concern related to mislabeling of an electrical component.

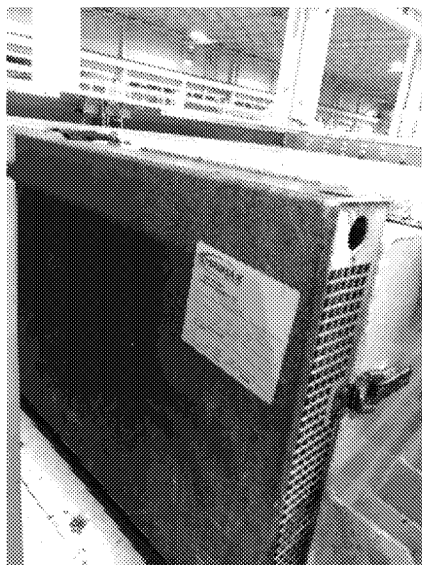
Figure 3.86: Pre-Used APS Unit Installed

During the LRV pre-shipment inspection of LRV51 at the Brampton manufacturing facility (February 22 to March 5), it was observed by the RVI that two pre-used APS units had been installed on this vehicle. However, it was observed that these APS units at the Brampton facility do not appear to be a retrofit but a repair, as approximately 15 used APS units have been seen on the shop floor at the Brampton facility waiting to be repaired. Without additional information, it is assumed these used units waiting to be repaired are ones that failed during revenue service in Ottawa. There is an area in the Brampton facility dedicated to the repair of APS units, and a representative for the OEM, Adetel, is on-site full time performing the repairs (**Figure 3.86**).

As previously discussed above, the apparent lack of configuration control and traceability for vehicle related modifications/rectifications is a concern, if the repaired/used APS units that are refitted to production vehicles are in an unmodified state i.e., without the proposed software update. This could result in further reliability issues with the new LRVs coming from the Brampton facility.

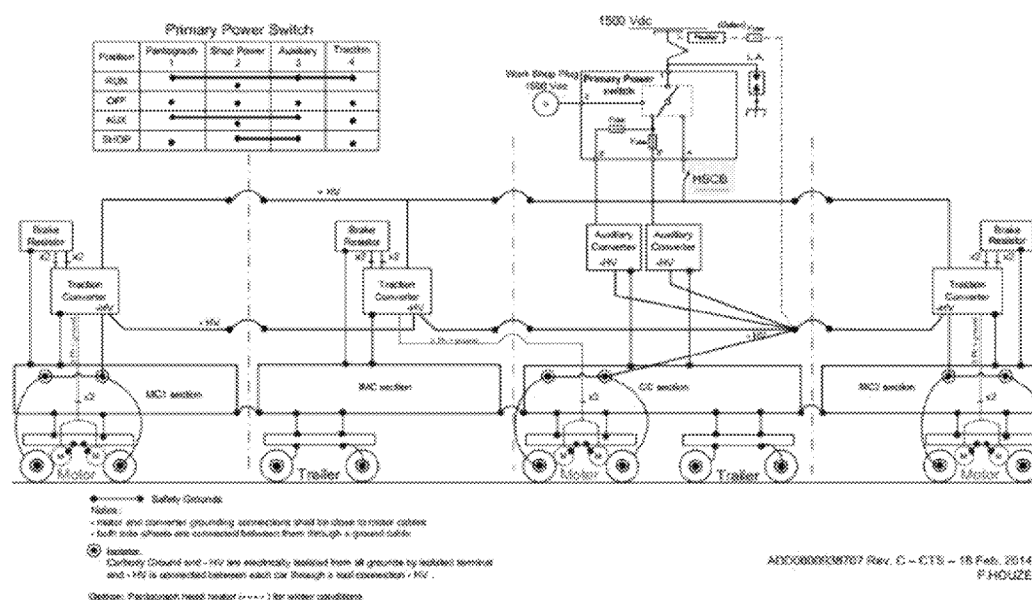
Figure 3.89: Citadis Sprit 404 - 1500Vdc HV Supply Circuits

The image below, taken from Alstom's *MTNMTN-TLOTT-WMS-003 - Citadis Spirit Vehicle Operating Manual_Rev E*, illustrates that when the HSCB is open, the traction converter will be isolated from the 1500Vdc high voltage supply, as required by 3.23 (c iii) above, whilst the Auxiliary Power Supply will not be affected and remains energised, which goes against requirement 3.23 (d).

Although Alstom's HSCB design is noncompliant to the PA clause 3.23 (d), Mott MacDonald is aware from previous/ongoing experience that Alstom's Citadis Spirit HSCB functionality is in fact consistent with other similar LRV HSCB designs/functions, noting that the PA requirement would result in a total loss of power supply for HVAC, low voltage DC power, battery charging, and lighting for instance, in the event of an emergency brake application.
