Ottawa LRT Independent Review Report

April, 2022
Confidential

City of Ottawa
c/o Singleton Urquhart
Reynolds Vogel LLP
150 King St West, Suite
2512
Toronto, ON
M5G 1J9

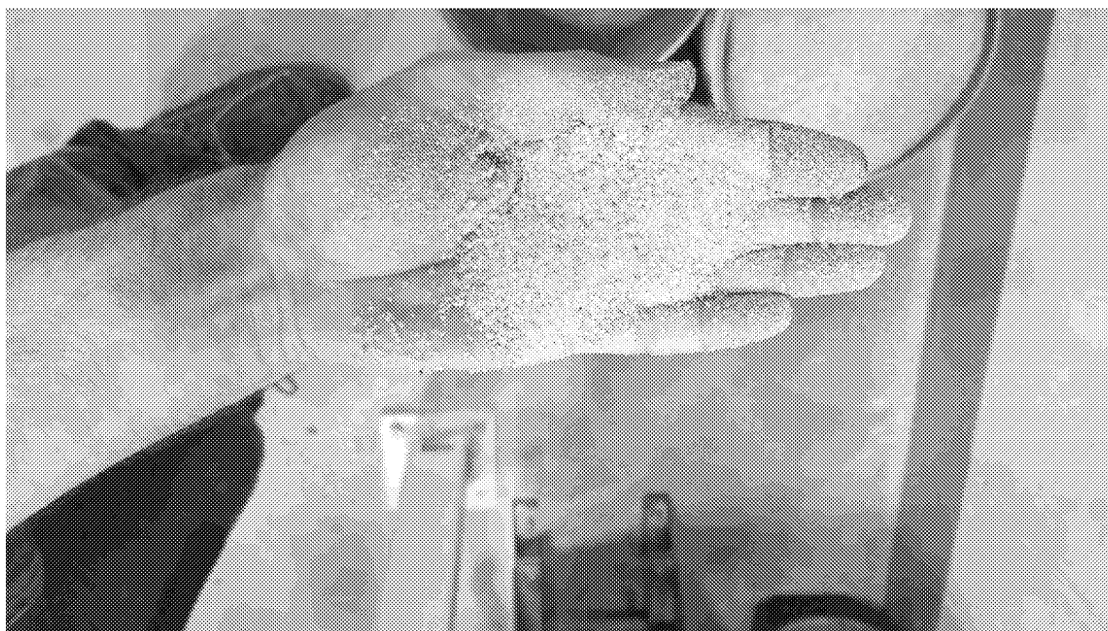
Figure 3.90: Photo of New Coarser Sand

Incorrect sand was initially supplied, which lead to clumping and freezing, clogging the on-board sand delivery system. This sand is an integral part of the vehicle braking and acceleration calculations and may be contributing to the wheel flats/braking/over speeding issues. New sand has now been supplied and was observed as part of the on-site visit.

The functionality of the on-board sanding system and new sand type needs to be confirmed against the OEM specification requirements. In addition to the on-board sanding system, the new sand type needs to be confirmed with the MSF sand dispensing system OEM to ensure there are no compatibility issues.

During winter it is recommended to top-up the sand boxes and test the sanding system functionality daily prior to operating on the network.

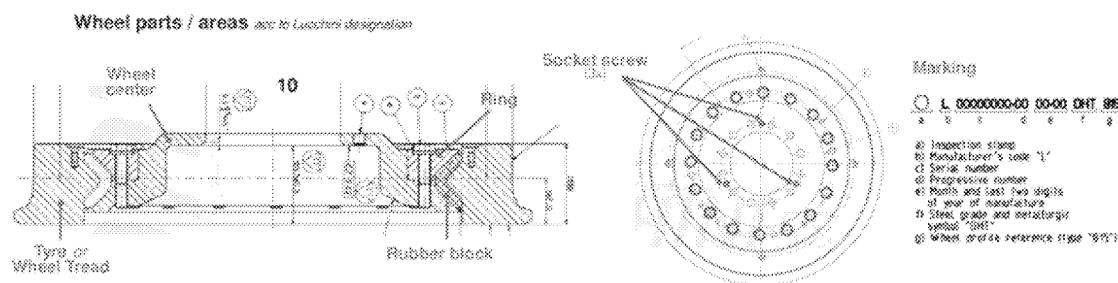
Figure 3.92: Wheel Parts Including Socket Screws

Our initial conclusions from this issue tend to indicate that the root cause has been identified, which was related to the leaving in place of the socket screws during the wheel assembly (see **Figure 3.91**), which protruded out of the threaded holes used to extract and remove the wheel. Additional wheels have since been identified with cracks appearing in the same manner as the previous, but without further information we are unable to determine whether they are related to what has been found previously.

Going forward, it is important to understand Alstom's mitigation strategy for preventing the issue from being repeated during future manufacturing, maintenance, and overhaul of the wheels. However, recent observations by Mott MacDonald at Brampton have identified that wheels are still arriving on-site with the screws still in place and has resulted in new vehicles being sent to Ottawa with them still in place. Mott MacDonald were aware that 1152 had been transported to Ottawa with them in situ, but this would be the last vehicle with them in place.

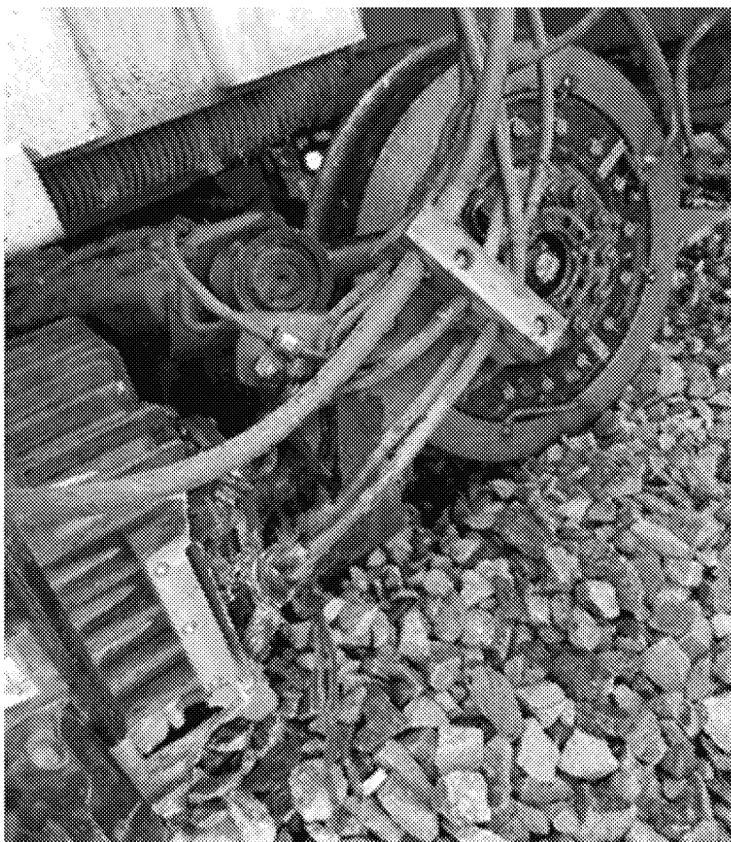
Figure 4.29: LRV1121 Derailment September 2021

While this Section of Volume 5 is not intended to cover the details of the derailments, as they have been covered elsewhere, it is however important to note that the confirmed primary cause of the September derailment was related to improperly torqued bolts on the gearbox, see **Figure 4.29** below. The investigation identified that there are issues related to maintenance and management practices, which further supports our other observations and findings related to vehicle maintenance concerns.

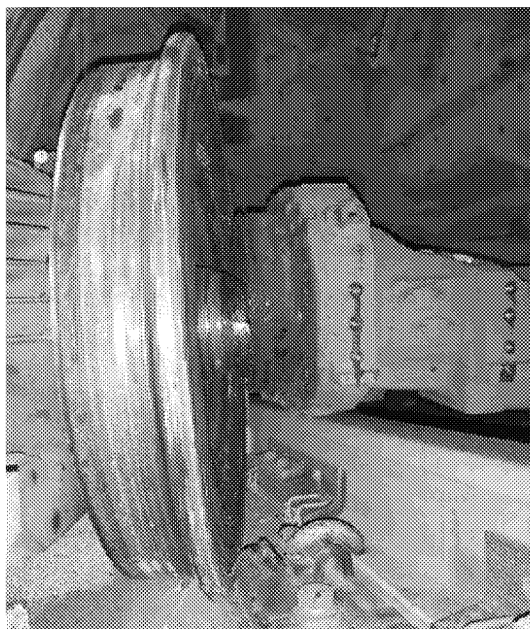
Figure 4.30: LRV1119 Derailment August 2021

The August derailment was related to a wheel bearing failure on 1119 that resulted in the detachment of a wheel which led to the train being derailed, see **Figure 4.30** below. It is understood that the root cause of this derailment is still under investigation.
