Rideau Transit Group 805 Belfast Road Ottawa, ON K1G 0Z4

25 April 2020

Subject: RTG Revised Plan

Ottawa LRT Project – Project Agreement, dated February 12, 2013 ("Project Agreement")¹, between the City of Ottawa (the "City") and Rideau Transit Group Partnership ("RTG")

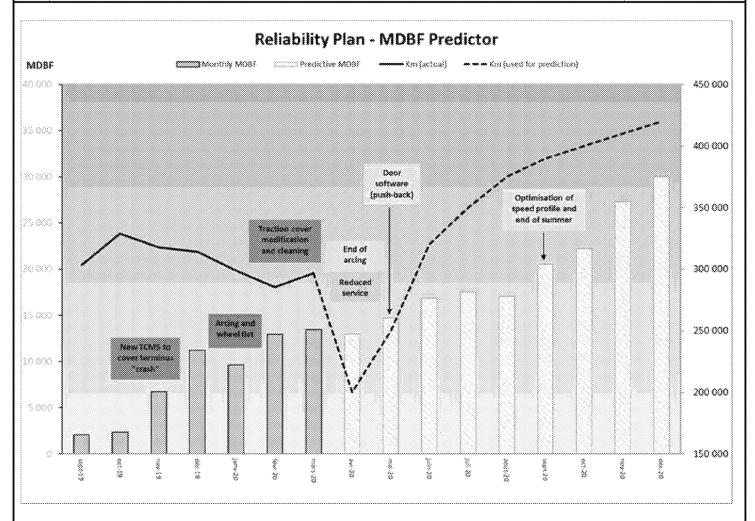
RTG considers the rolling stock service affecting related failures to be the focus and priority in translating information pertaining to the reliability curve, as they naturally contribute to a higher percentage of the impact on reliability and availability of trains for service.

The Growth Curve represented currently in the plan (image above), is primarily focused on the predictors associated with rolling stock. The predictors are representative of the forecasted modifications, software enhancements and planned fixes associated with the key rolling stock vehicle systems identified in the plan.

The curve is a conservative representation at this stage that still considers nominal failure rates and accounts for a certain level of progressive improvement based on the timing predicted for the key vehicle systems (e.g. Inductors, Passenger Door Mods etc.).

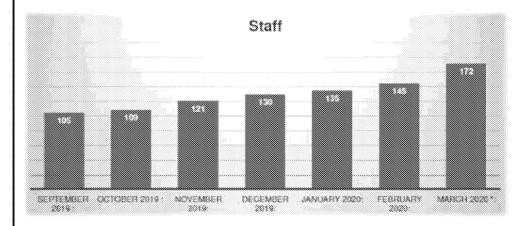
The Vehicle Maintainer (VM) since revenue start-up has continued to increase staffing as demonstrated in the graphic below ("Staff"). Since September 2019 resourcing has increased by more than 60%. The VM has made adjustments in structure and alignment with operational and maintenance demands.
