Weekly MRS review

28/08/2019

Since beginning of Trial Run (August 3<sup>rd</sup> to August 26<sup>th</sup>) – Main events

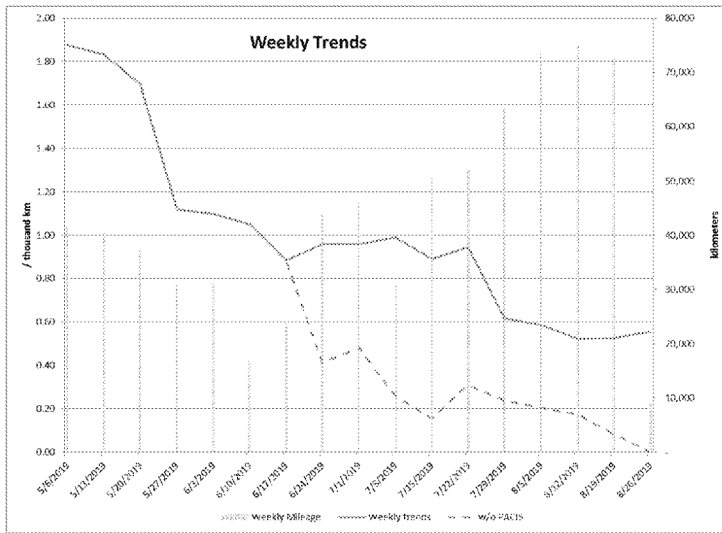
### Reliability – weekly trends

From August 3<sup>rd</sup> to August 26<sup>th</sup> – All events

- From DOR from RTM, 247.514 km, 752 MRS related to vehicle (out of 2344 overall).

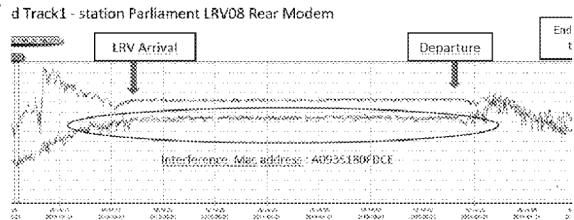
Delay in obtention of Lyon & Parliament stations wayside :

- in case of forced short stop (5s between door open and door closure)
- Potential interferences with other systems.

In case of loss of mission (less than 10% of switching for ATO to ATP-M), driver's intervention to select the station.
